Exhibit 7B MPE Test Report Photographs

Motorola Solutions Inc.

EME Test Laboratory

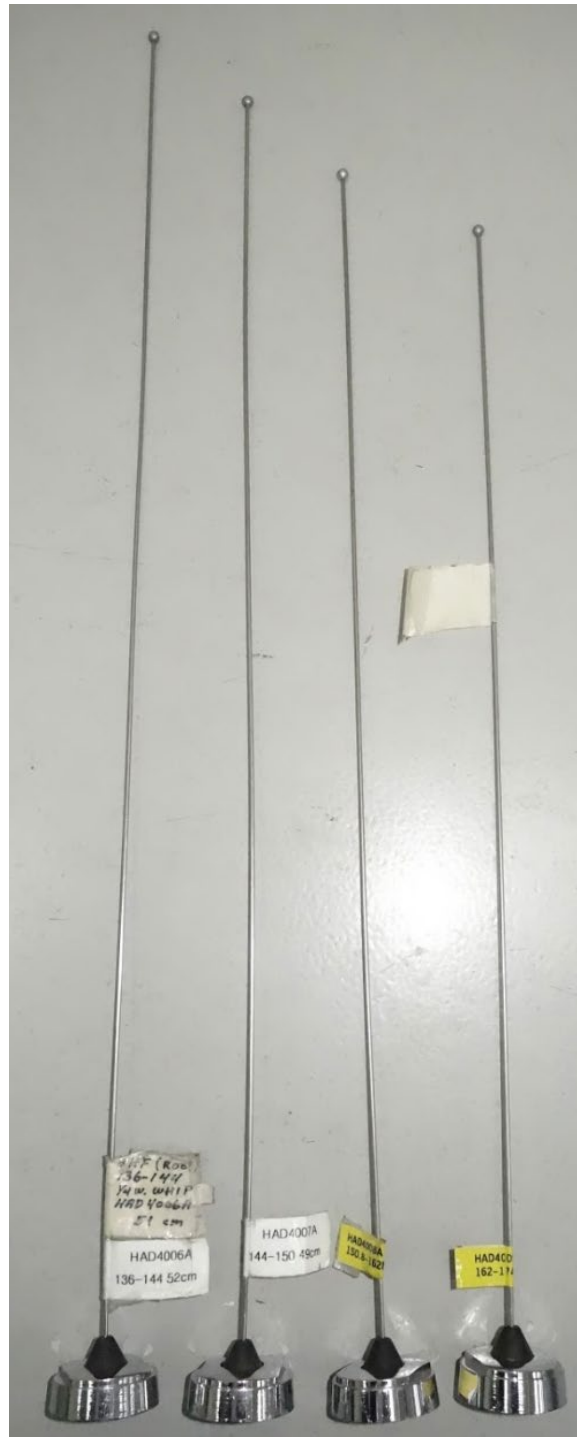
**VHF Antenna kit numbers, from left to right
HAD4006A, HAD4007A, HAD4008A, HAD4009A**

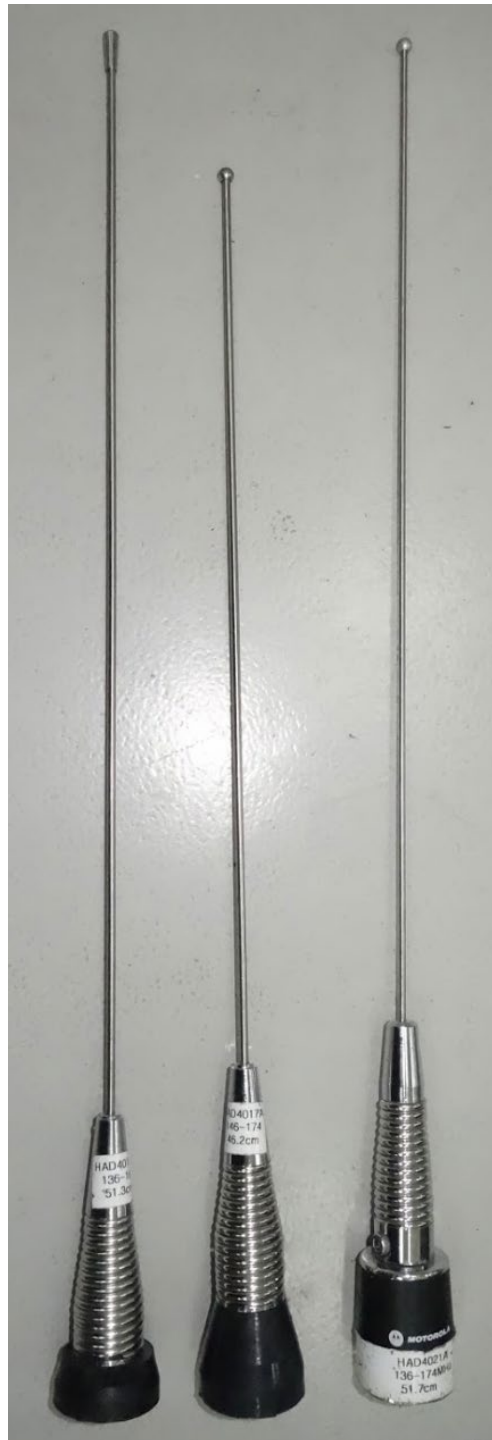
**VHF Antenna kit numbers, from left to right
HAD4016A, HAD4017A, HAD4021A**

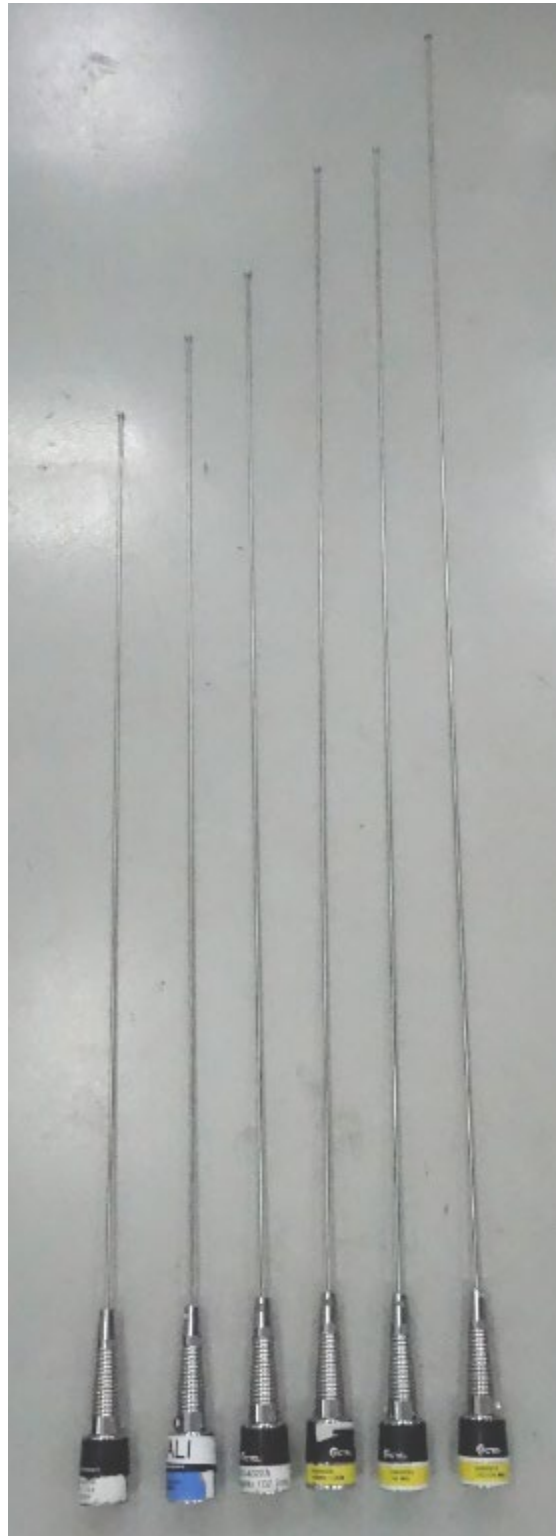
VHF Antenna kit numbers
HAD4022A (6 pcs)

Note: Antenna length trimmed to frequency.

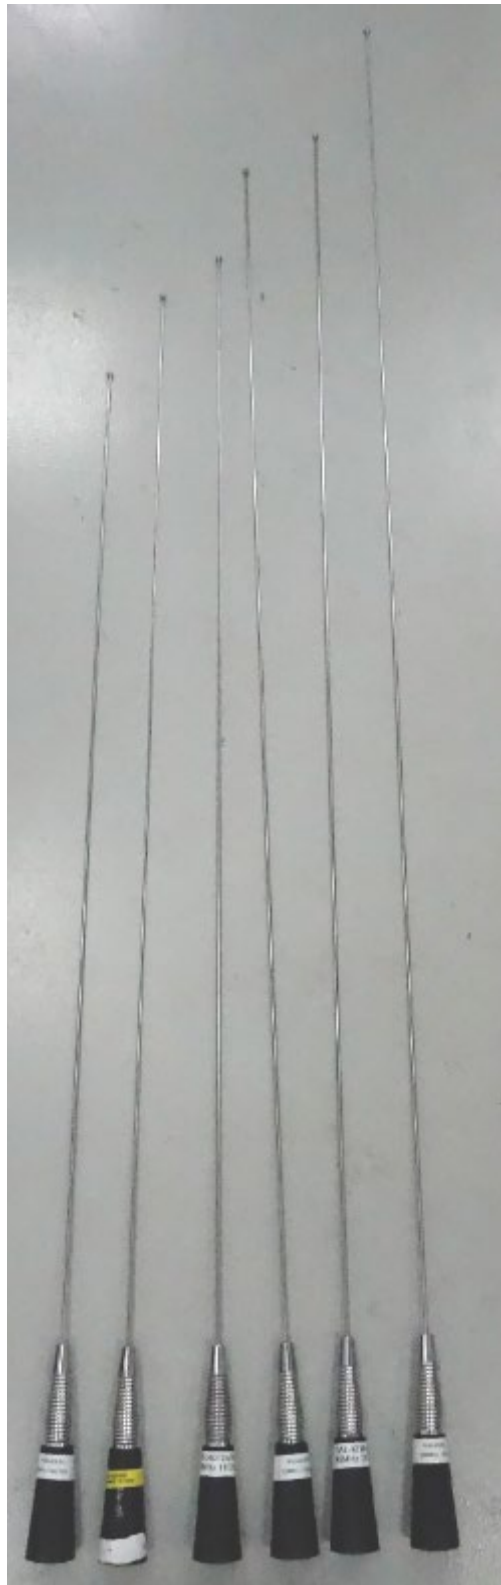
**VHF Antenna kit numbers
RAD4010ARB (6 pcs)**

Note: Antenna length trimmed to frequency.

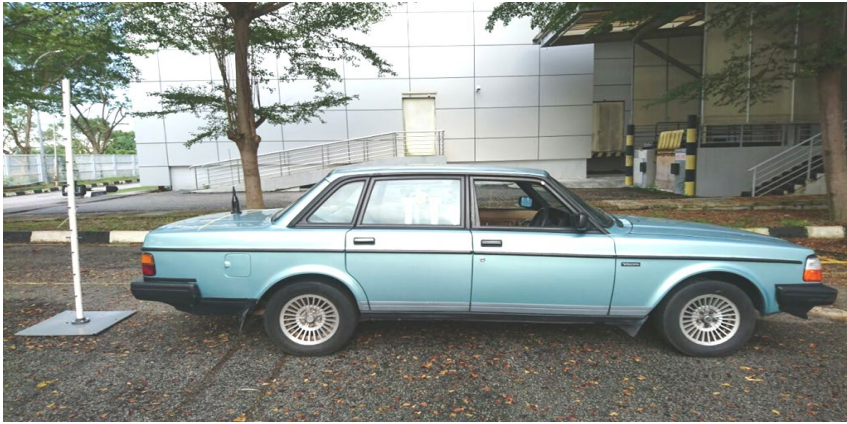
Test measurement setup for Bystander, trunk mount antenna behind vehicle

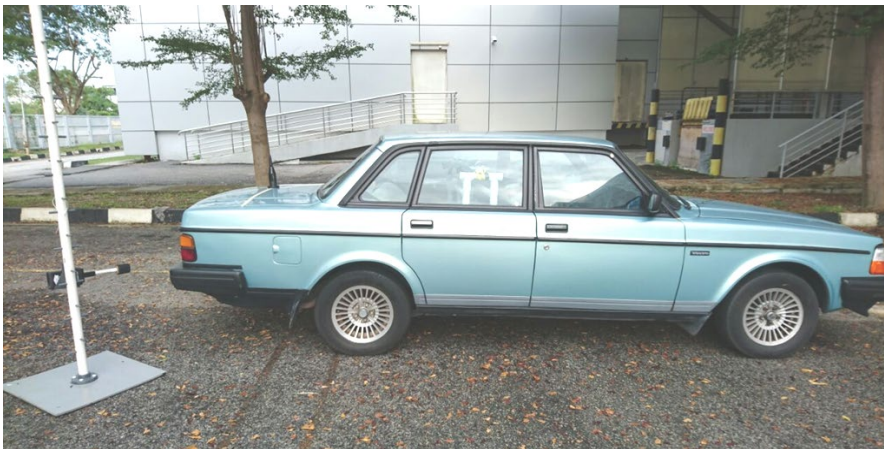
Test measurement setup for Bystander 45 degree (diagonal) trunk mount antenna

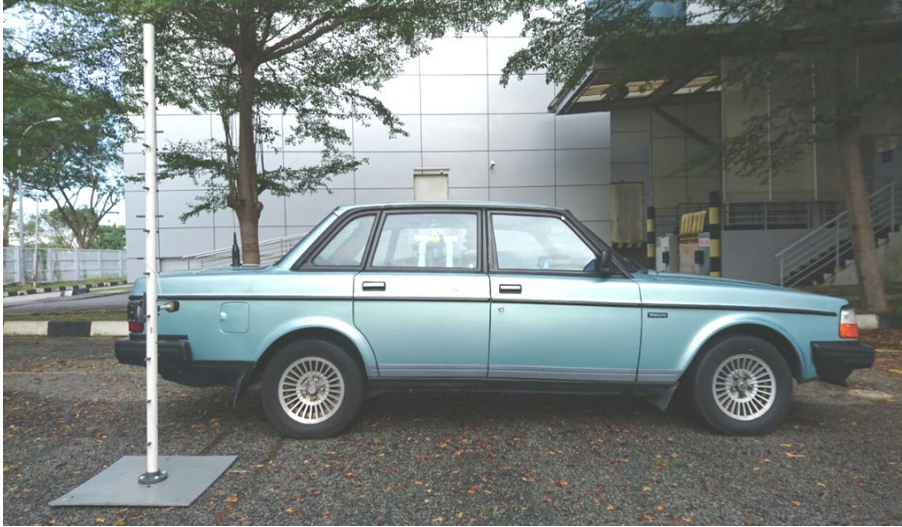
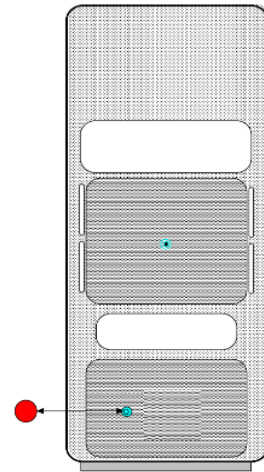
Test measurement setup for Bystander 90 degree (side) trunk mount antenna

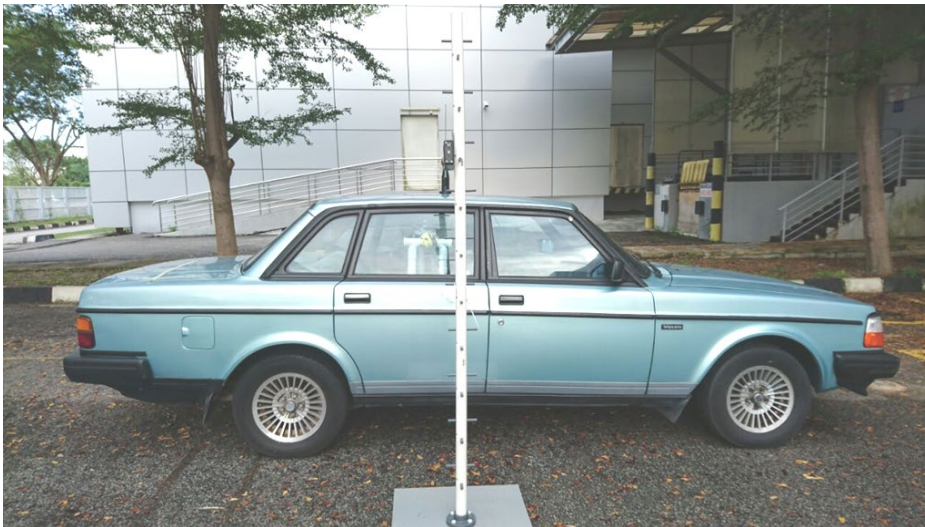
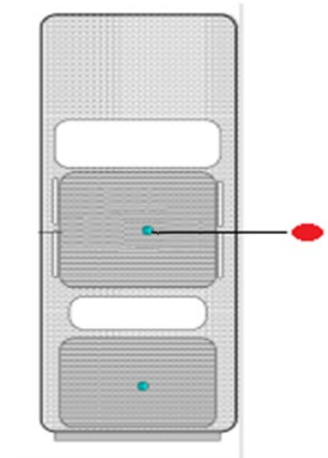
Test measurement setup for Bystander roof mount antenna

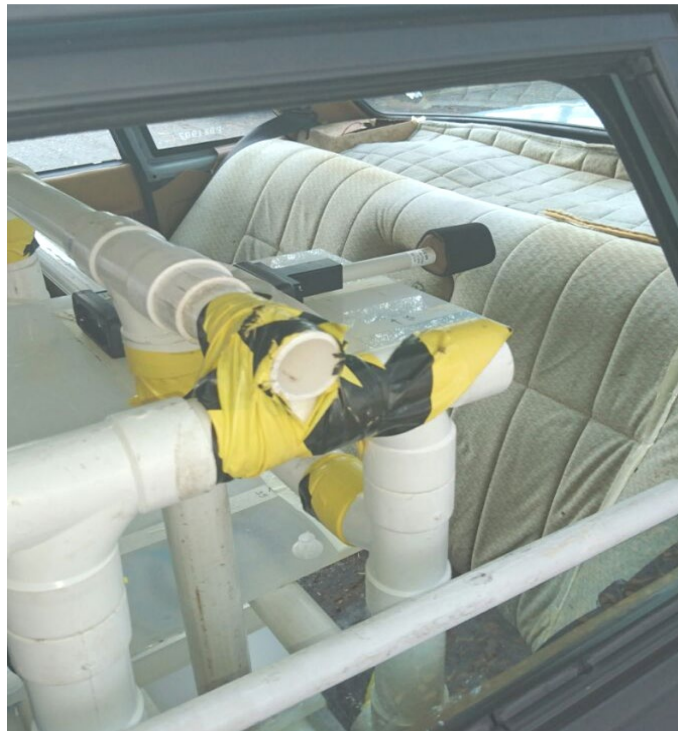
Test measurement setup for Passenger Back

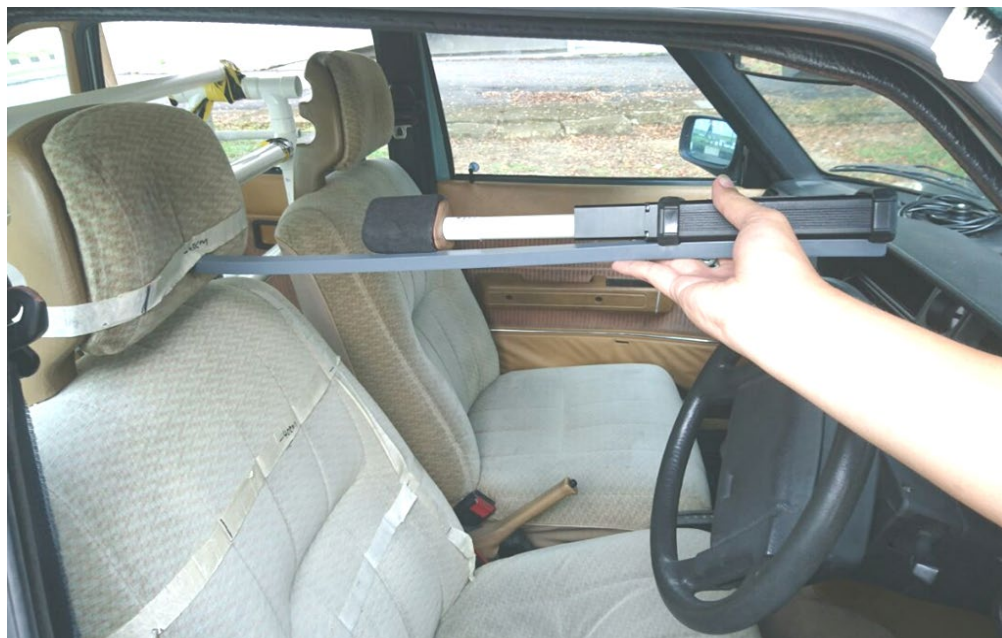
Test measurement setup for Passenger Front

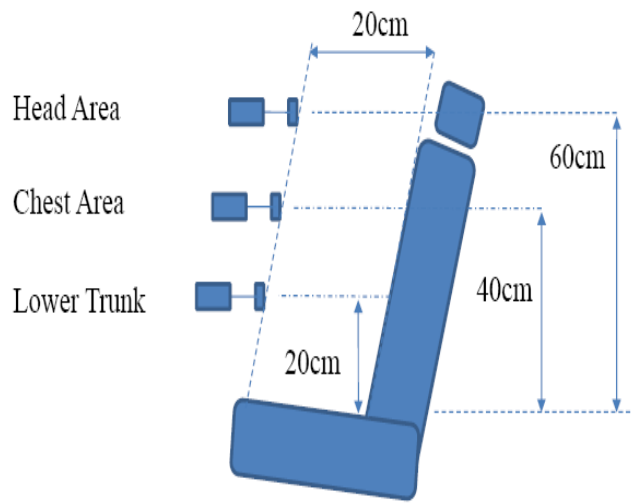
Test positions for Passenger Back and Front

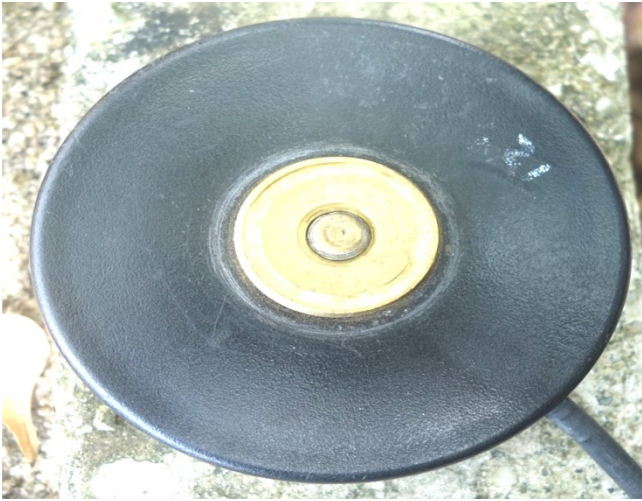
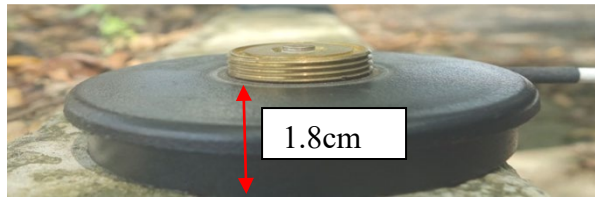
Magnetic mount base (top and side view)
