**Exhibit 7B MPE Test Report Photographs**

**Motorola Solutions Inc.**

**EME Test Laboratory**

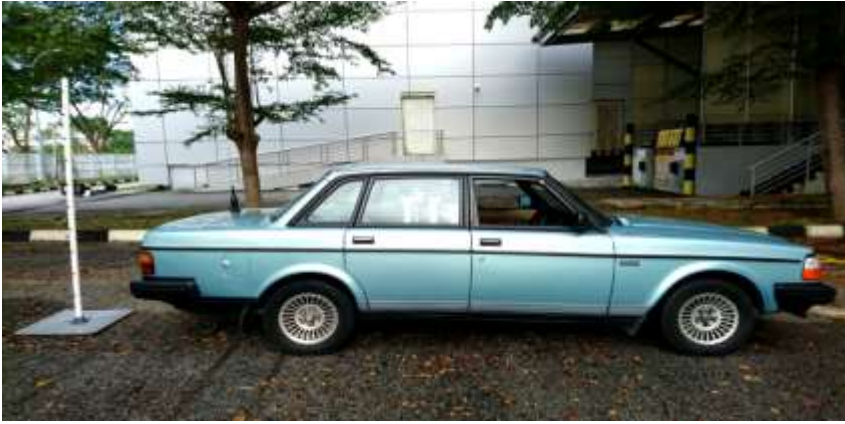
Test measurement setup for Bystander, trunk mount antenna behind vehicle

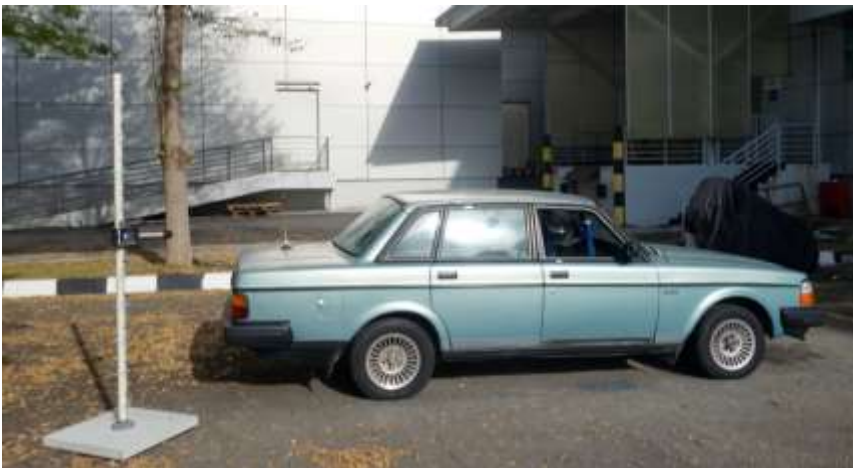
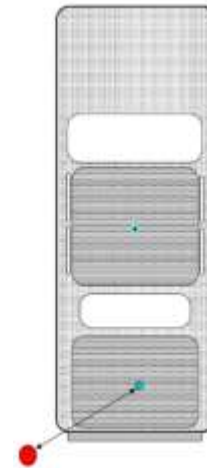
Test measurement setup for Bystander 45 degree (diagonal) trunk mount antenna

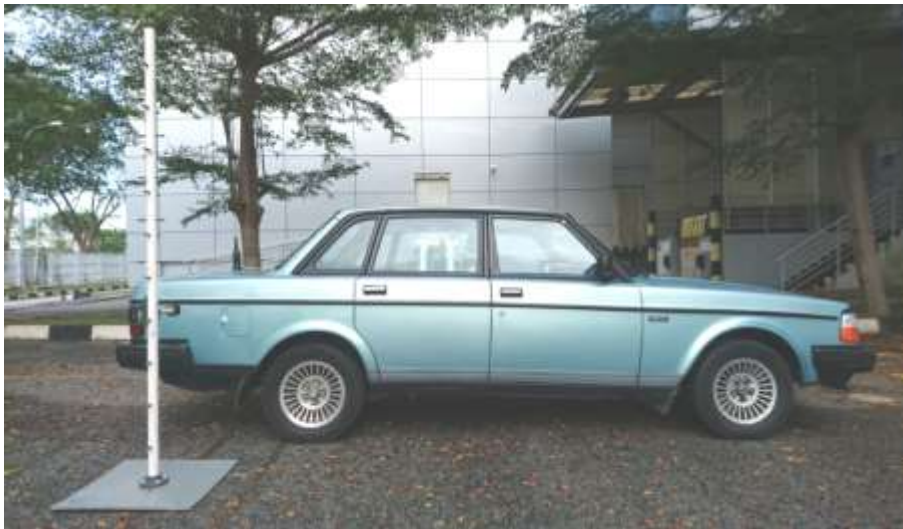
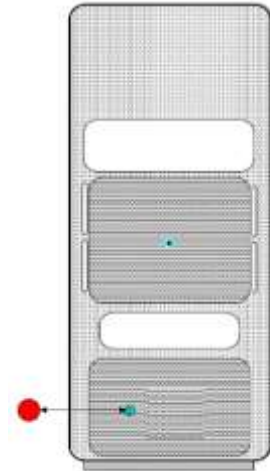
Test measurement setup for Bystander 90 degree (side) trunk mount antenna

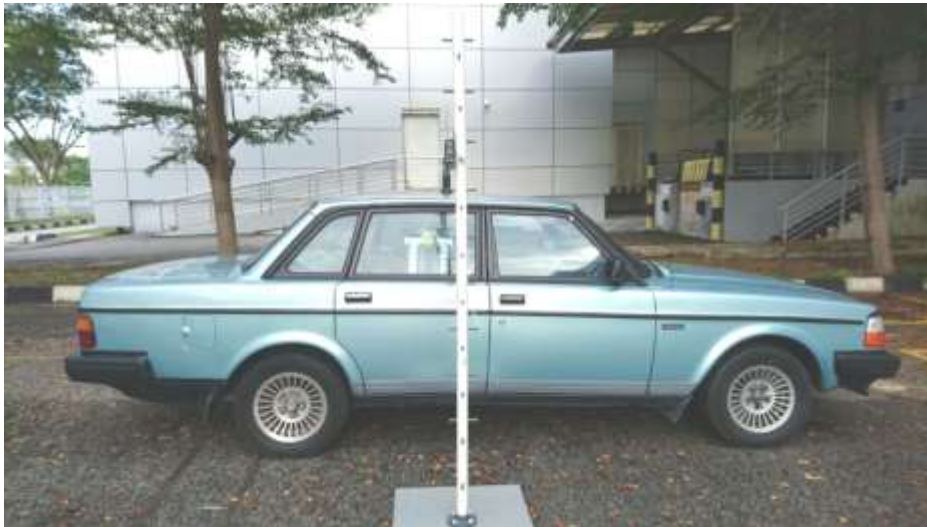
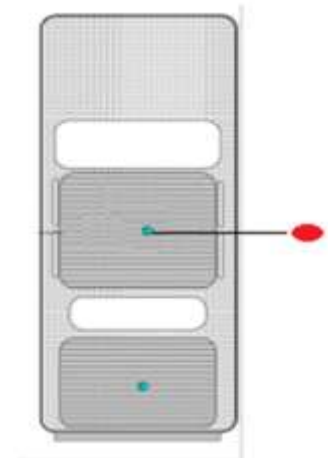
Test measurement setup for Bystander roof mount antenna

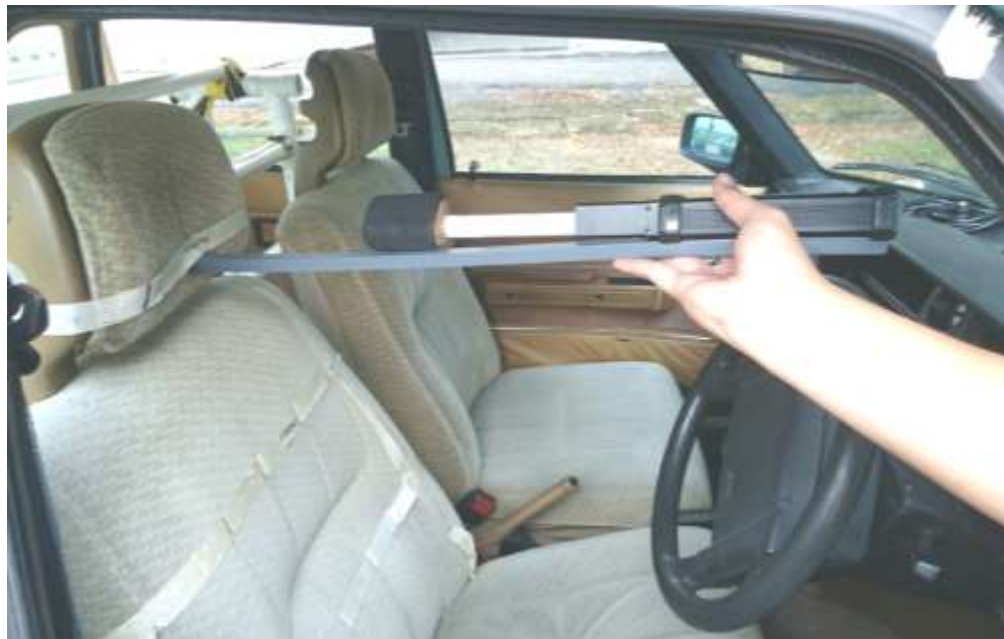
Test measurement setup for Passenger Front

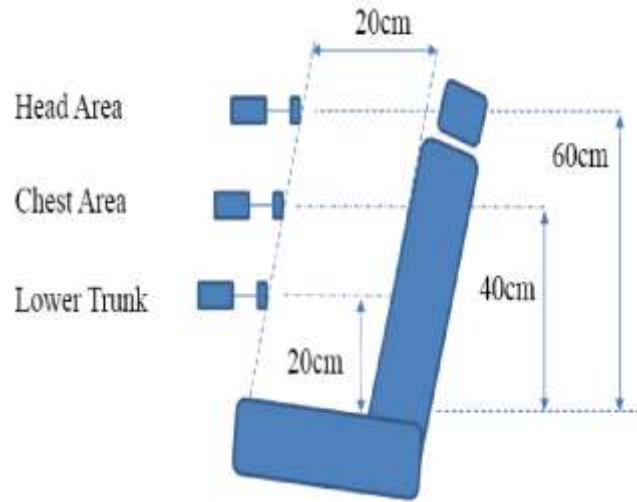
Test positions for Passenger Back and Front

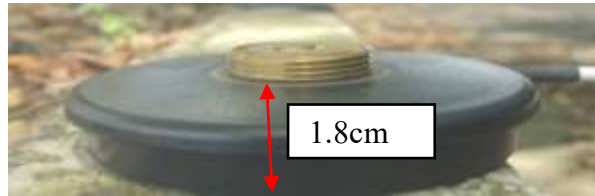
### 3.0 Magnetic mount base for antenna installation photos

**Magnetic mount base (top and side view)**
