APPLICANT:
Ericsson Radio Systems AB

Exhibit 7
Test Setup Photo
FCC ID NO.
B5KKRC16145

Test Setup Photos

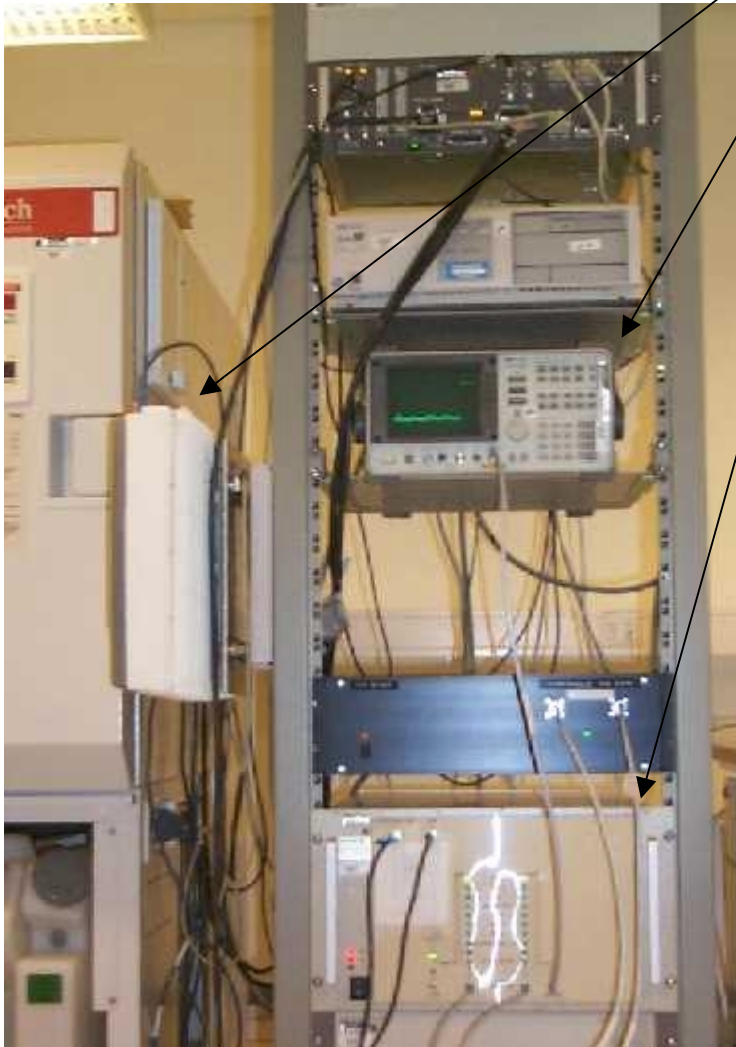
Picture 1

- 2.1033(7) The test setup is as shown in picture 1 below.
 The RBS 2401 is connected via a RF cable through a RF box to the spectrum analyser.
 The losses in the RF box are calibrated before each test.

RBS 2401 GSM 1900
Spectrum Analyser HP 8563E
Modulation RF-Box(Inv no YY 1873)

Note : When measuring RF-Output power, the spectrum analyser is changed to a BOONTON 56526 and the RF box is changed to a power RF box LPY 107610.
When measuring Phase/Frequency error, Frequency stability the spectrum analyser is changed to a Anritsu GSM tester MS8604A and the RF box is changed to a power RF box LPY 107610.
When measuring in temperature a climate chamber Vötsch VC 7020 is used.
