Photo Report on Test Setups

Report Reference: MDE_GNNET_1606_FCC_Photo_Setups

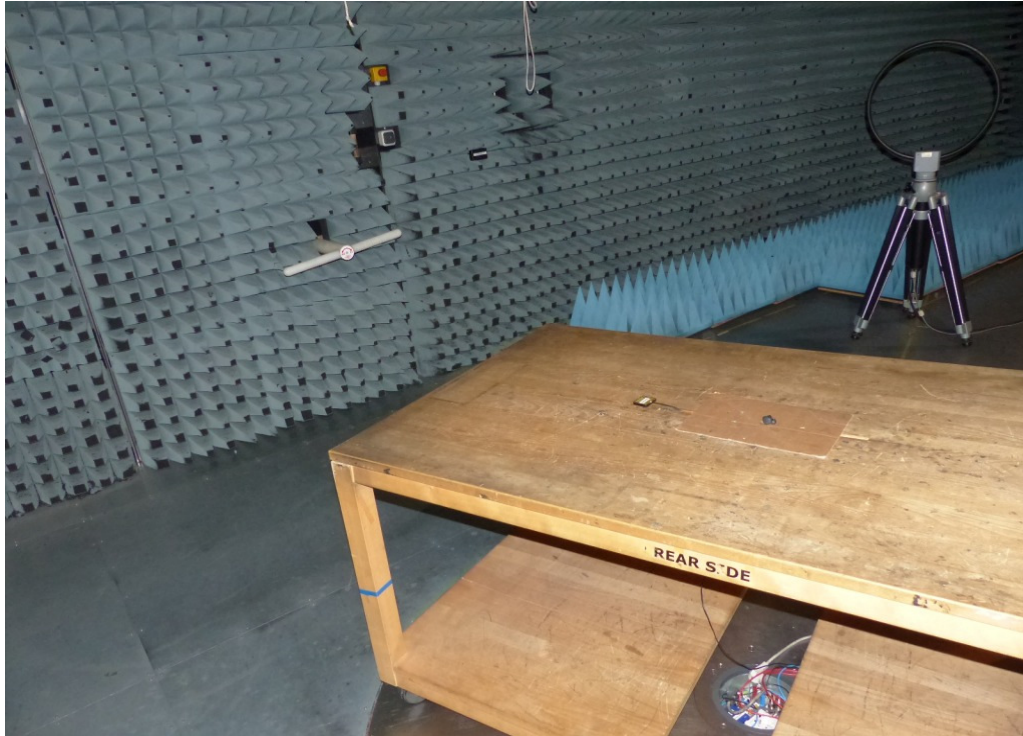
Photo 1: Test setup for radiated measurements (Enclosure, below 30 MHz, intentional radiator §15, ANSI C63.10)

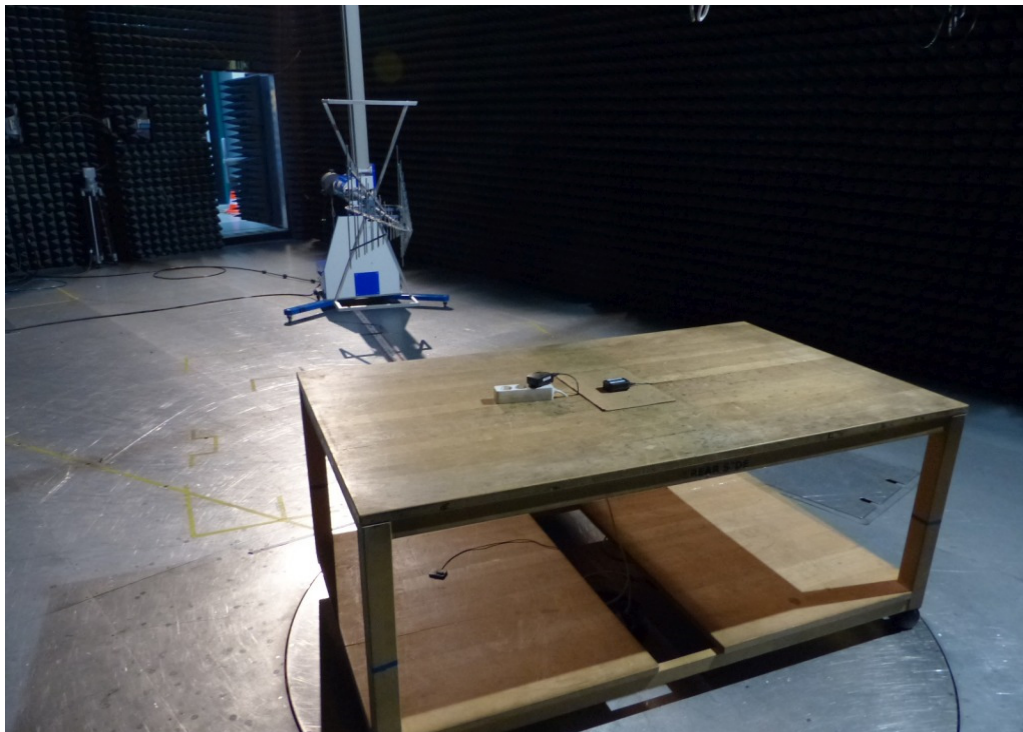
Photo 2: Test setup for radiated measurements (Enclosure, semi-anechoic chamber, 30 MHz to 1 GHz, intentional radiator §15, ANSI C63.10)

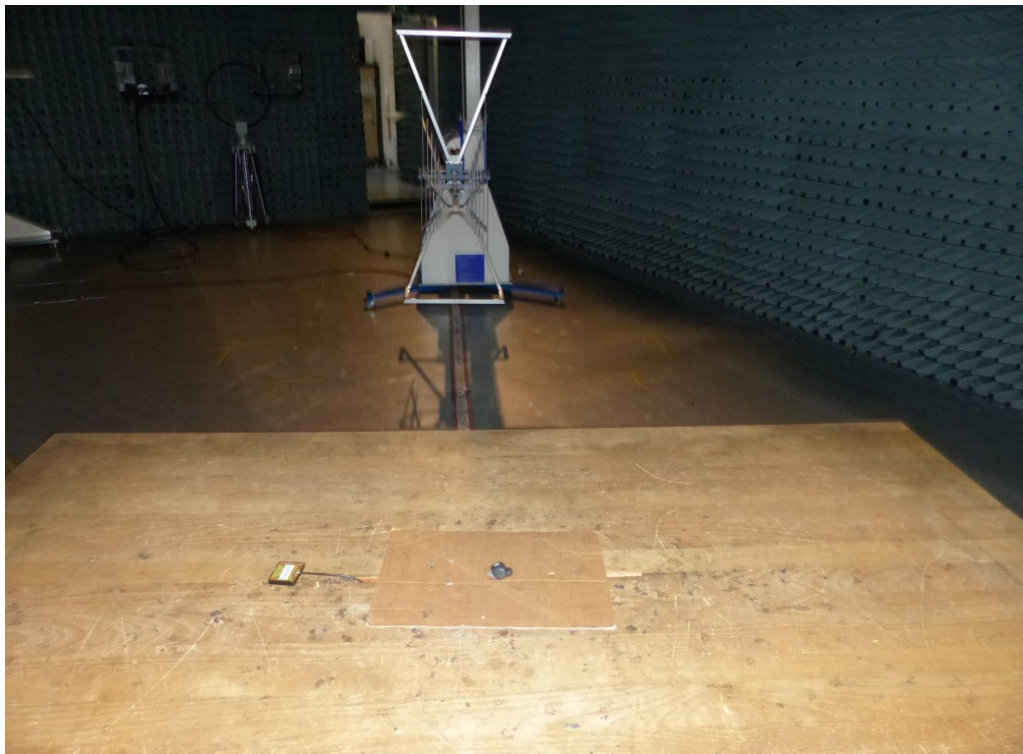
Photo 4: Test setup for radiated measurements.
