InterLab[®] Photo Report on Test Setups

Report Reference: MDE_GNNET_1311_FCCb_Photo_Setups

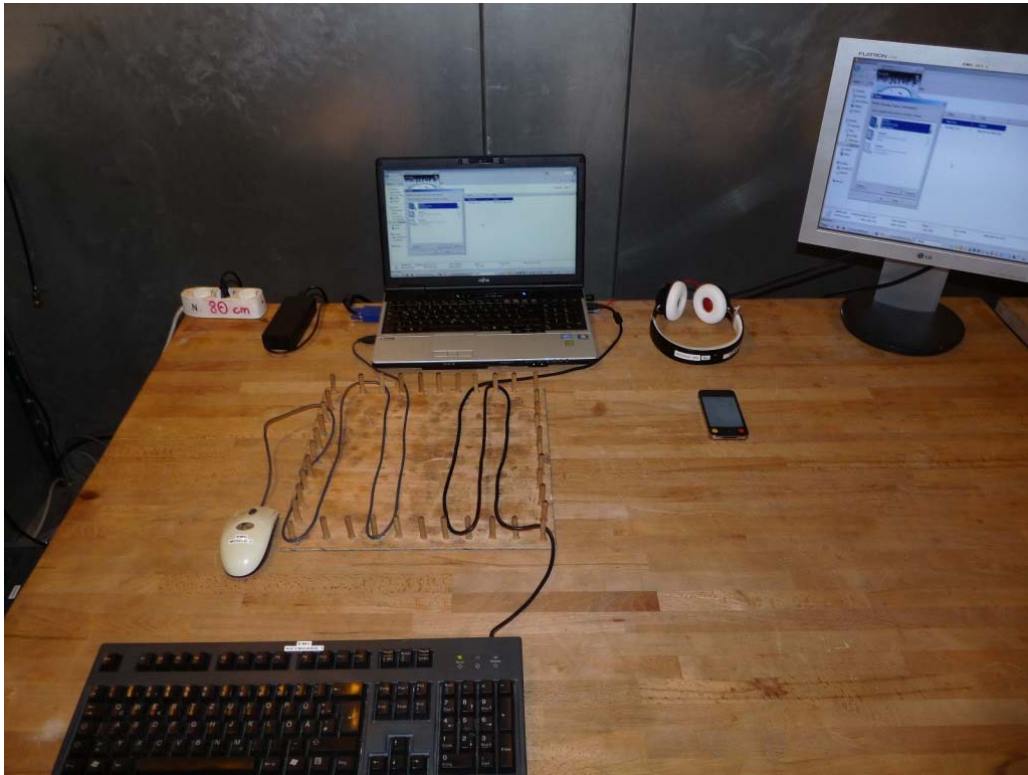
Photo 1: Test setup for conducted measurements (AC Port (power line), computer peripheral setup, EUT supplied by USB-cable from computer, intentional / unintentional radiator §15) Computer supplied by 110v 60Hz AC.

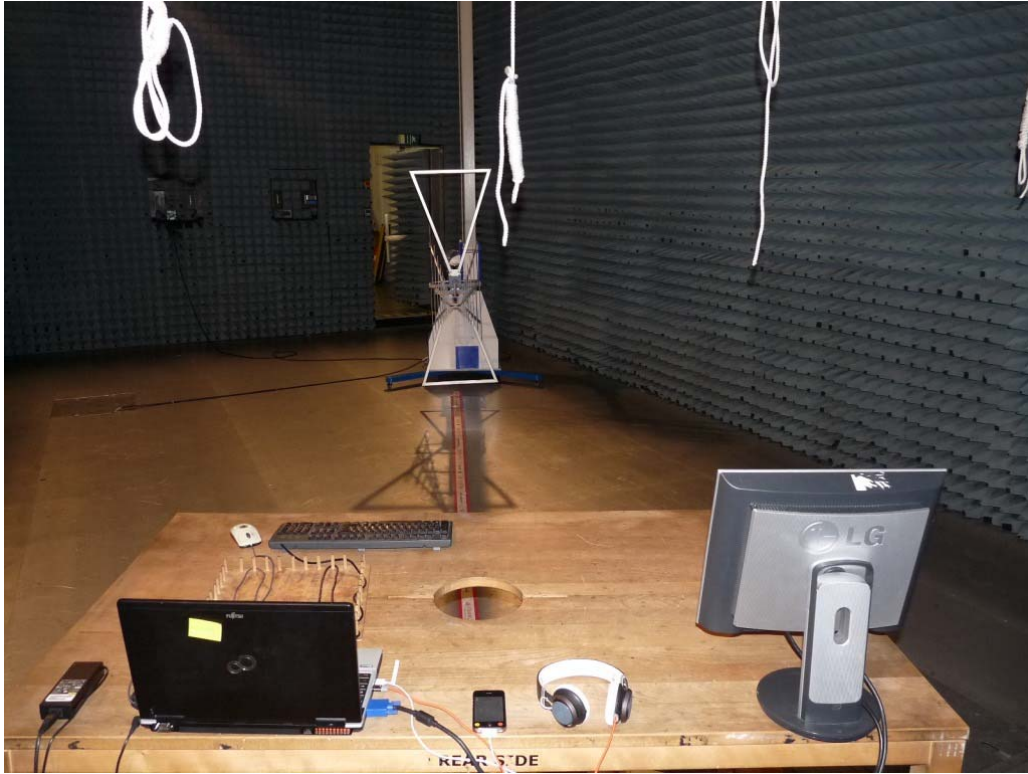
Photo 2: Test setup for radiated measurements (computer peripheral setup, EUT supplied by USB-cable from computer, unintentional radiator S15)
