InterLab[®] Photo Report on Test Setups

Report Reference: MDE_GNNET_1310_FCCa_Photo_Setups

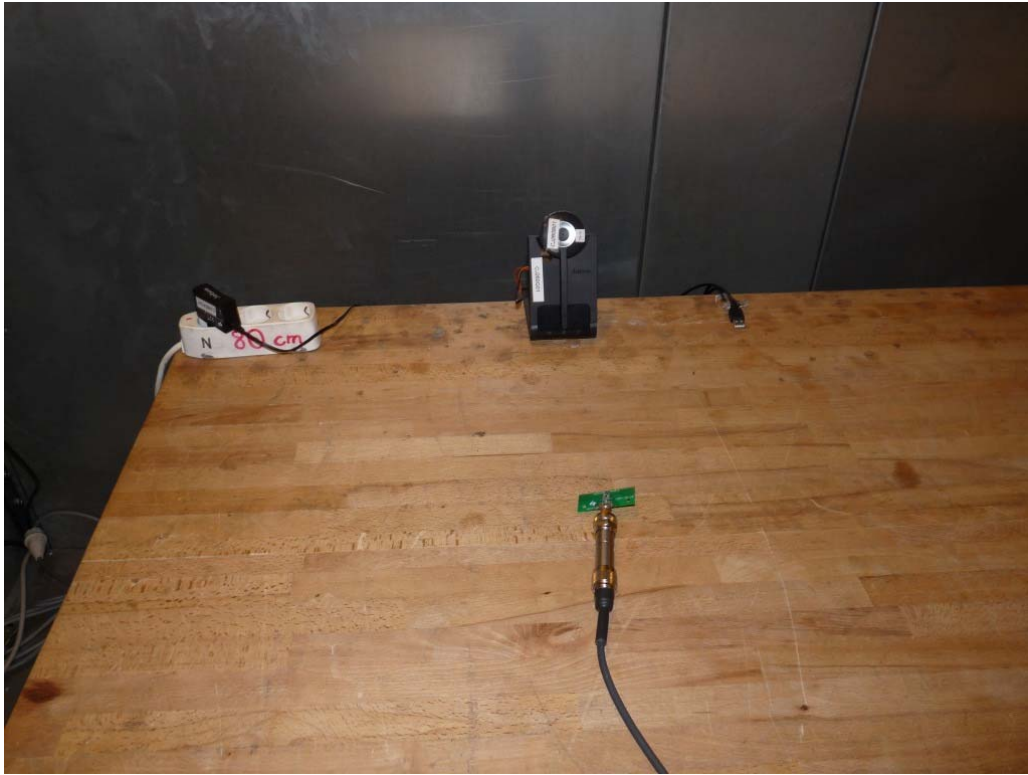
Photo 1: Test setup for conducted measurements (AC Port (power line), EUT supplied by AC/DC adapter, intentional / unintentional radiator §15)

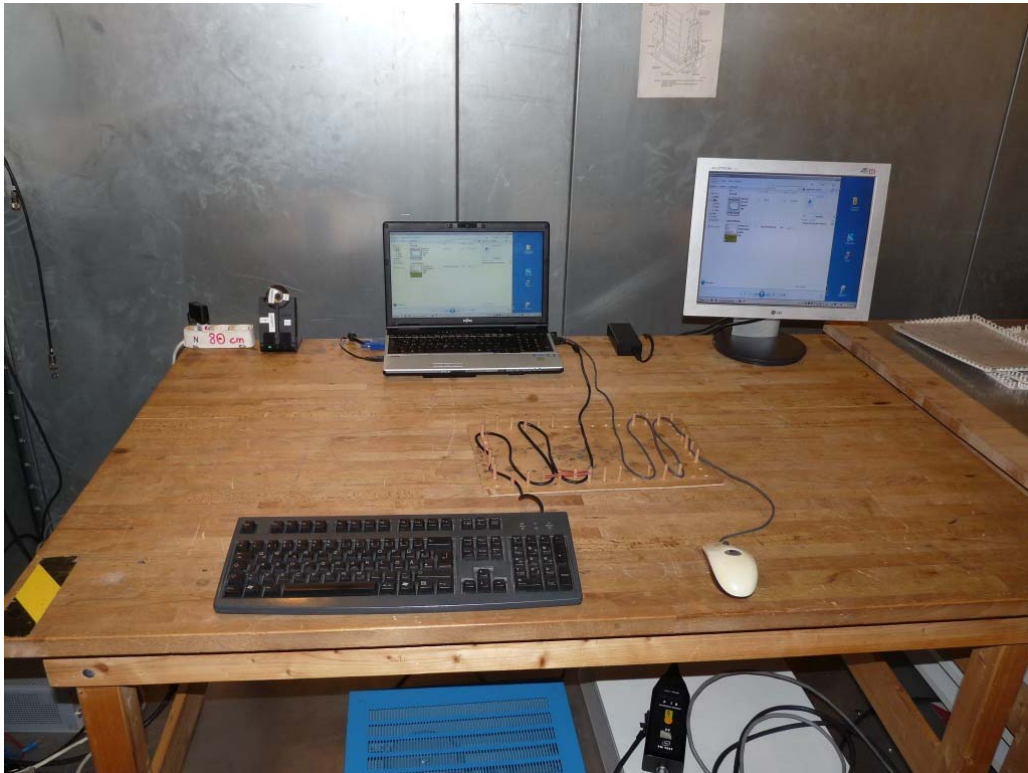
Photo 2: Test setup for conducted measurements (computer peripheral setup, EUT supplied by AC/DC adapter. USB-cable from computer as data traffic my streaming music, unintentional radiator §15)

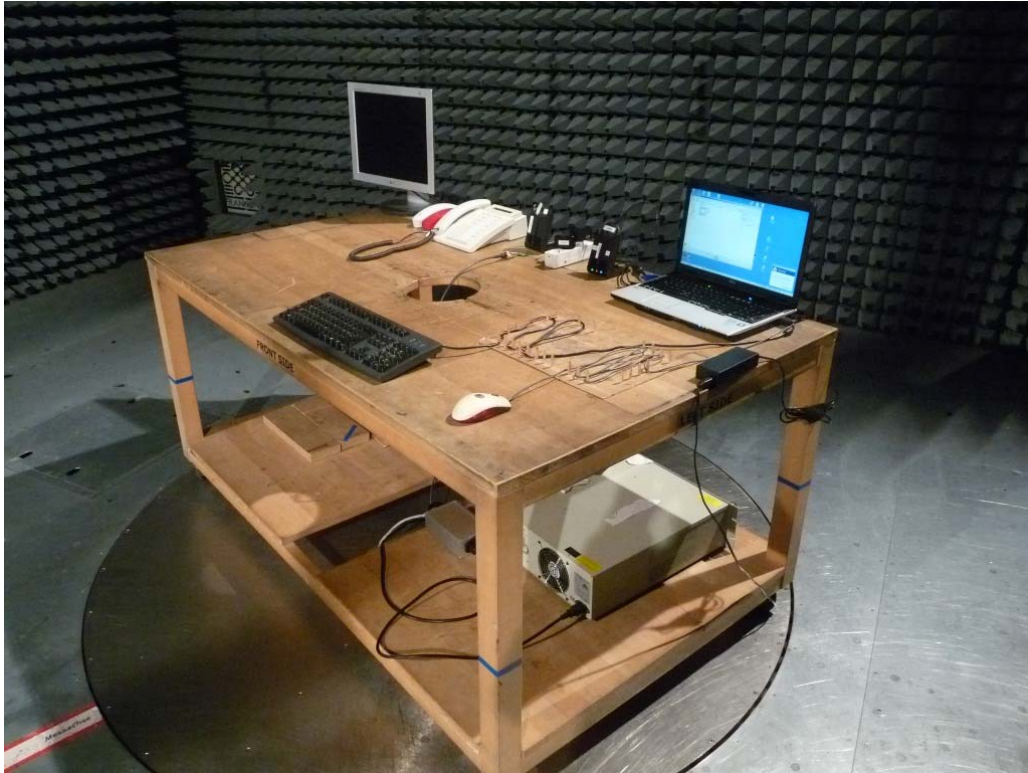
Photo 3: Test setup for radiated measurements (AC Port (power line and computer peripheral setup), EUT supplied by AC/DC adapter. Data traffic on USB-Cable by streaming music, unintentional radiator §15)

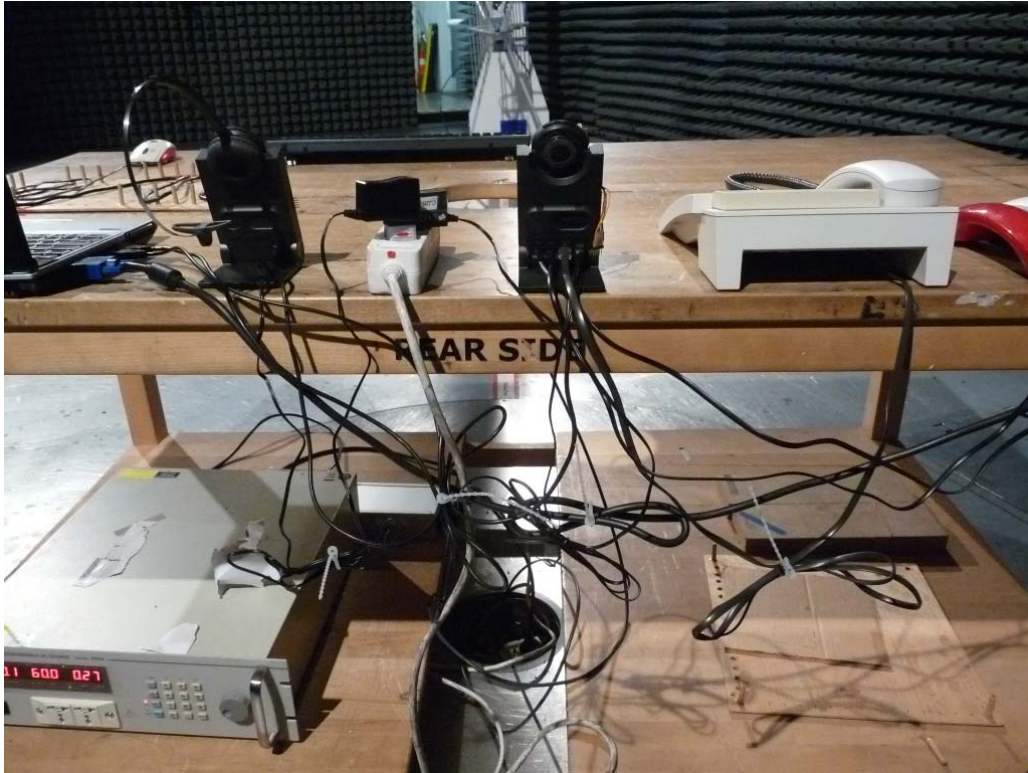
Photo 4: Test setup for radiated measurements (AC Port (power line and computer peripheral setup), EUT supplied by AC/DC adapter. Data traffic on USB-Cable by streaming music, unintentional radiator §15)
