Certification Test Report

CFR 47 FCC Part 2 and Part 22, Subpart C

Model: MR853D

FCC ID No.: BCR-853D125

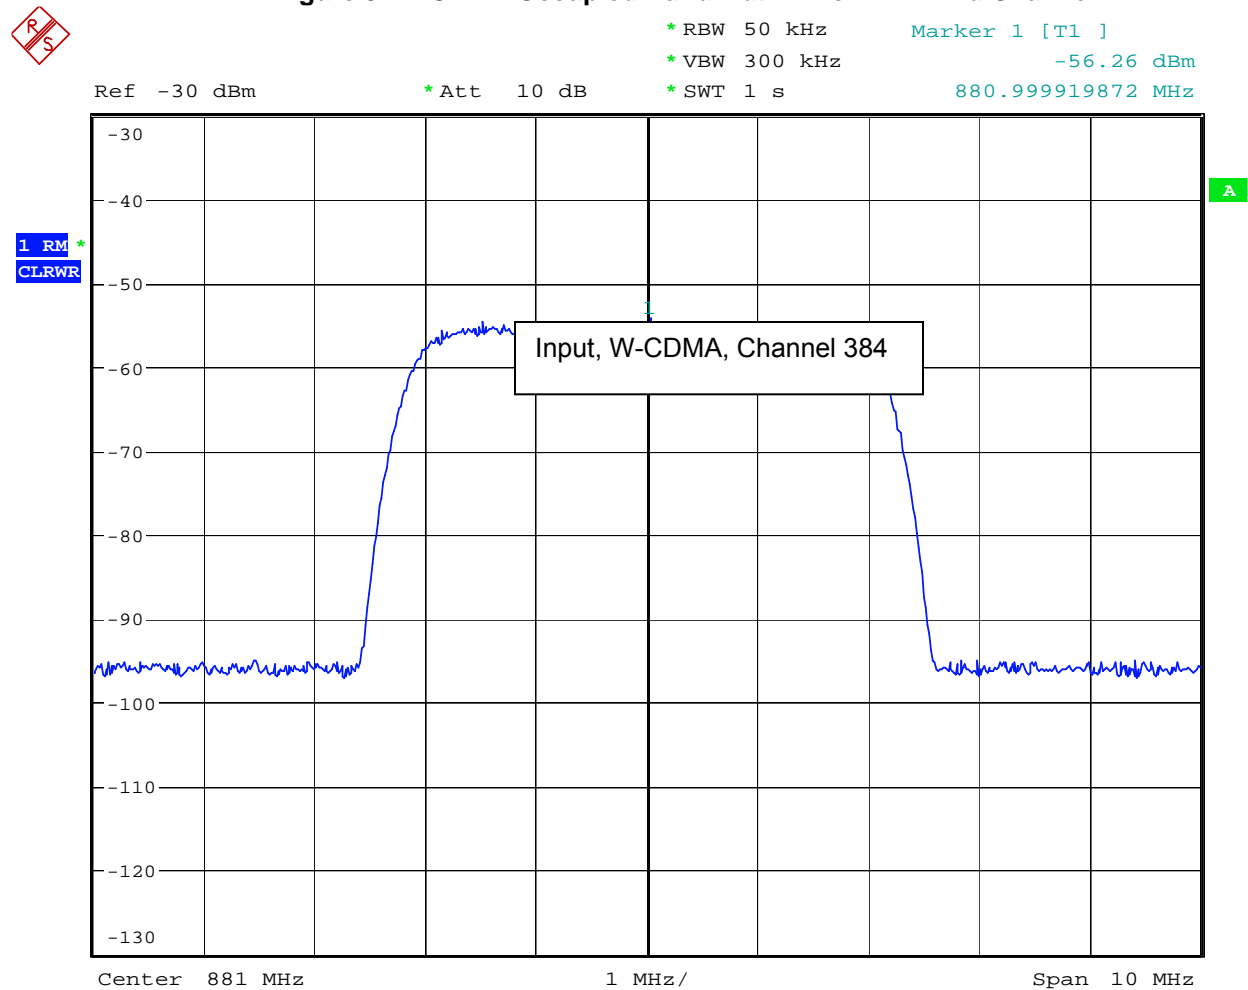
Figure 5 W-CDMA Occupied Bandwidth – Downlink Mid Channel

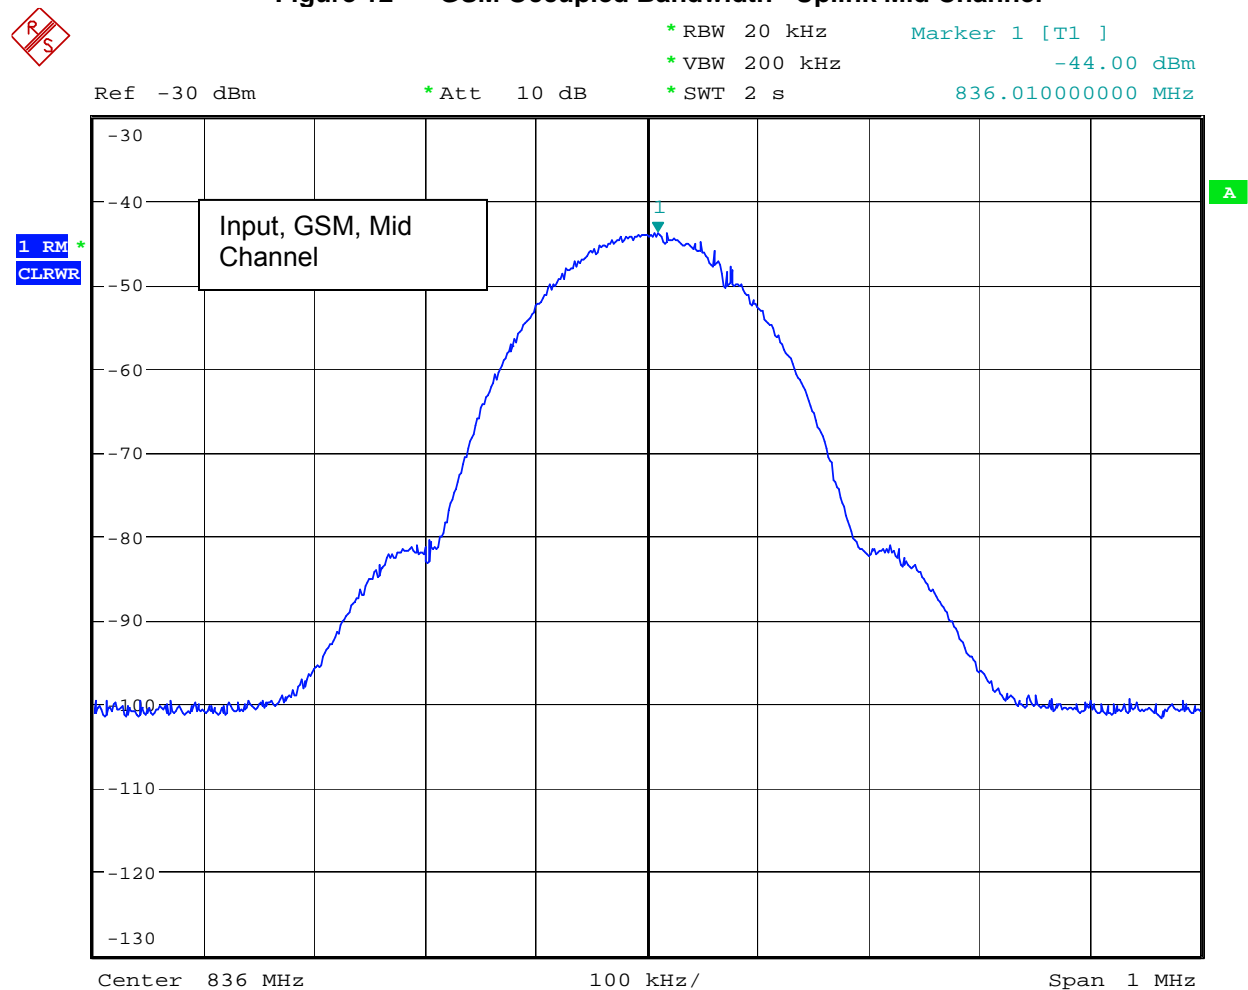
Figure 12 GSM Occupied Bandwidth –Uplink Mid Channel
