**Test Plot: Occupied Bandwidth (Input vs. Output)**

Job No.: 0L0367R Date: 04/09/01  
Specification: Temperature(°C): 22  
Tested By: David Light Relative Humidity(%) 50  
E.U.T.: MOR 801Bi Power  
Configuration: Transmit iDEN signal  
Serial Number: 0013  
Location: Lab 1 RBW: Refer to plots  
Detector Type: Peak VBW: Refer to plots

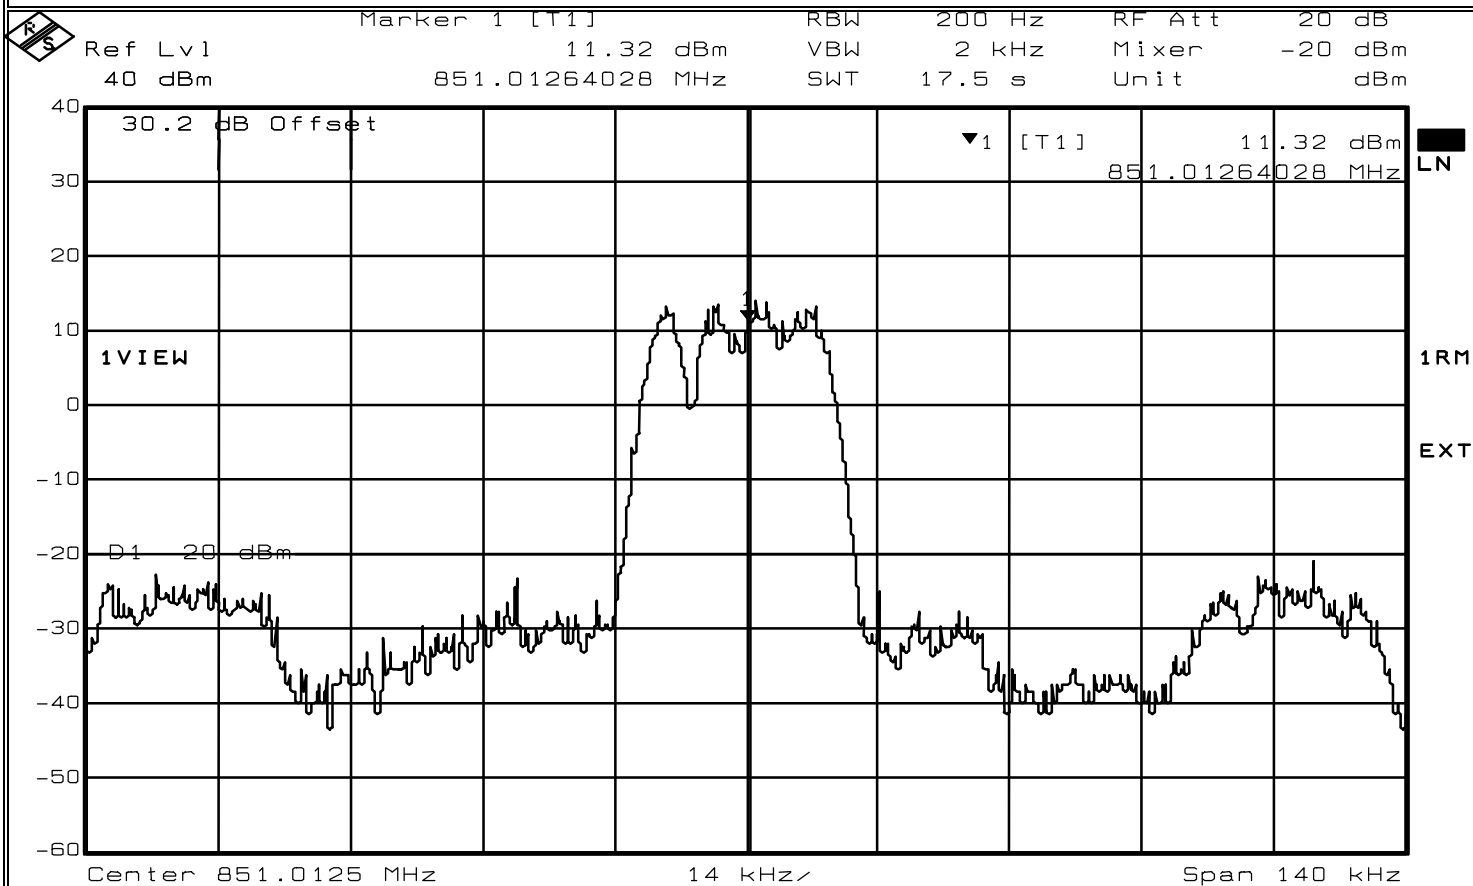
Notes: Output signal - iDEN Modulation  
Lower bandedge

hi pwr occupied bw iDEN (RETEST)

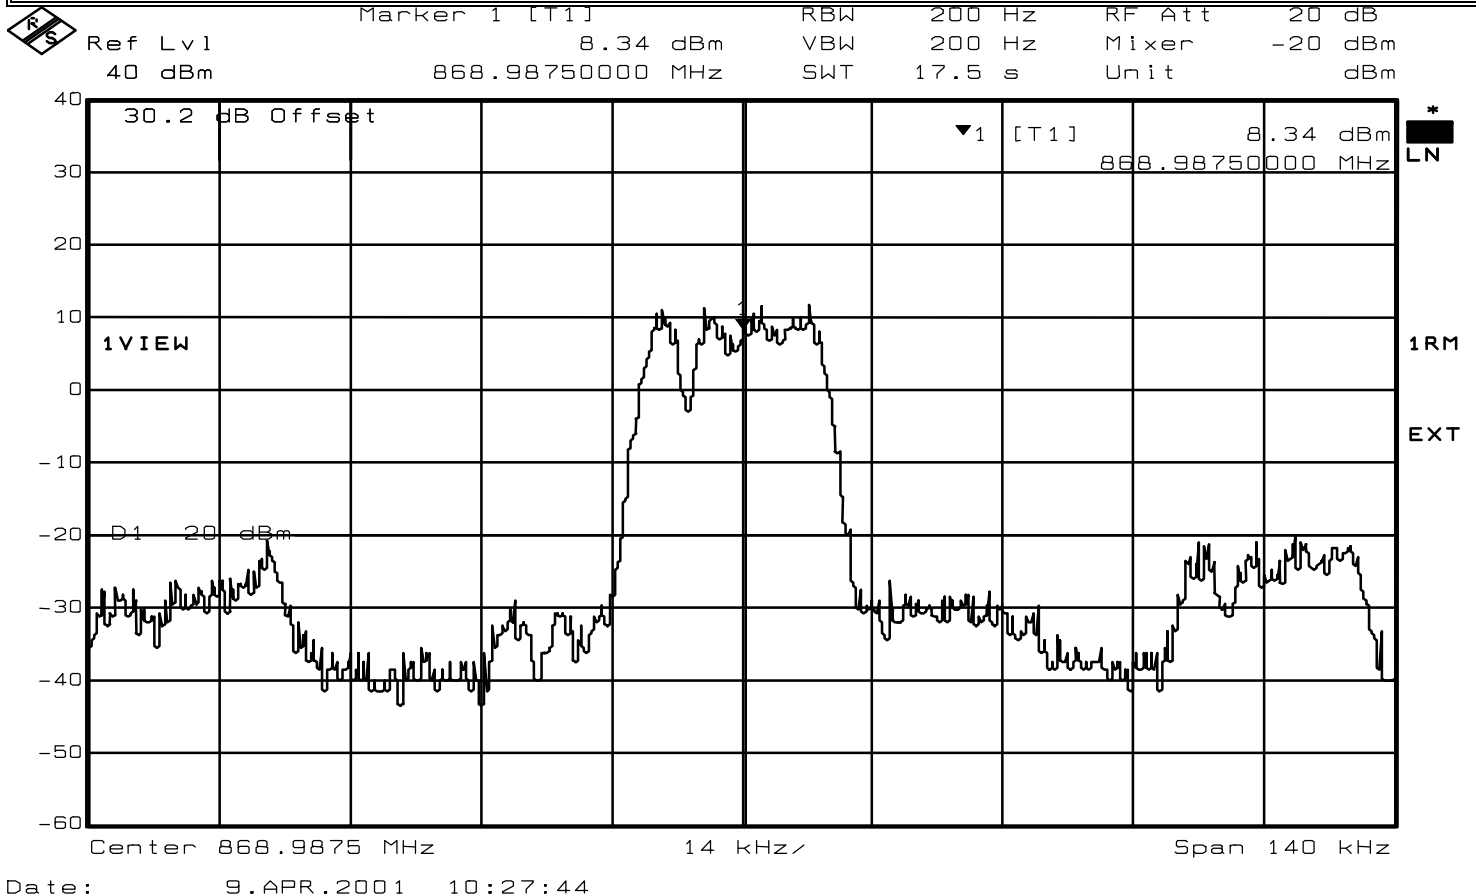
Notes: **Output signal - iDEN Modulation**  
**Upper bandedge**

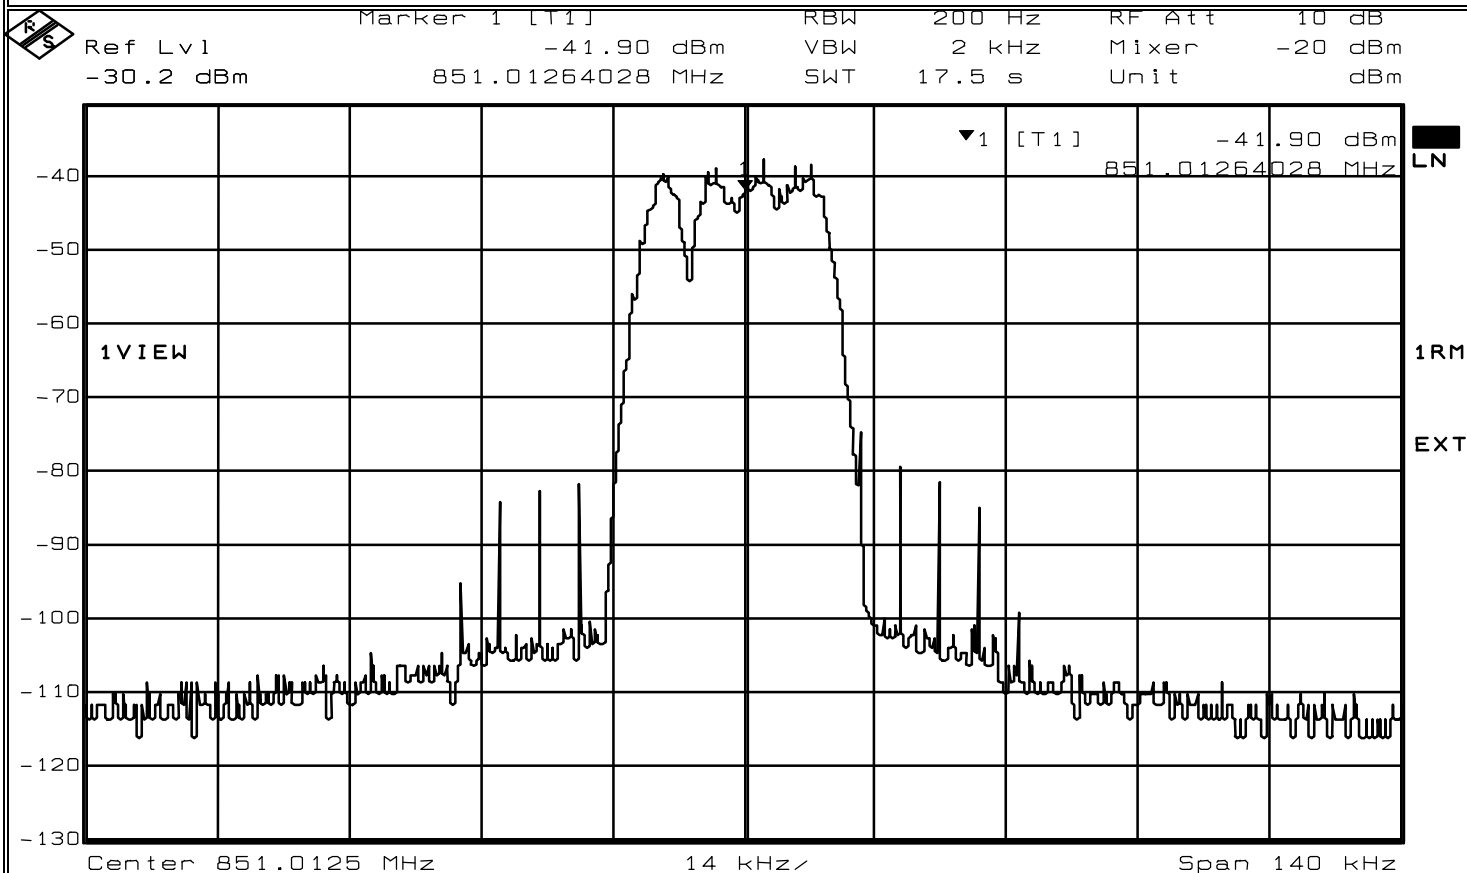
Notes: **Input signal - iDEN Modulation**

hi pwr occupied bandwidth (RETEST)

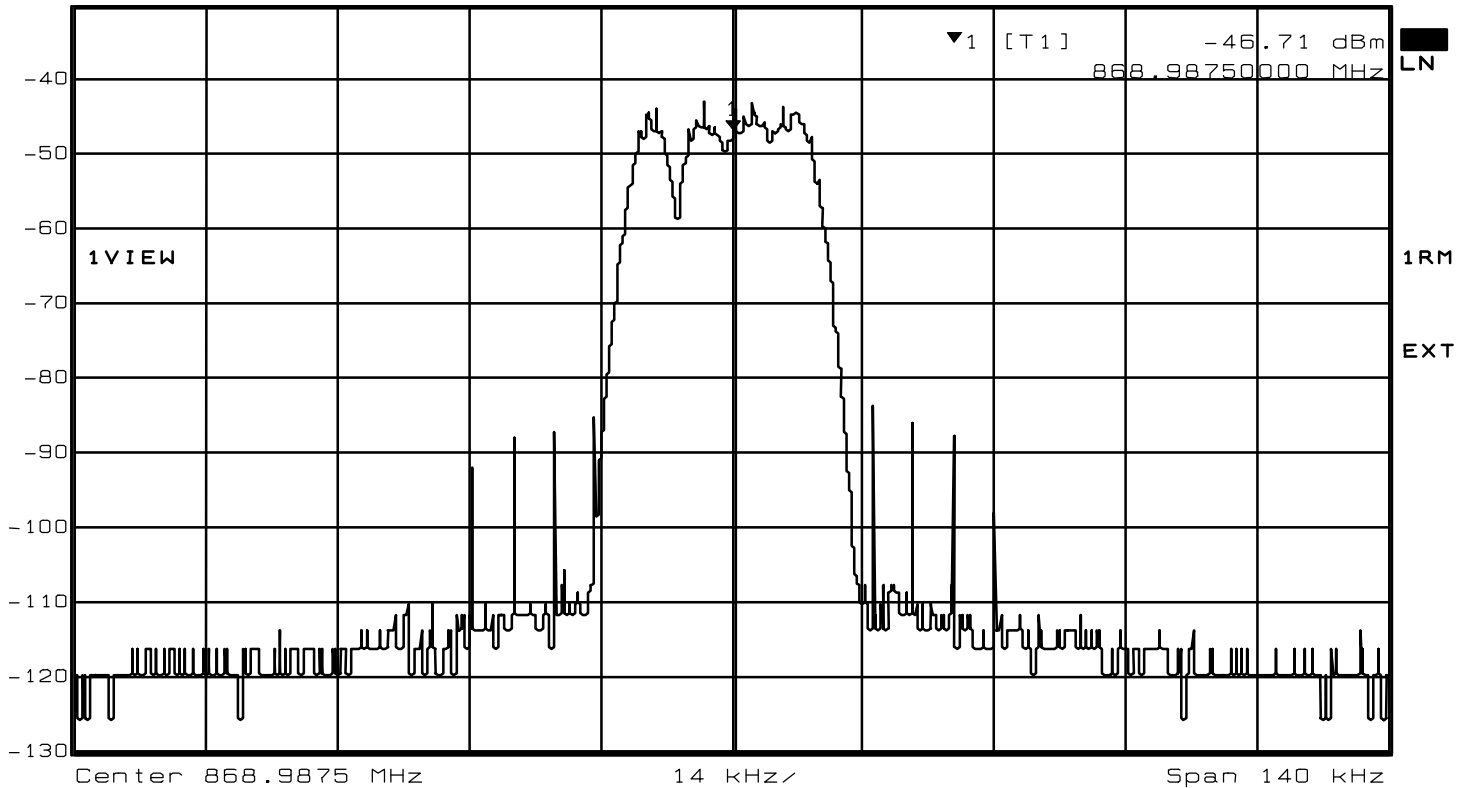
| Ref Lvl | Marker 1 [T1] | RBW | 200 Hz | RF Att | 10 dB |
| -30.2 dBm | -46.71 dBm | VBW | 2 kHz | Mixer | -20 dBm |
| | 868.98750000 MHz | SWT | 17.5 s | Unit | dBm |

Notes: **Input signal - iDEN Modulation**  
**Upper bandedge**
