KTL Dallas, Inc.

**Test Plot: Occupied Bandwidth (Input vs. Output)**

Job No.: 0L0367R Date: 04/06/01  
Specification: Temperature(°C): 22  
Tested By: David Light Relative Humidity(%) 50  
E.U.T.: MOR 801Bi Power  
Configuration: Transmit Voice signal  
Serial Number: 0013  
Location: Lab 1 RBW: Refer to plots  
Detector Type: Peak VBW: Refer to plots

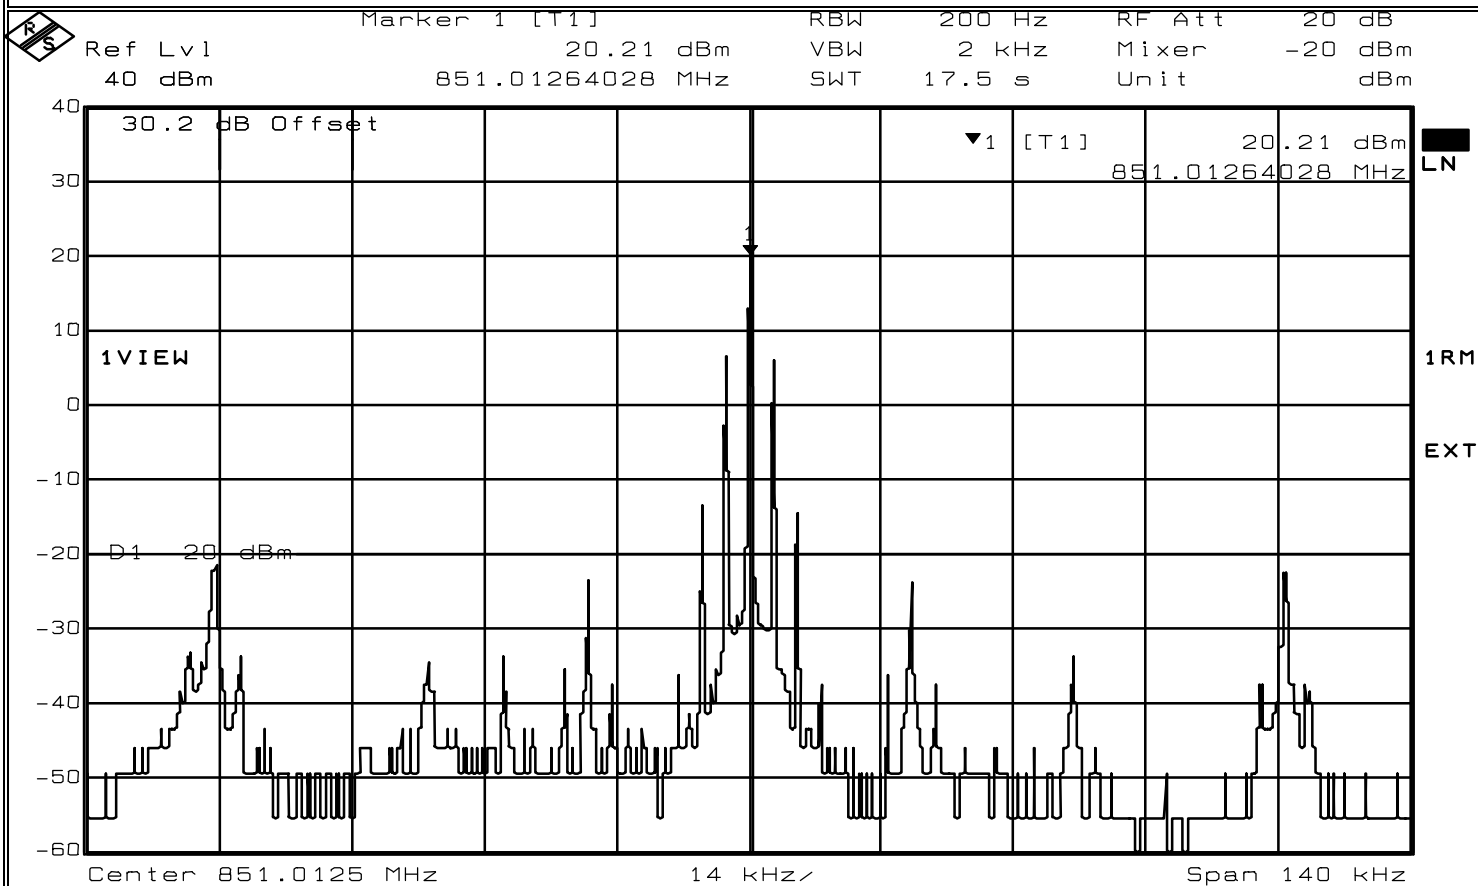
Notes: Output signal - Voice Modulation

Lower bandedge

hi pwr occupied bw voice (RETEST)

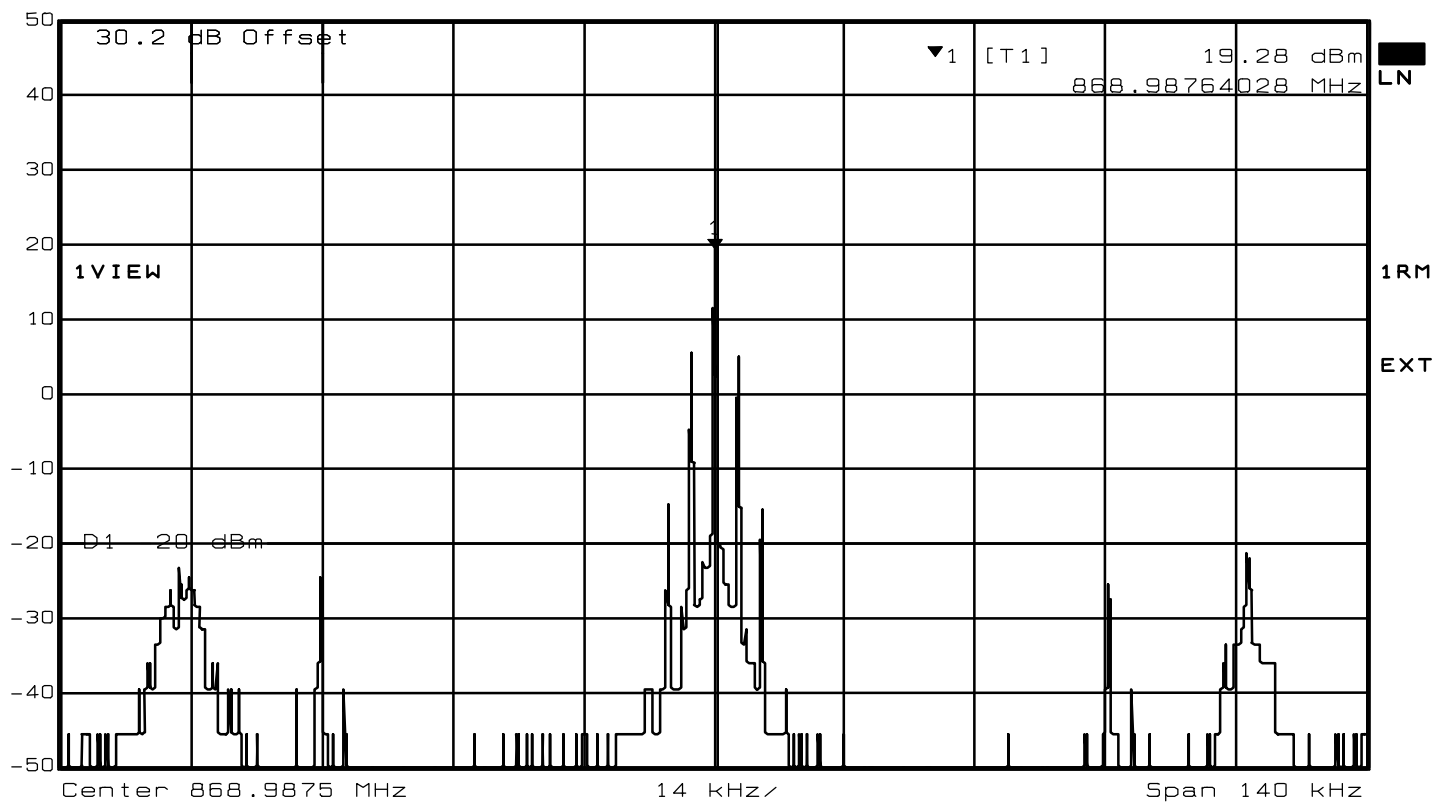
Ref Lvl 50 dBm Marker 1 [T1] 19.28 dBm RBW 200 Hz RF Att 30 dB  
868.98764028 MHz VBW 2 kHz Mixer -20 dBm  
SWT 17.5 s Unit dBm

Notes: **Output signal - Voice Modulation**  
**Upper bandedge**

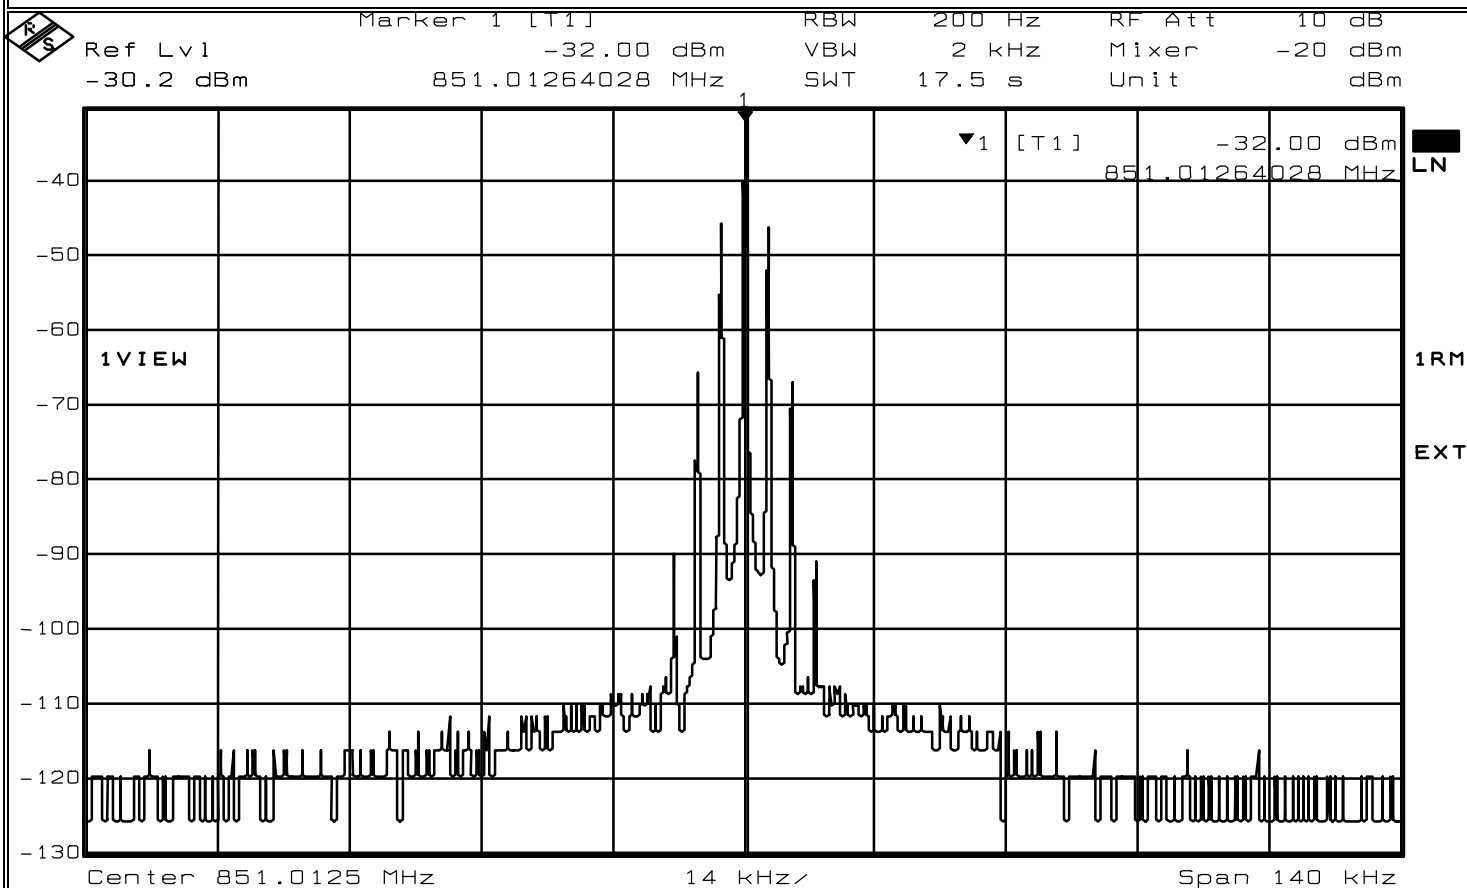
Notes: **Input signal - Voice Modulation**

hi pwr occupied bandwidth (RETEST)

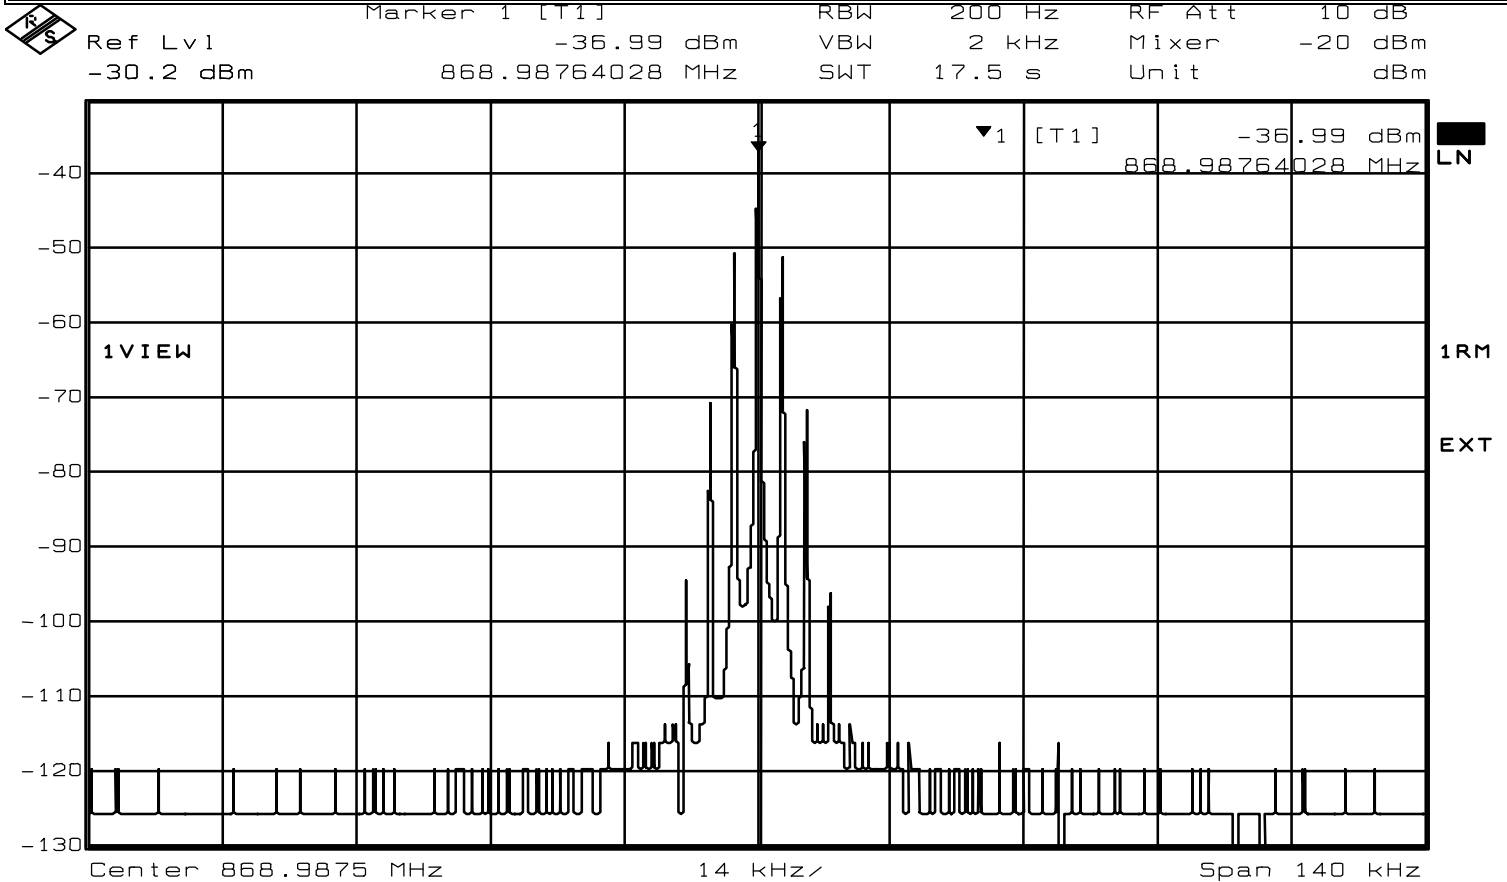
Notes: **Input signal - Voice Modulation**  
**Upper bandedge**
