B.1 Exposure Positions Consideration (SAR)

File Number: C1M1810100 Report Number: EM-SR180021

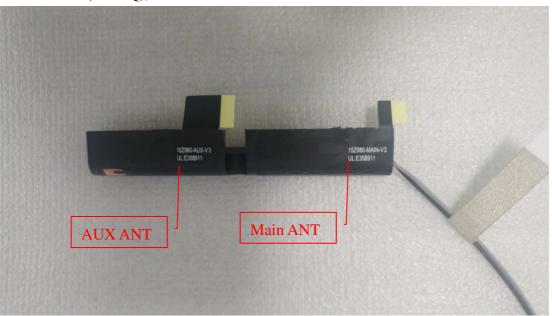
Antenna: LG (INPAQ), M/N WA-F-LBLB-04-056

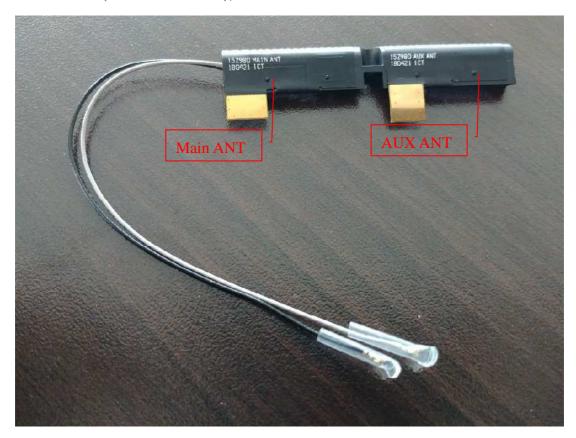
Antenna: LG (LUXSHARE-ICT), M/N 15Z980 ANTENNA ASM

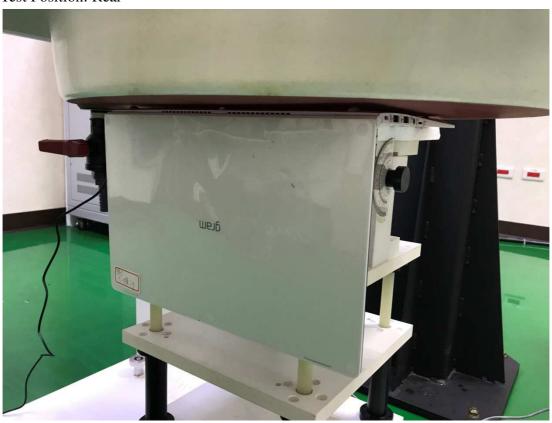
Test Position: Rear

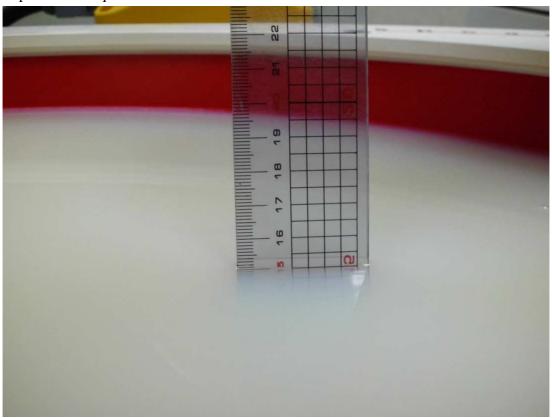
Depth of the Liquid in the Phantom-Zoom In
