**FCC TEST REPORT**  
*for*  
**THALES ATM, INC.**  
**GLIDESLOPE**  
**Model #: 098786-0001**

## **EMC TEST REPORT**

**47 CFR Ch.1 (10-1-03 Edition)**  
**Parts 2, 15, & 87**

Report No: FR2900BSC

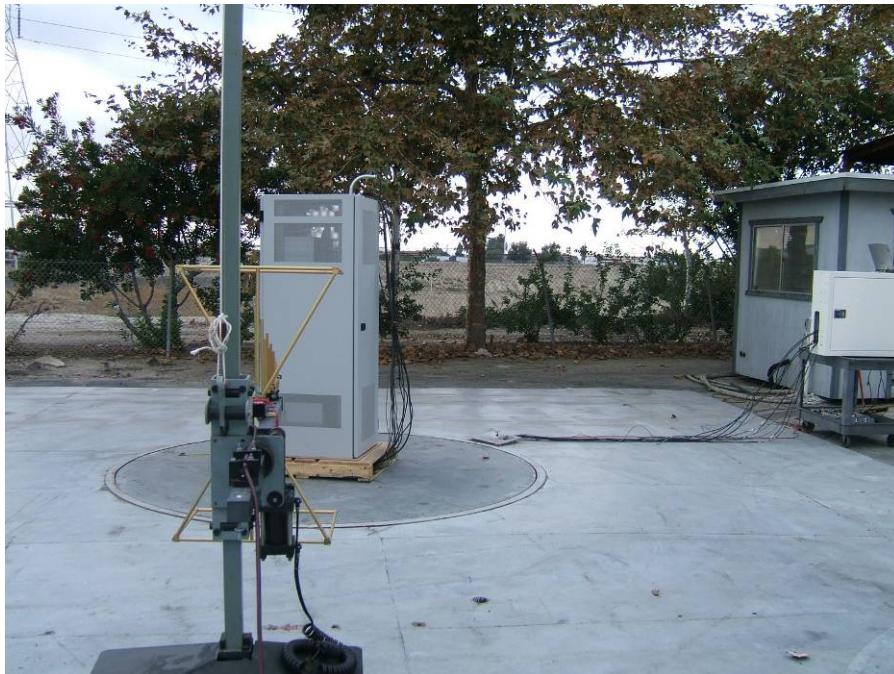
Glideslope Test Setup Photo

The transmitter was placed on a wooden turntable 0.1 meters above the ground plane and at a distance of 3 meters from the antenna. The transmitter was activated and the frequency spectrum of the fundamental was observed. The turntable was rotated through 360 degrees to locate the position registering the highest amplitude emission. The amplitude of the fundamental frequency was measured and recorded. The frequency spectrum was then searched for spurious emissions generated from the transmitter. The amplitude of each spurious emission was maximized by raising and lowering the FSM antenna and rotating the turntable before data was recorded. A log periodic antenna was used for frequencies of 200 MHz to 5 GHz and pyramidal horn antennas were used for frequencies of 5 GHz to 40 GHz. Emission levels were measured and recorded from the spectrum analyzer in dB $\mu$ V.

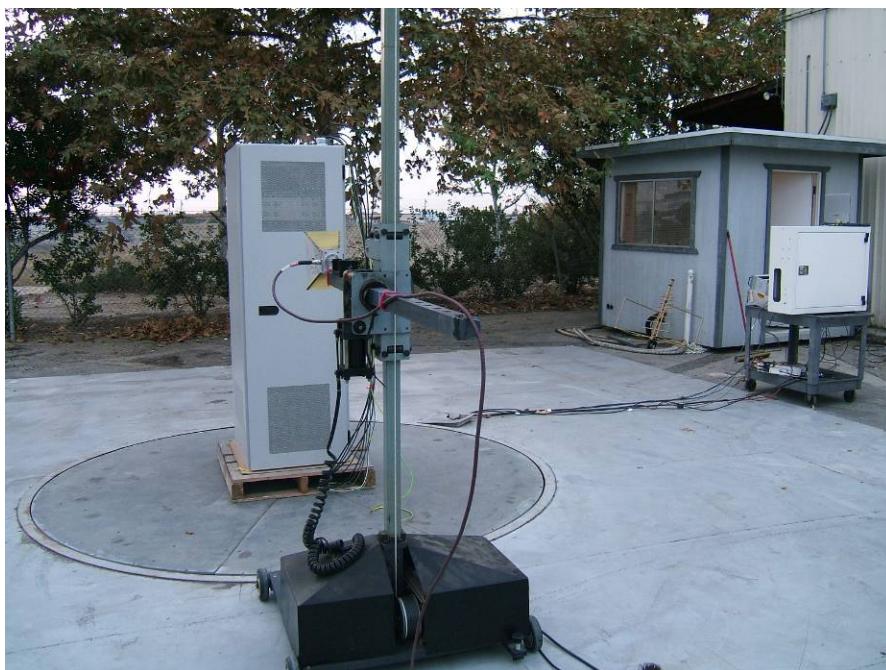
Glideslope Test Setup Photo

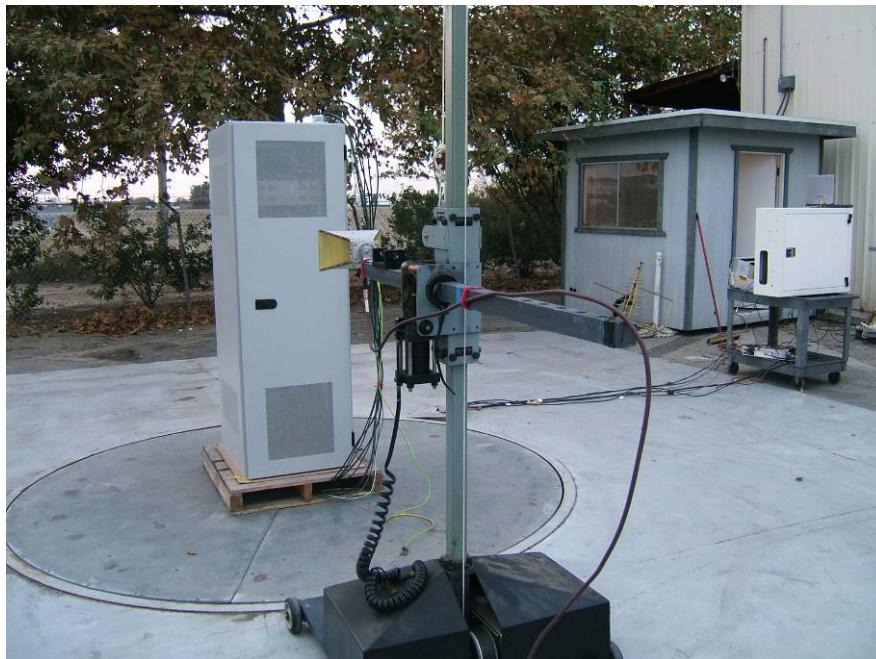
**Glideslope Test Setup Photo**
