APPENDIX 3: Photographs of test setup

Radiated emission
Above 1GHz

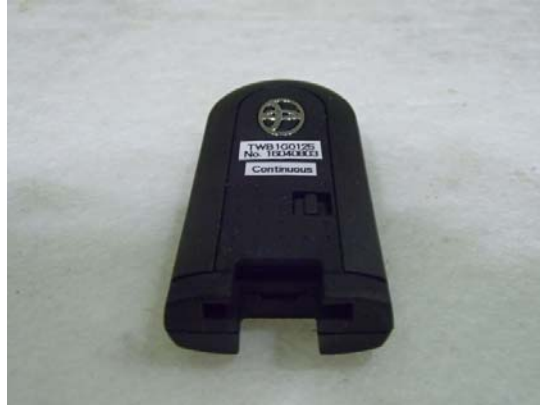
Worst case position

(Horizontal: X-axis / Vertical: Y-axis) Below 1GHz

(Horizontal: X-axis / Vertical: Z-axis) Above 1GHz

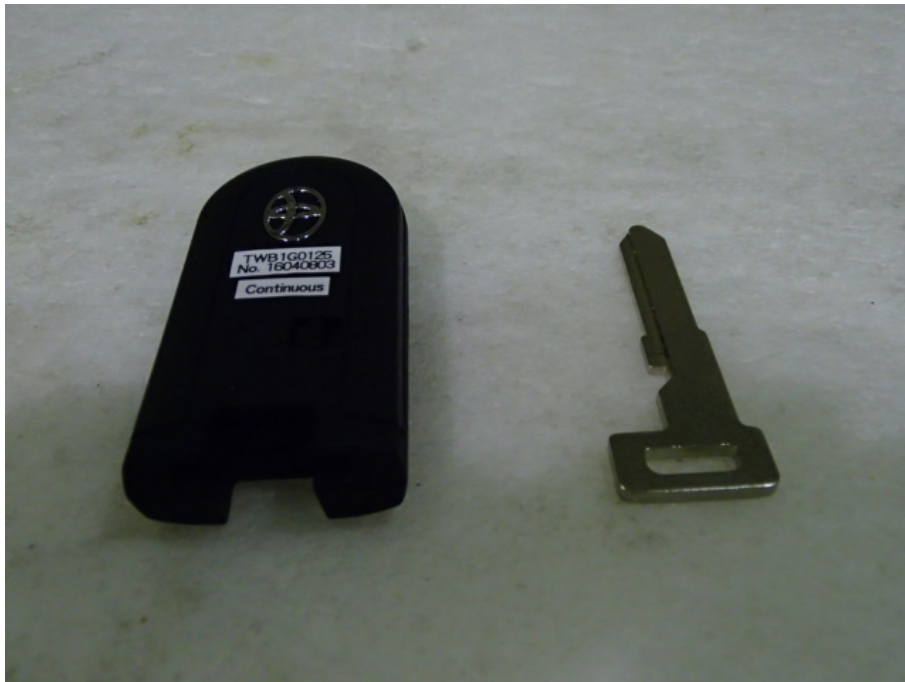
Worst case position

Mechanical Key (Not Inserted) Worst

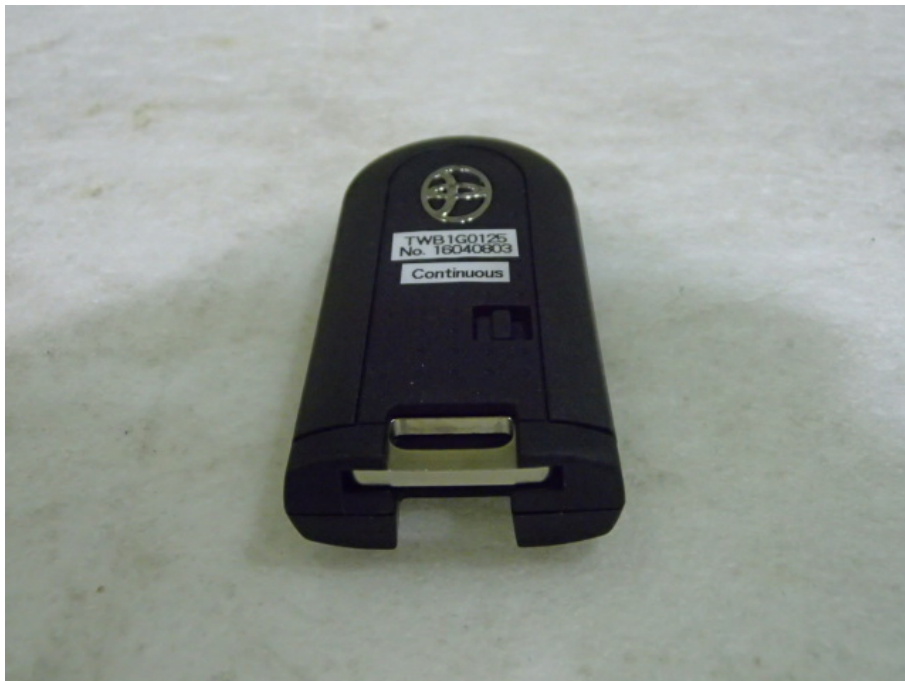
Mechanical Key (Inserted)
