APPENDIX 3: Photographs of test setup

Radiated Emission

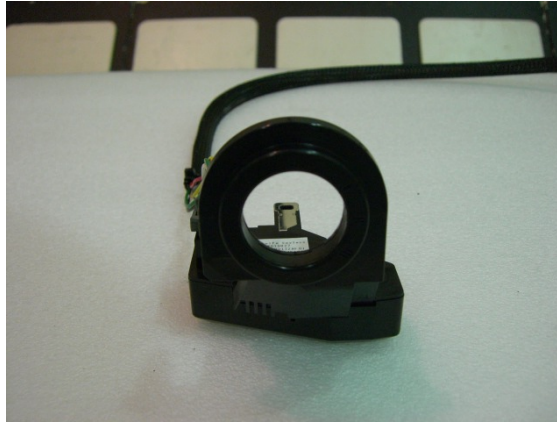
X-axis

Worst Case Position
Below 30MHz: Y-axis
Above 30MHz Hori:X-Axis Vert:X-Axis
