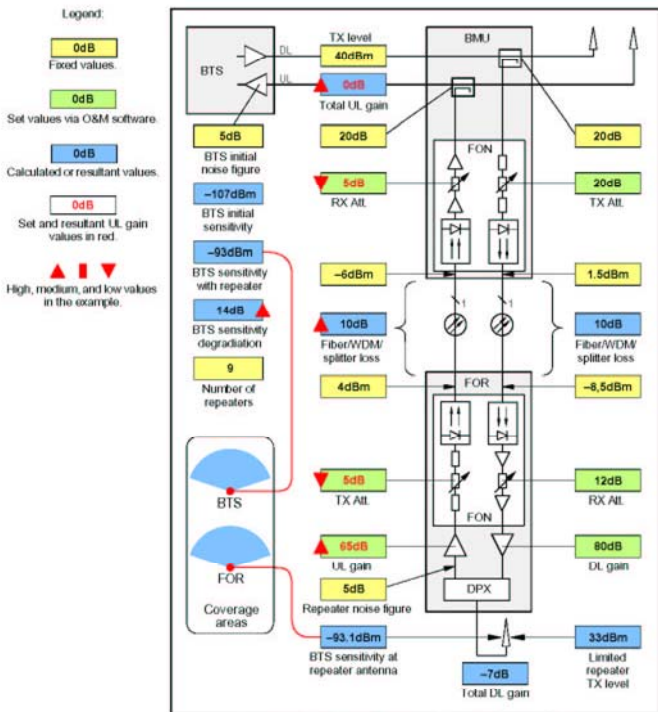
Figure 6-9. Nine FORs, high optical loss, high total uplink gain

Figure 6-9 shows one of nine FORs connected to one of three FON units in the BMU with high optical loss, high uplink gain and an uplink attenuation adapted to the optical loss. The *BTS sensitivity degradation* is high.

High total uplink gain and a *BTS sensitivity with repeater* very close to the *BTS sensitivity at the repeater antenna* indicates a similar coverage area for the BTS and the FOR.
