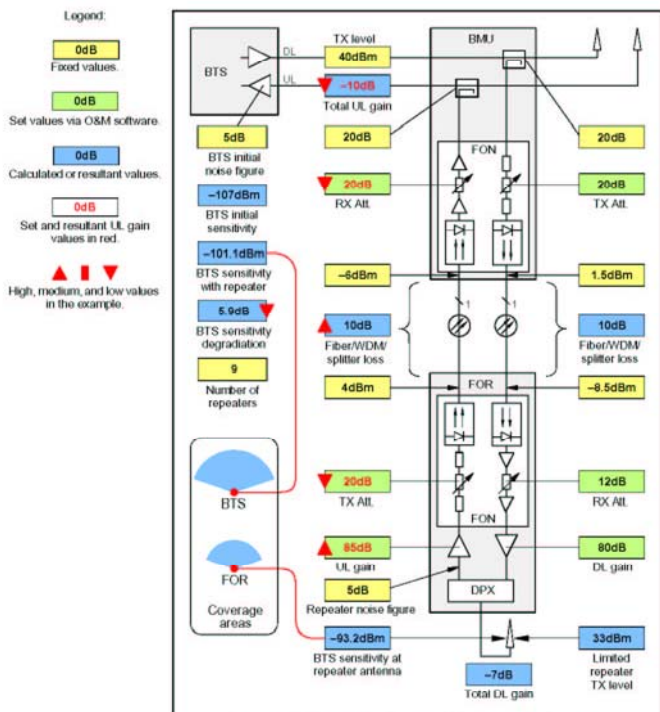
Figure 6-11. Nine FORs, high optical loss, low total uplink gain

Figure 6-11 shows one of nine FORs connected to one of three FON units in the BMU with high optical loss, and an uplink attenuation adapted to the optical loss. The *BTS sensitivity degradation* is low.

Low total uplink gain decreases the *BTS sensitivity with repeater* under the *BTS sensitivity at the repeater antenna* level, indicating a larger coverage area for the BTS than for the FOR.
