**EMC Technologies Report Number: M061025\_Cert\_EYTF3CSFT\_WLAN**

## **APPENDIX B2**

### **Test Setup Photograph**

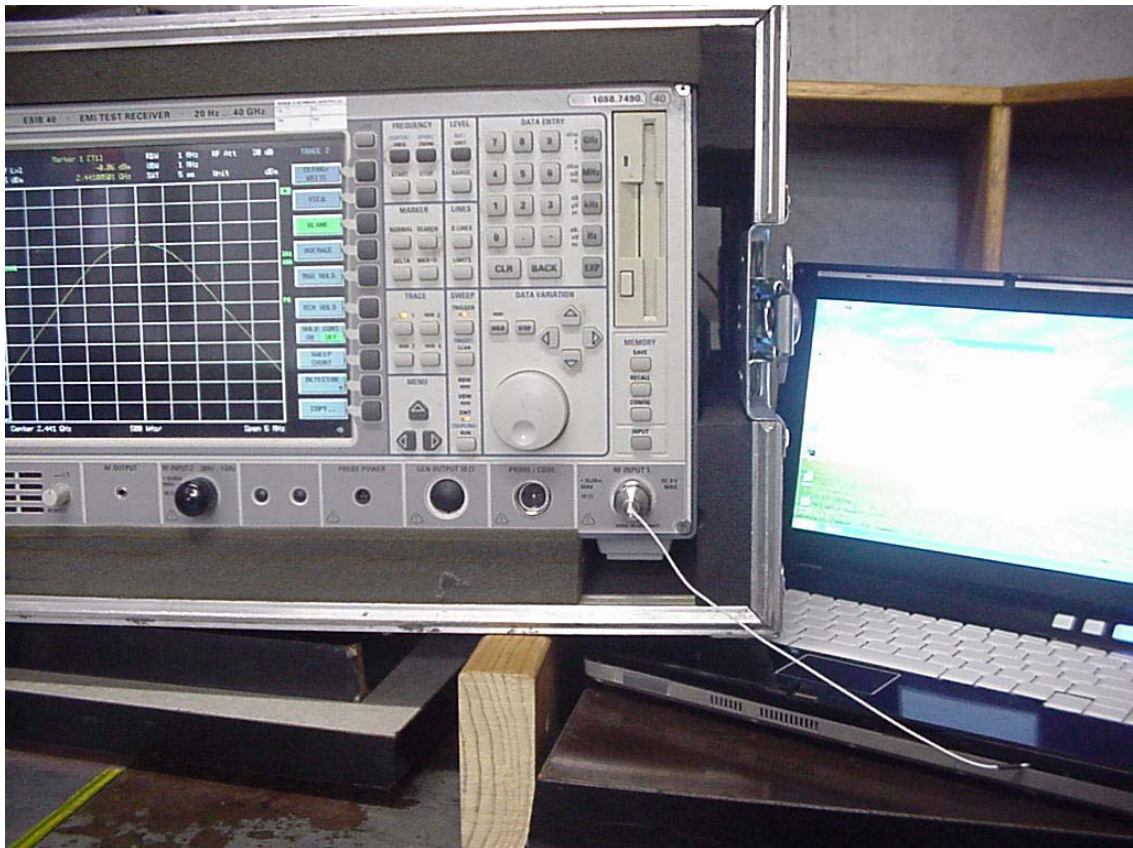
**Peak Output Power, Bandwidth, Harmonics, Band Edge and Channel Occupancy Test Setup**

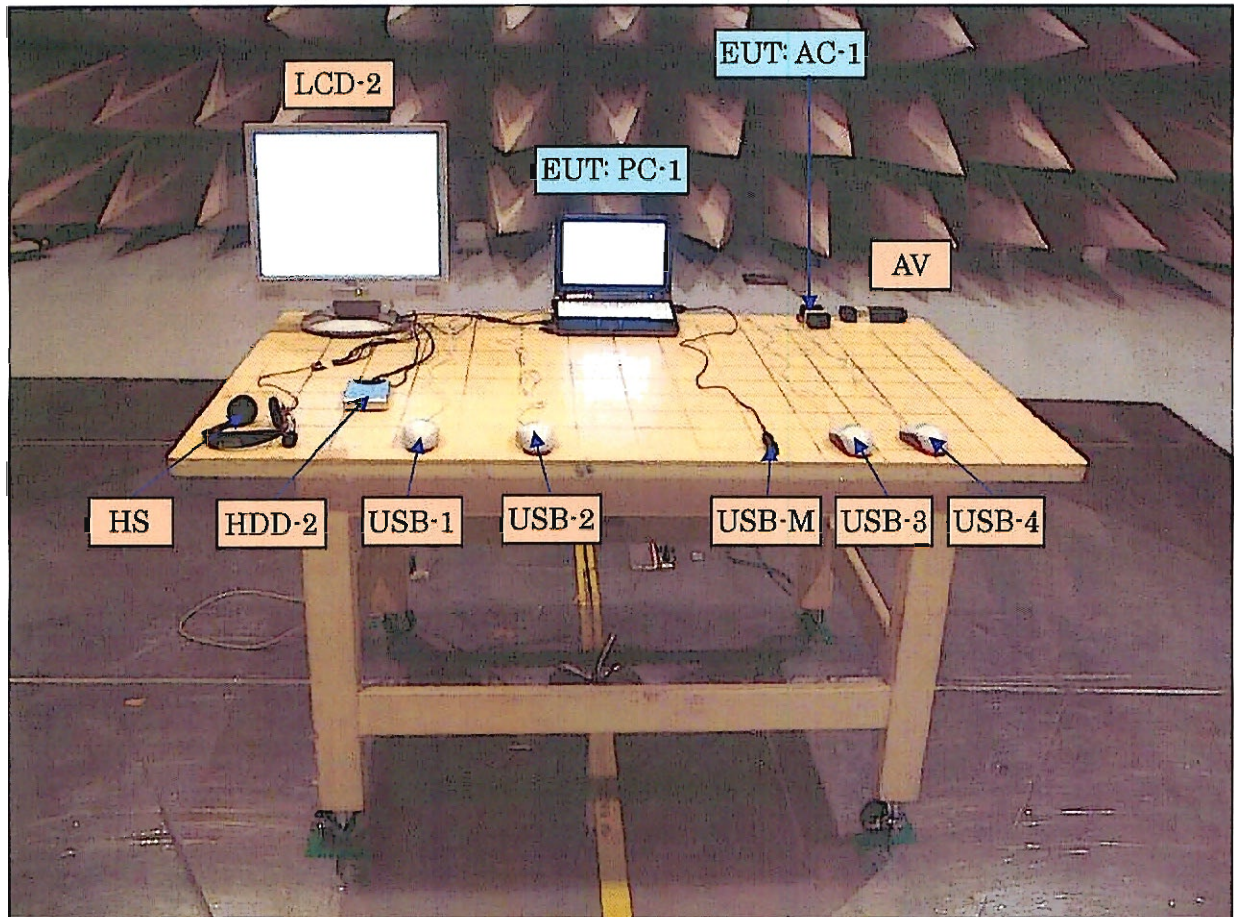
Photo-1.1 Radiated emission measurement for 30-1000 MHz (Front)

- HUB and PC-2 were set at outside of the chamber.

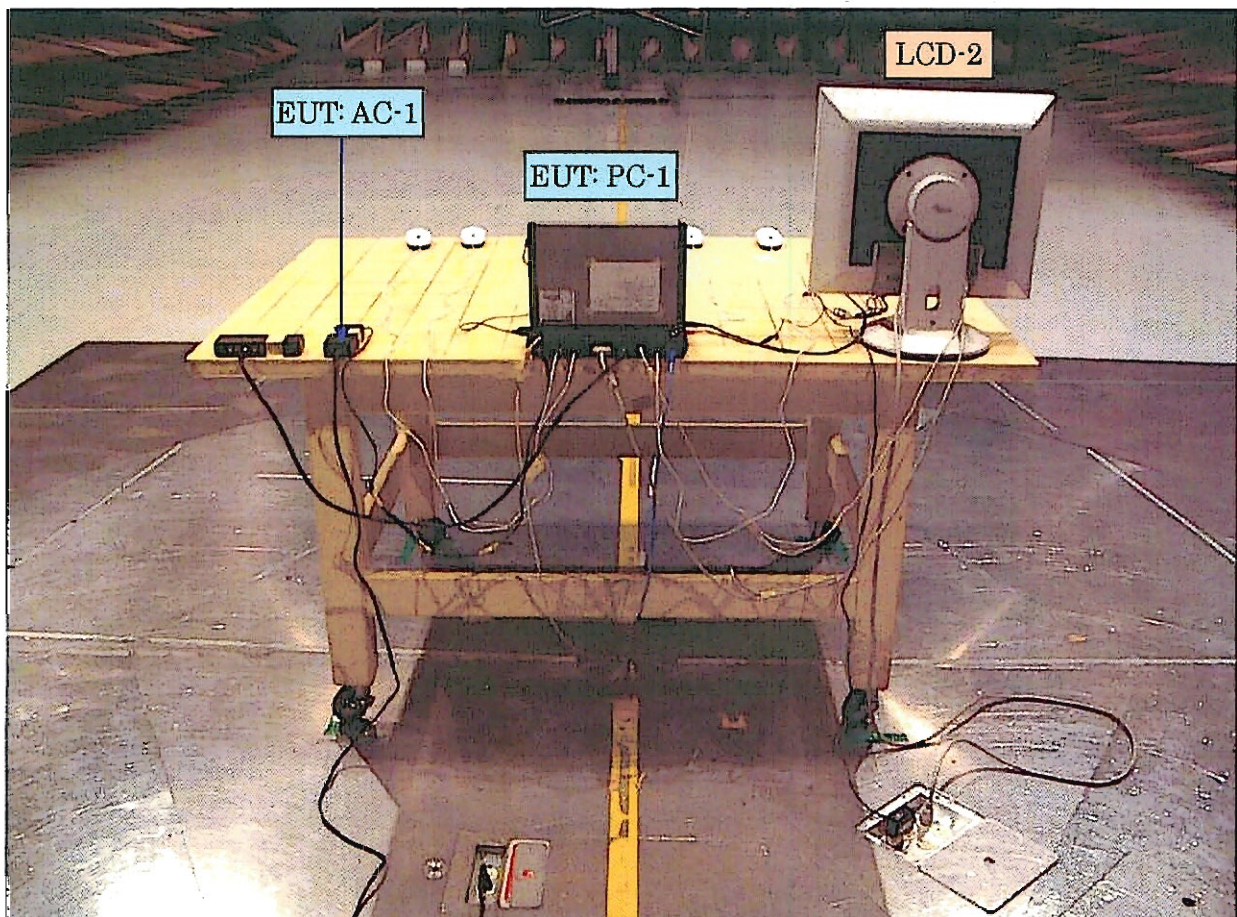
Photo-1.2 Radiated emission measurement for 30-1000 MHz (Back)

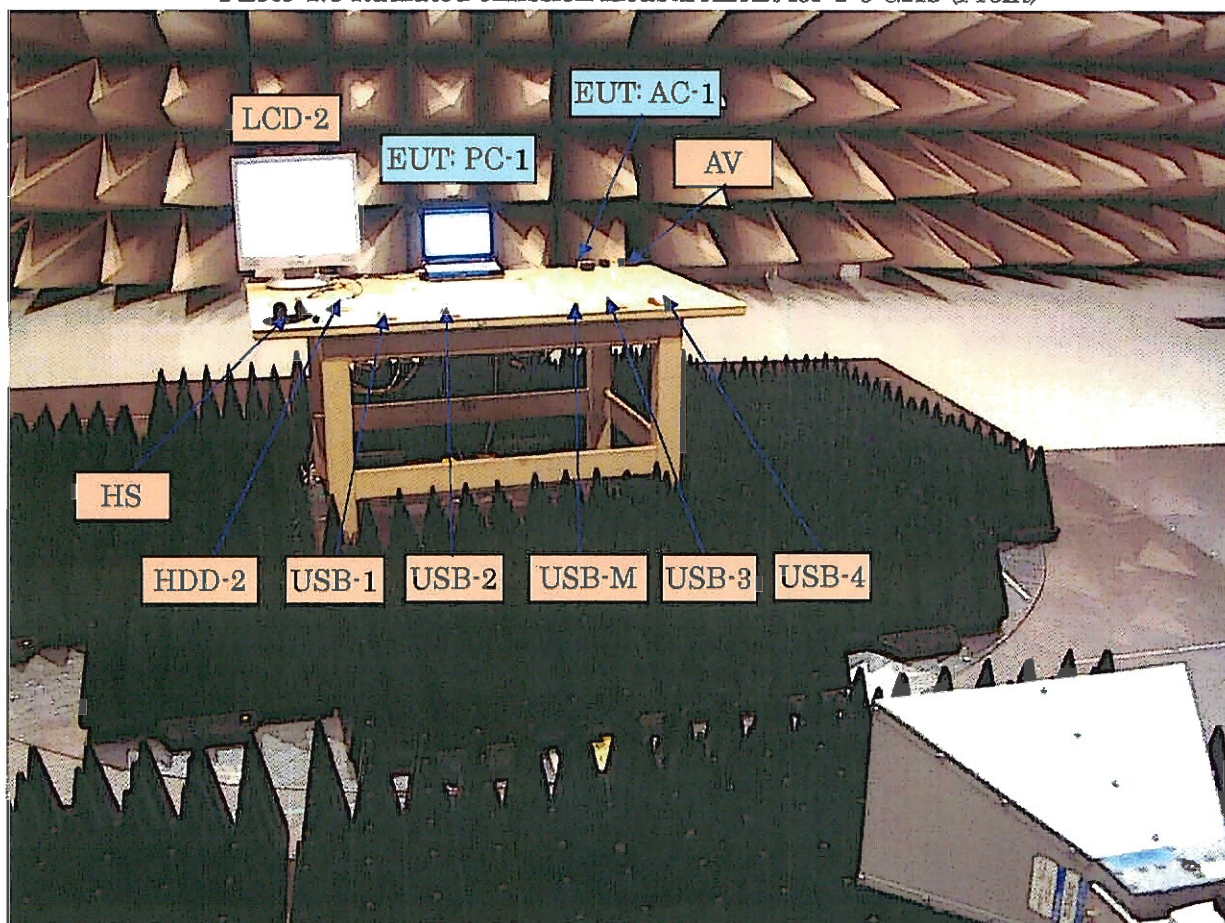
Photo-1.3 Radiated emission measurement for 1-6 GHz (Front)

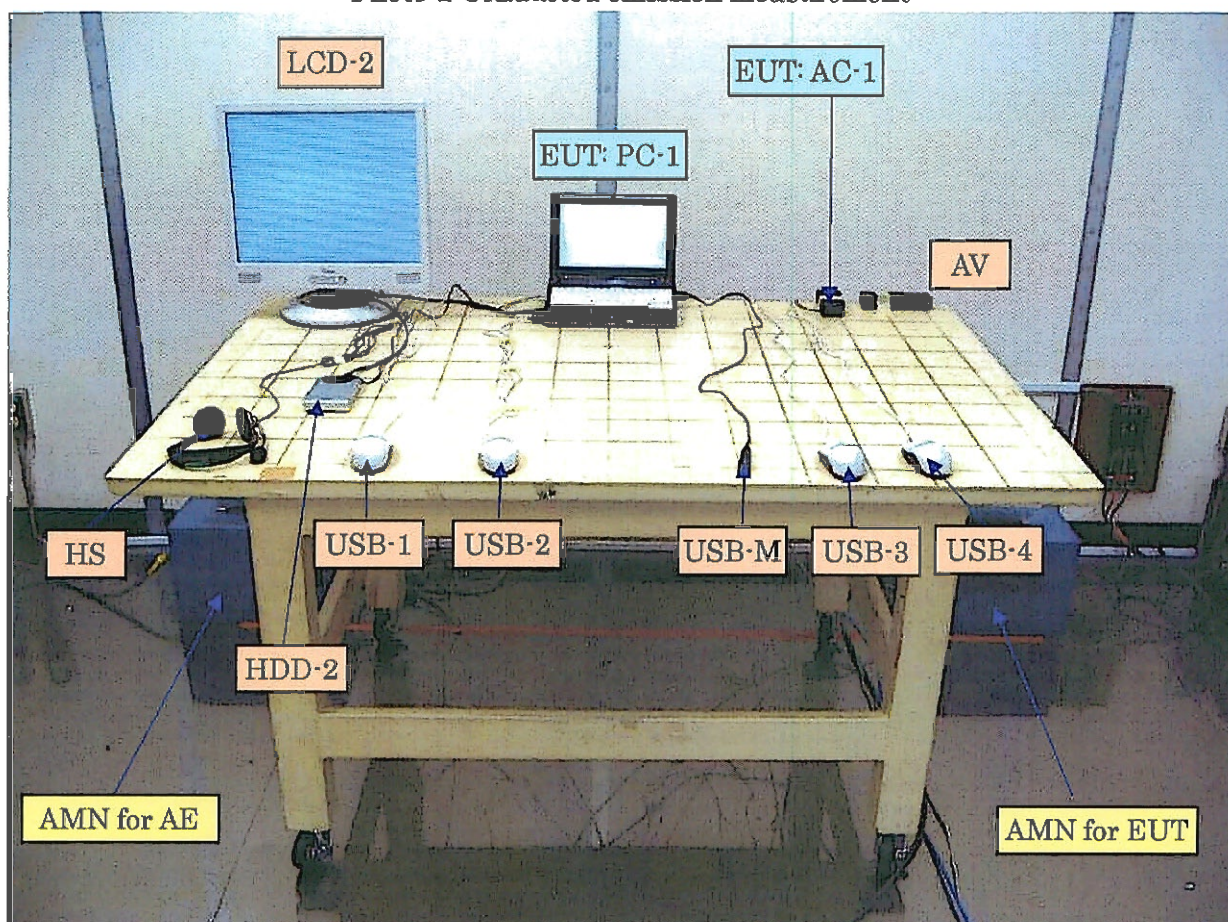
Photo-2 Conducted emission measurement
