APPENDIX B2
Test Setup Photograph

Radiated Spurious Emissions Test Setup

FCC Part 15 class B test set up photos

Photos extracted from report FG08_097EAL

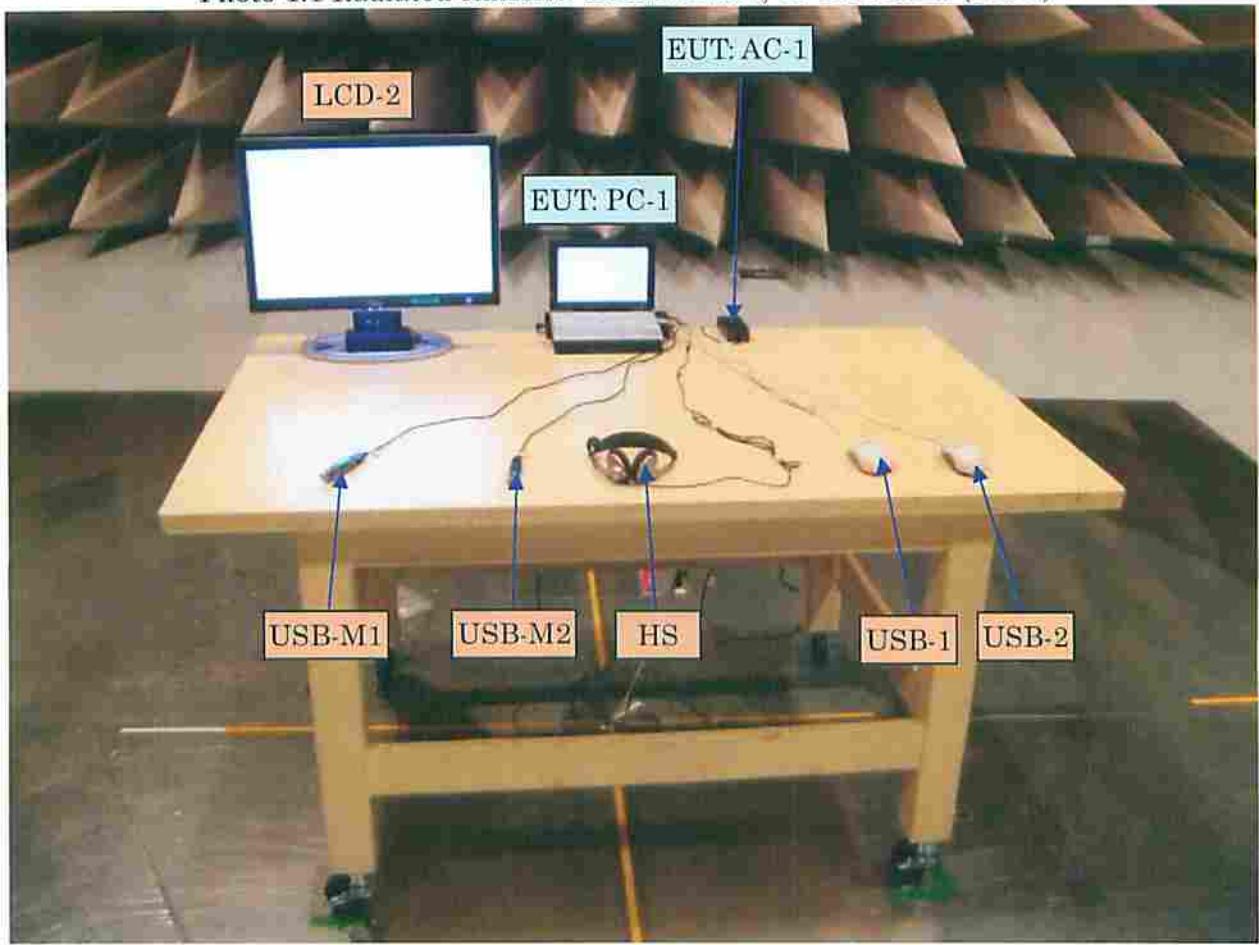
Photo-1.1 Radiated emission measurement; 30-1000 MHz (Front)

- HUB, TEL and PC-2 were set at outside of the chamber.

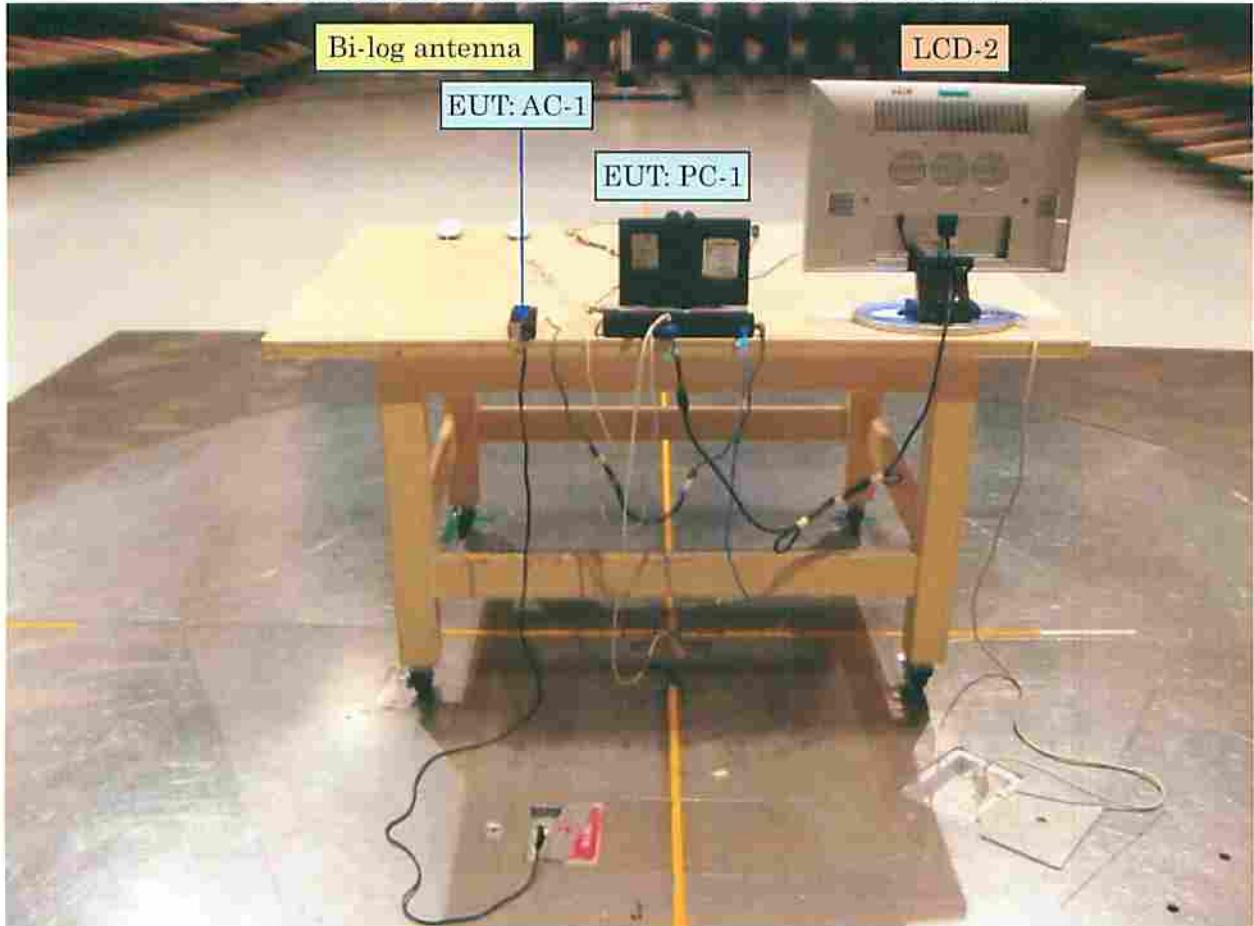
Photo-1.2 Radiated emission measurement; 30-1000 MHz (Back)

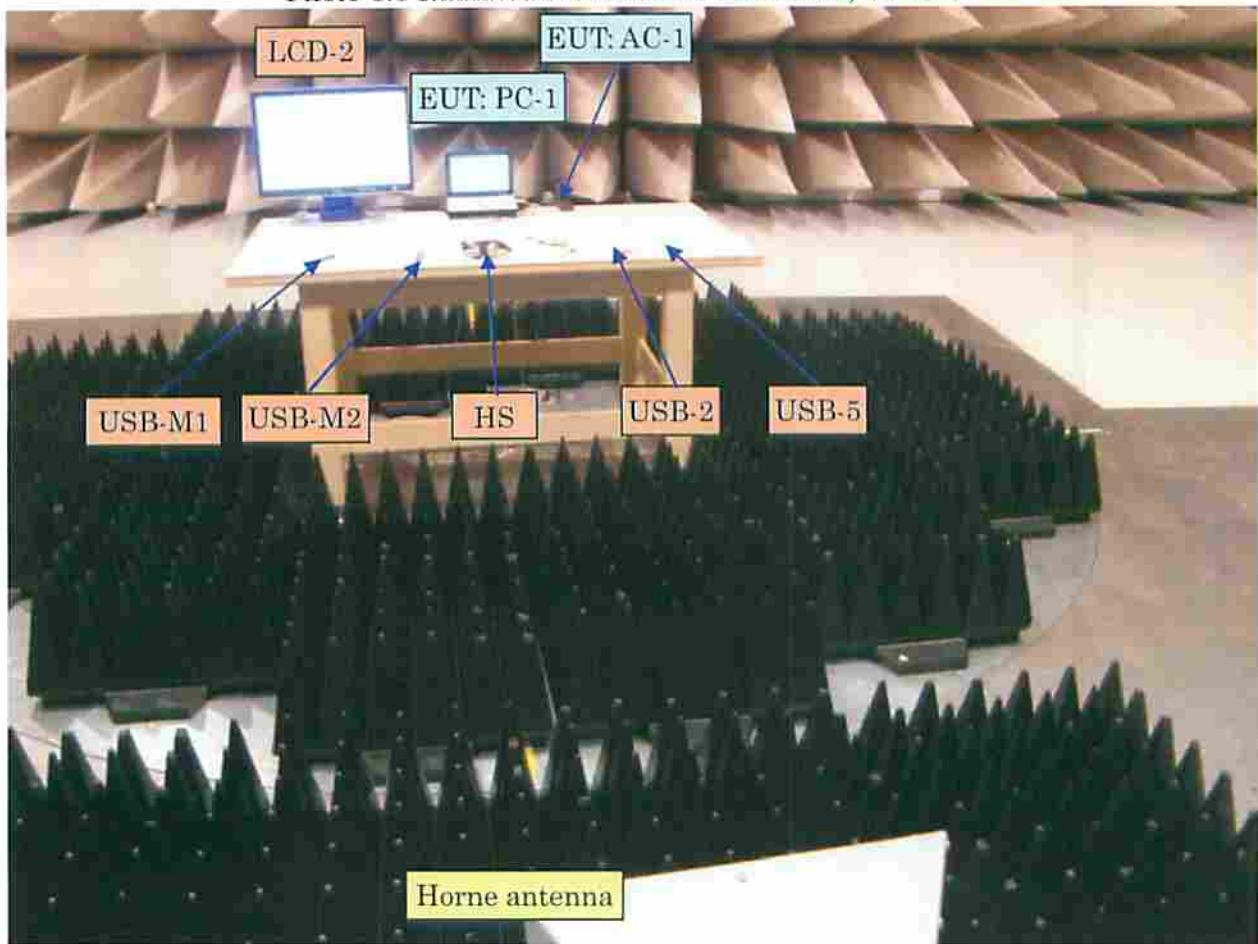
Photo-1.3 Radiated emission measurement; 1-7 GHz

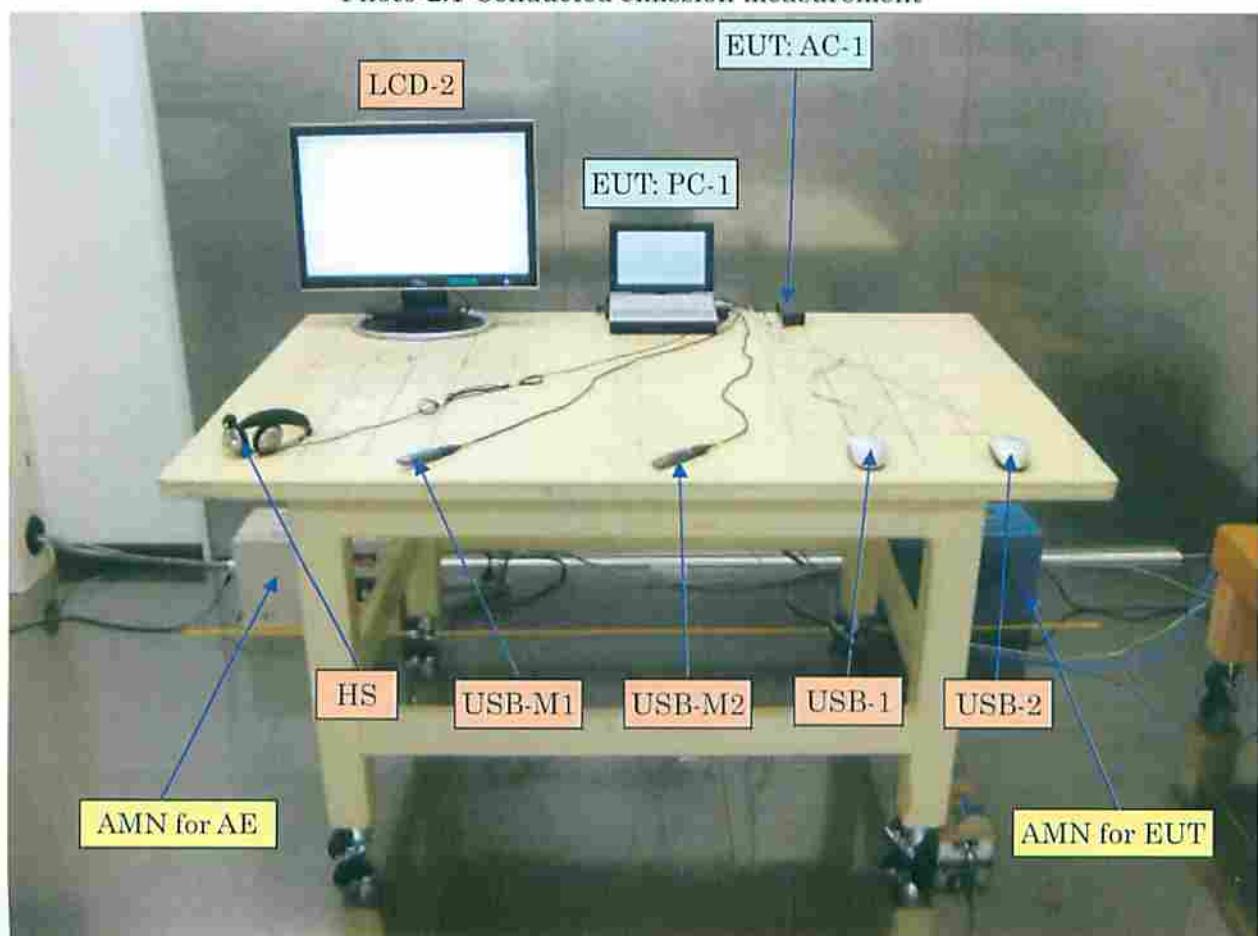
Photo-2.1 Conducted emission measurement
