APPENDIX B2
Test Setup Photograph

Radiated Spurious Emissions Test Setup

FCC Part 15 class B test set up photos

Photos extracted from report FG08_101EAL

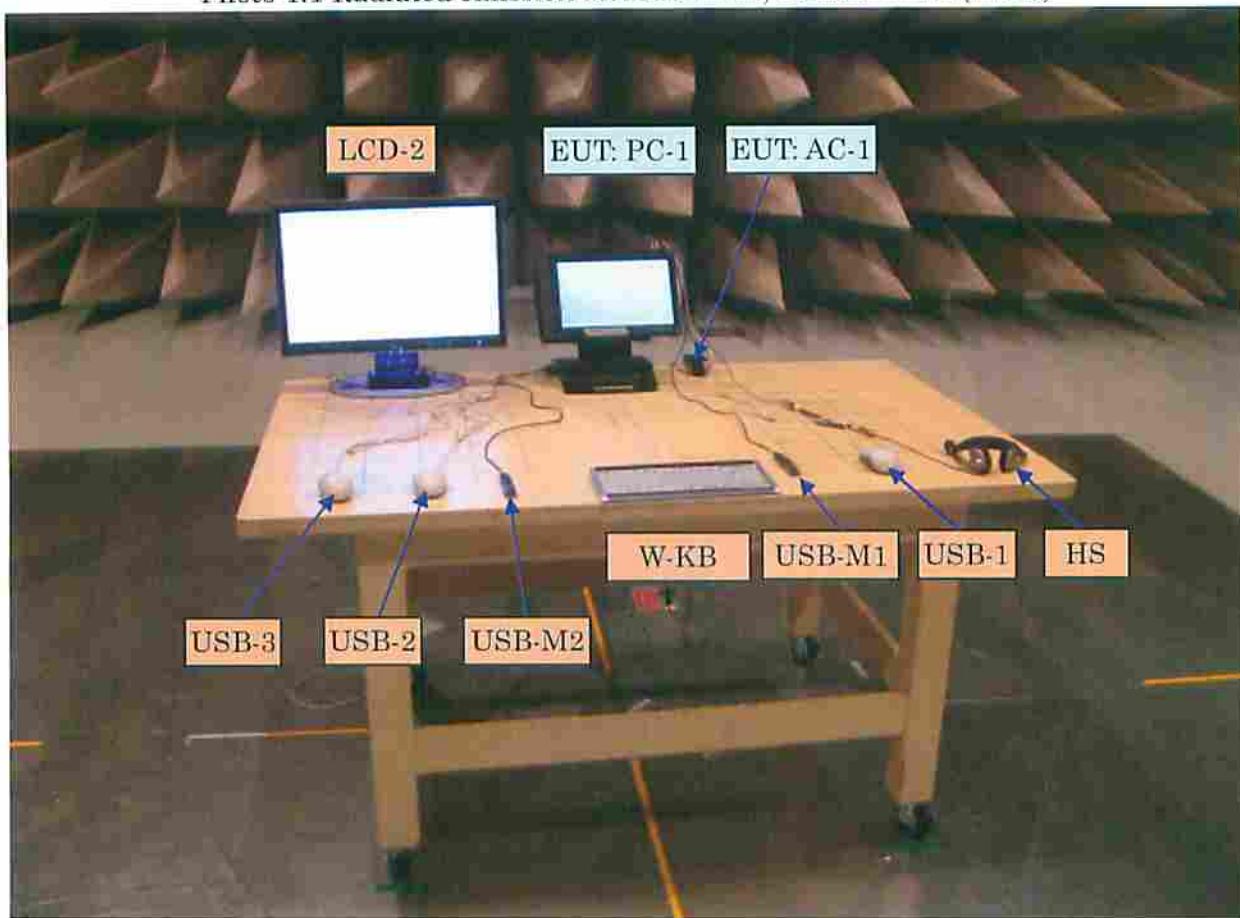
Photo-1.1 Radiated emission measurement; 30-1000 MHz (Front)

- PC-2 and HUB were set at outside of the chamber.

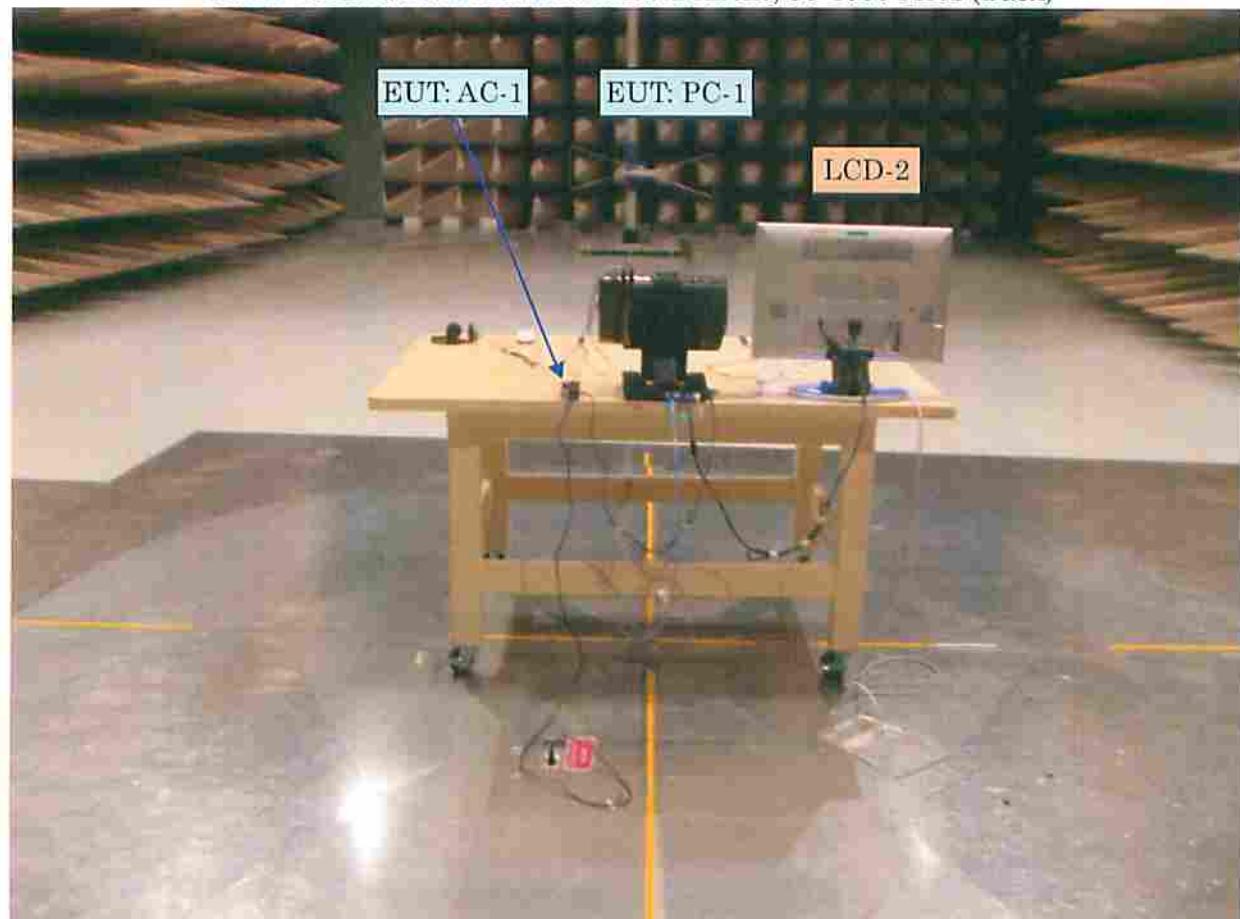
Photo-1.2 Radiated emission measurement; 30-1000 MHz (Back)

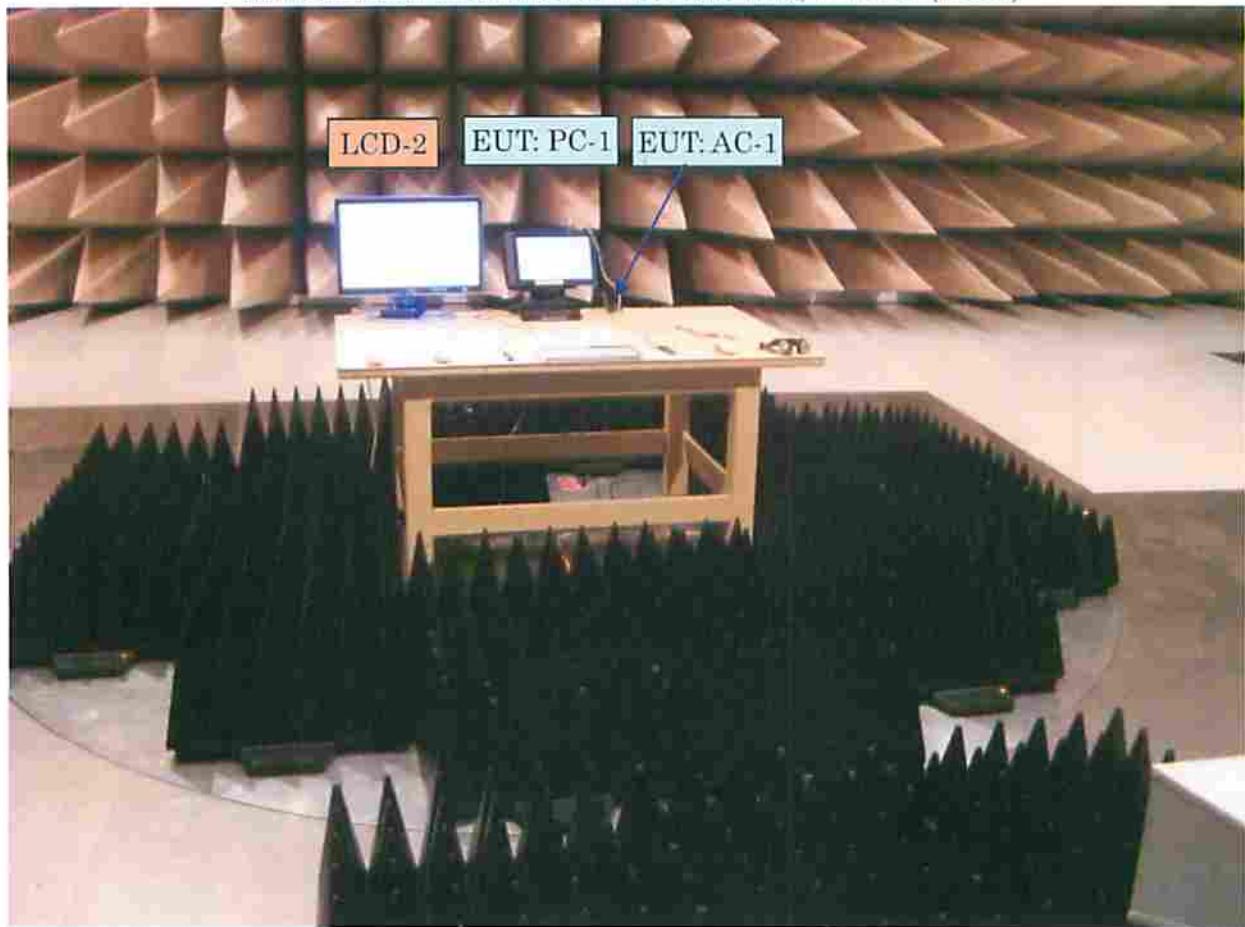
Photo-1.3 Radiated emission measurement; 1-7 GHz (Front)

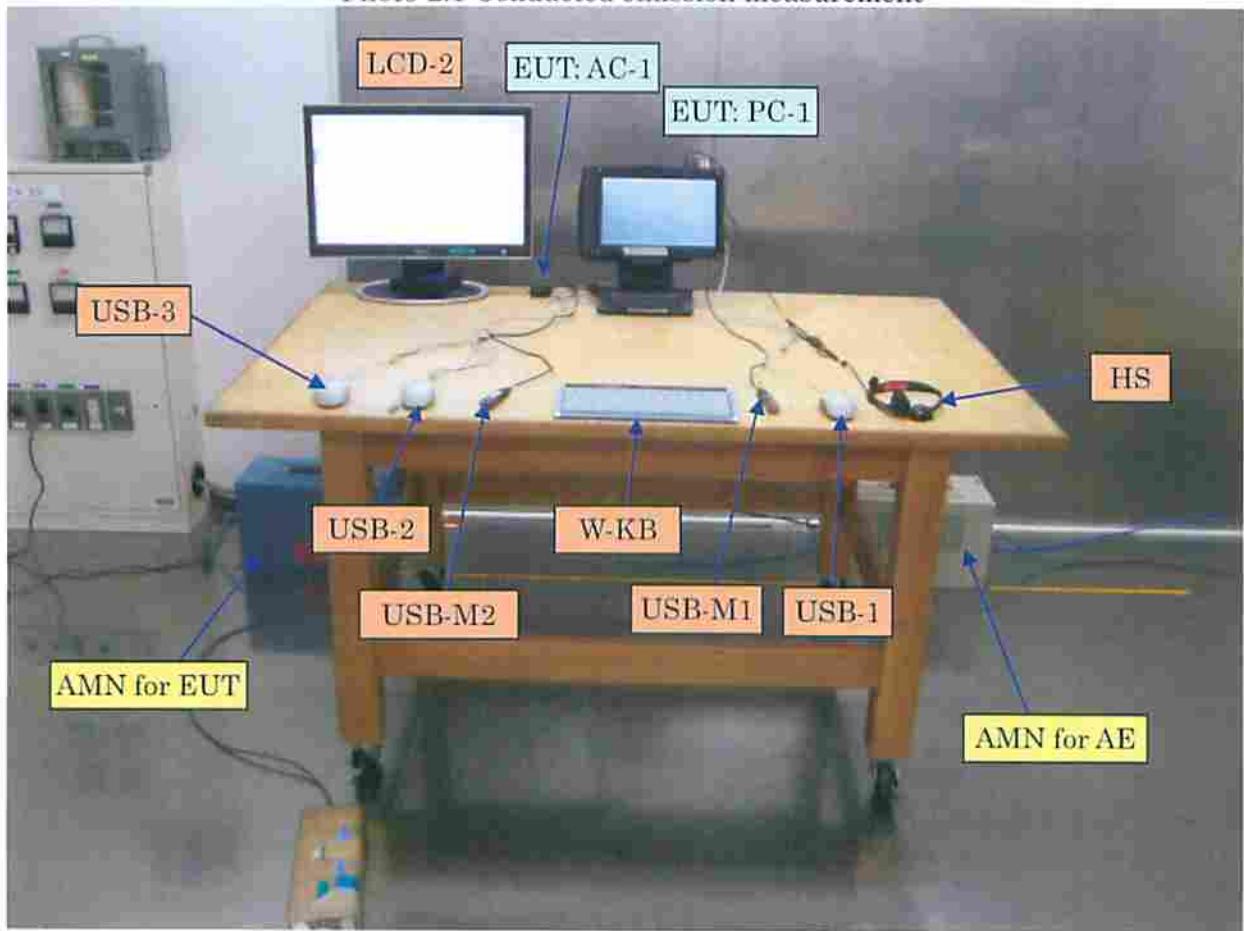
Photo-2.1 Conducted emission measurement

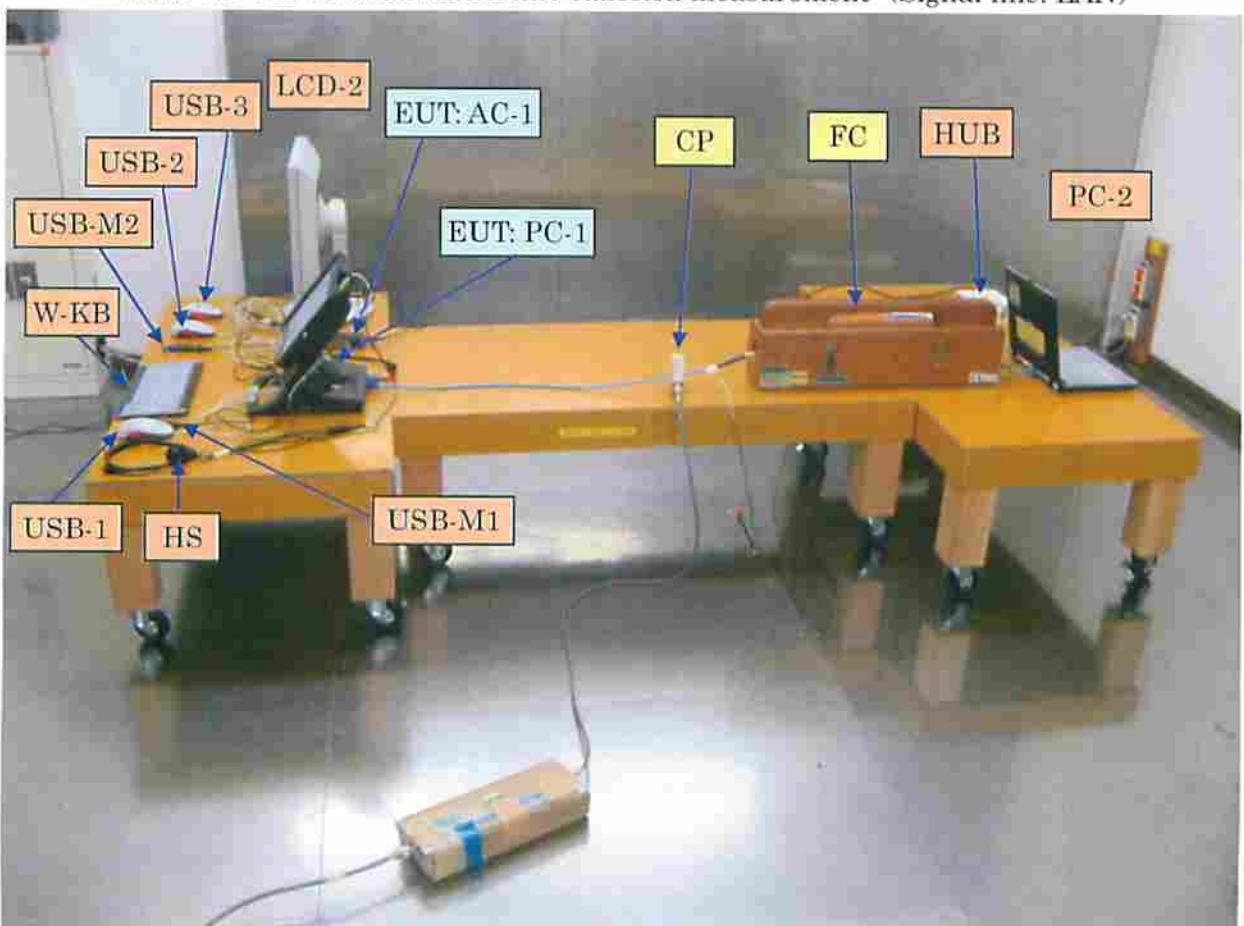
Photo-2.2 Telecommunication line emission measurement (Signal line: LAN)
