Registration number: W6M22207-21977-C-54  
FCC ID: GX9HSGWGEN2

## **Appendix**

### **Measurement diagrams**

Spurious Emissions radiated

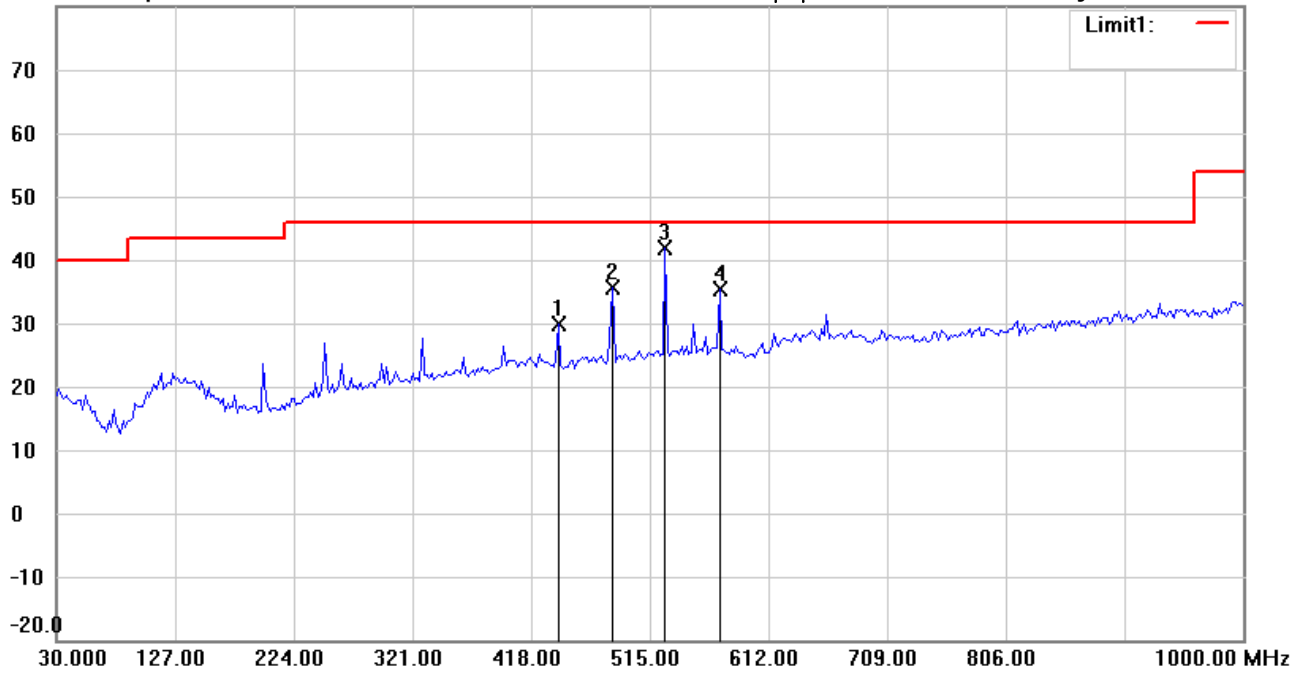
Radiated Emission Measurement

Site : Chamber

Condition : FCC\_part 15 RE-Class E\_30-1000MHz

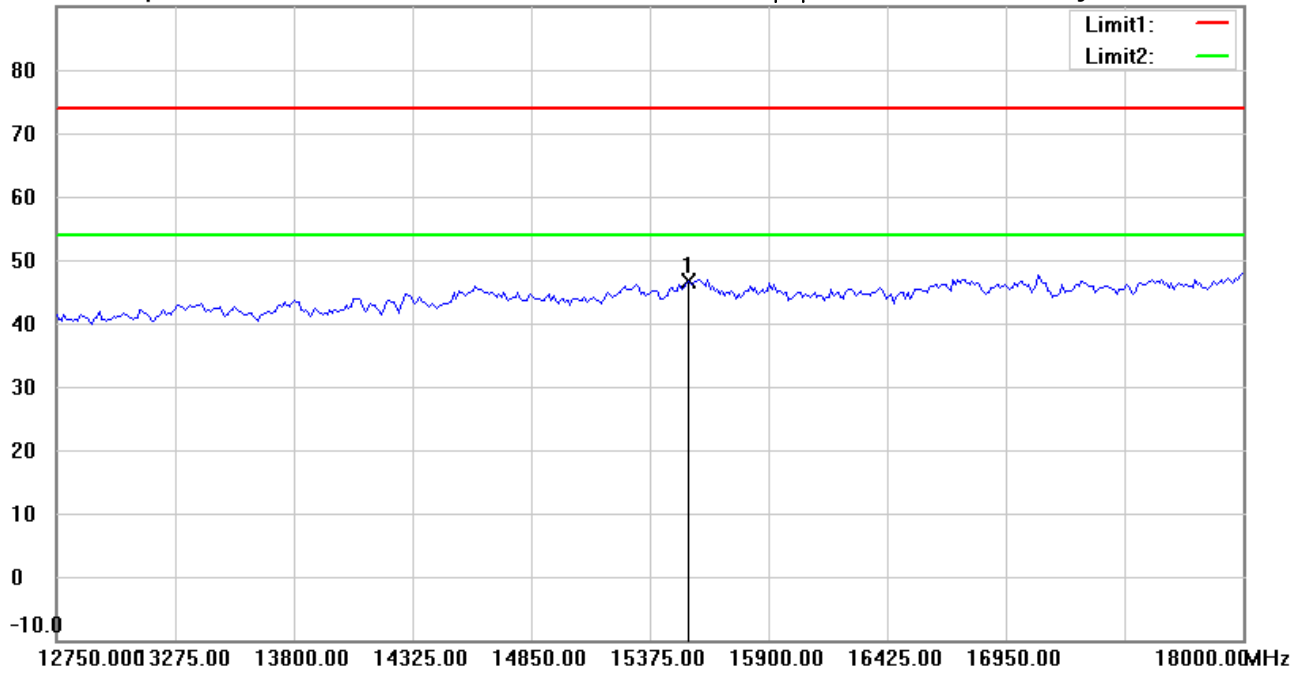
Site : Chamber

Condition : FCC\_part 15E RE\_Above 1GHz\_PK

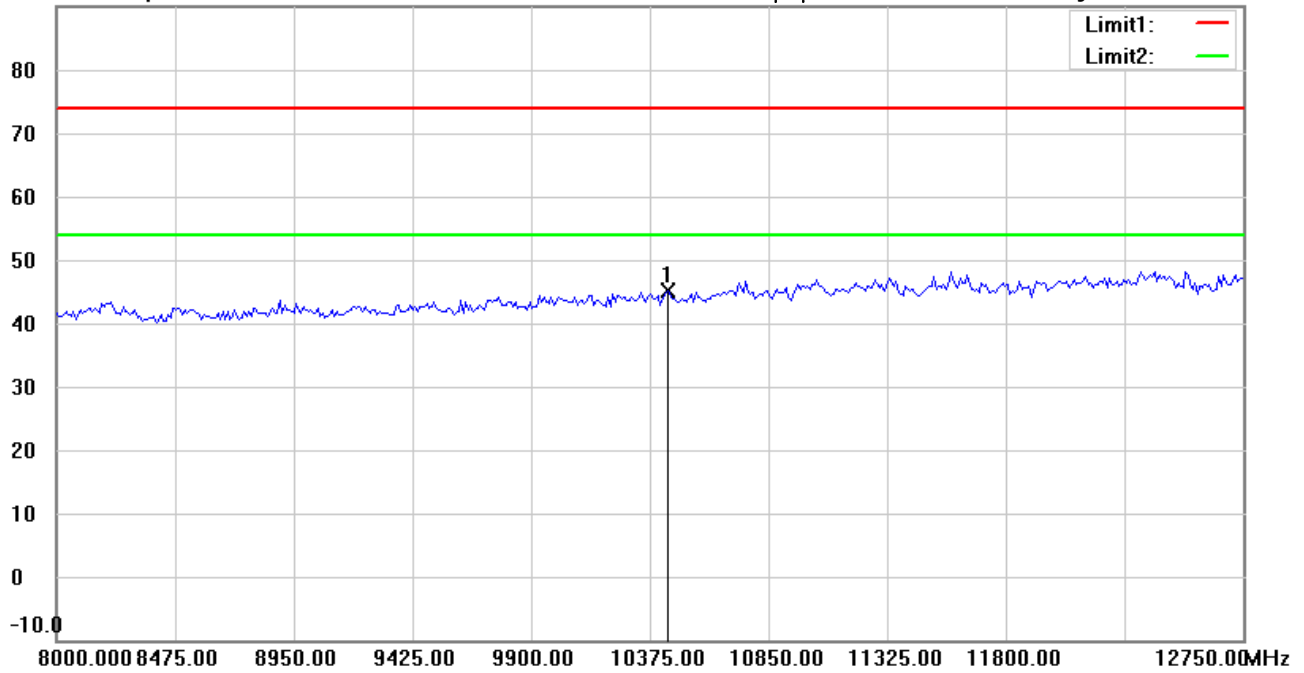
Site : Chamber

Condition : FCC\_part 15E RE\_Above 1GHz\_PK

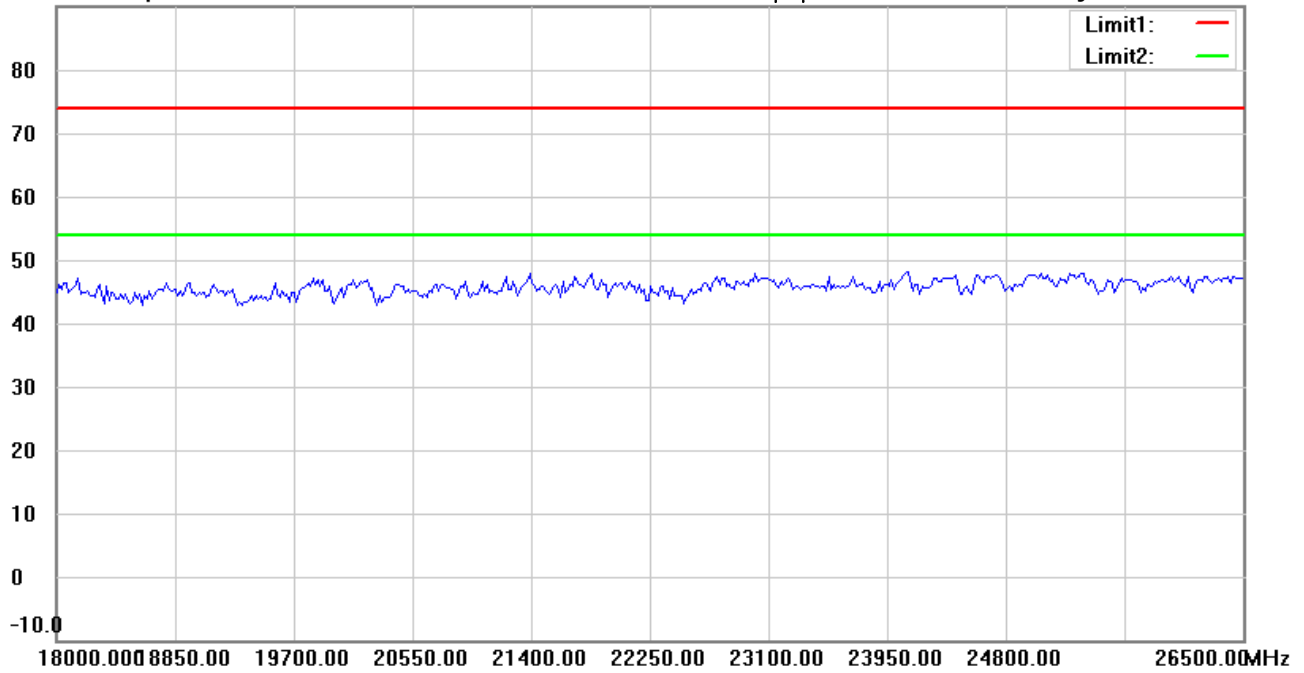
Site : Chamber

Condition : FCC\_part 15E RE\_Above 1GHz\_PK

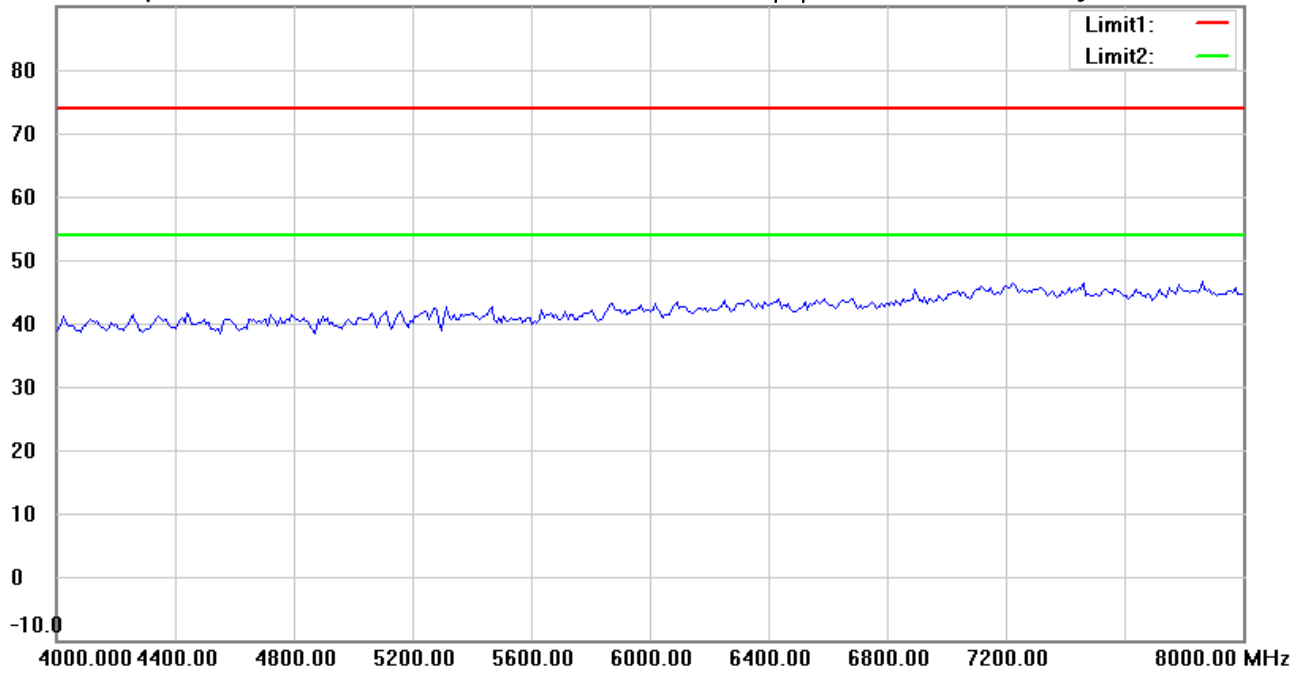
Site : Chamber

Condition : FCC\_part 15E RE\_Above 1GHz\_PK
