APPENDIX 3: Photographs of test setup

Radiated emission

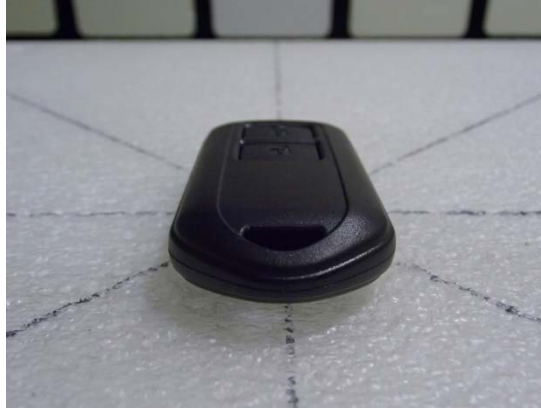
Worst case position
(Horizontal: X-axis / Vertical: Y-axis)
