APPENDIX 3: Photographs of test setup

Radiated emission
(Below 1GHz)

Radiated emission
(Above 1GHz)

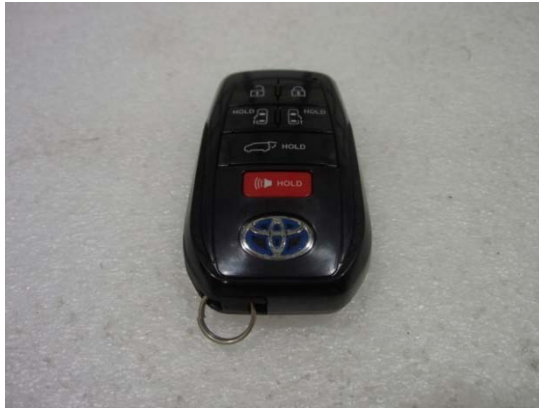
Worst case position
(Horizontal: X-axis / Vertical: Y-axis)

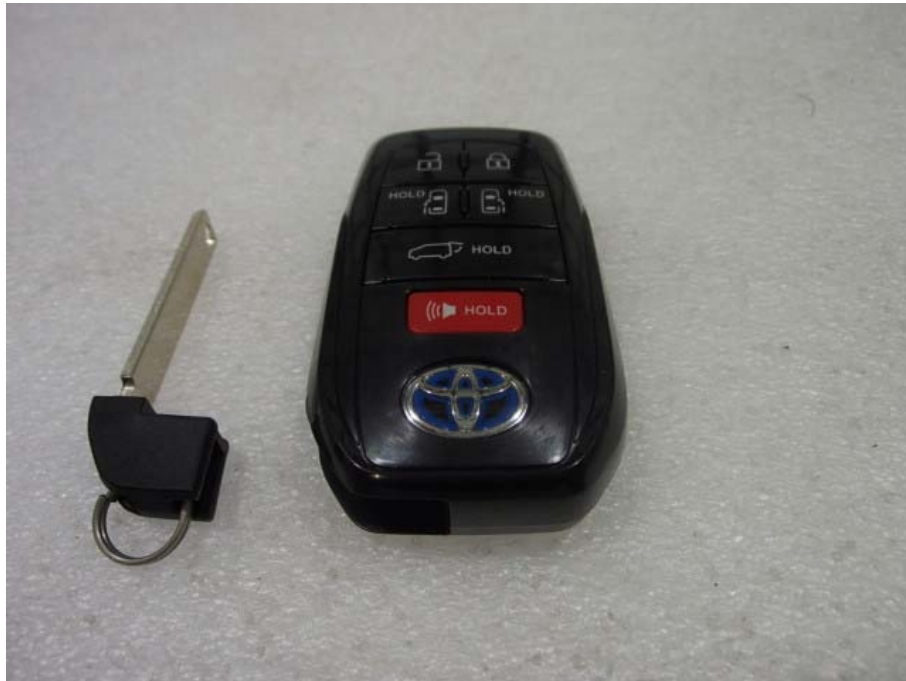
Mechanical Key (Not Inserted)

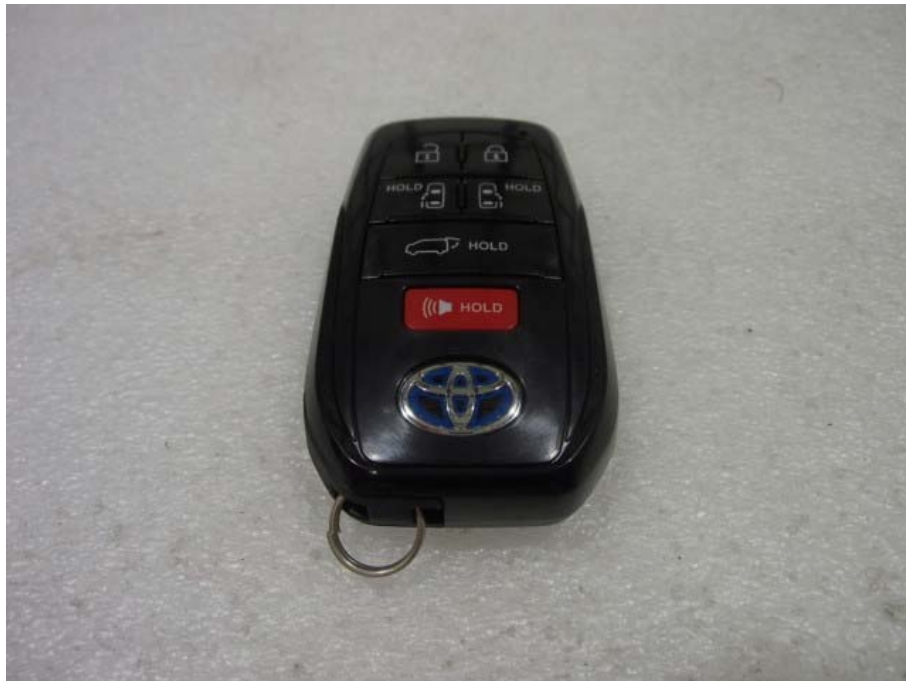
Mechanical Key (Inserted) Worst
