APPENDIX 3: Photographs of test setup

Radiated emission

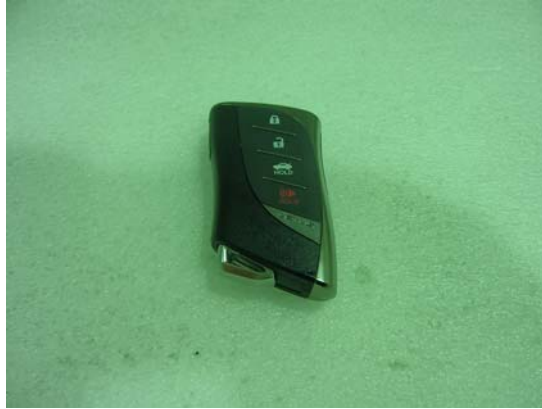
Worst case position

Below 1GHz (Horizontal: X-axis / Vertical: Y-axis)

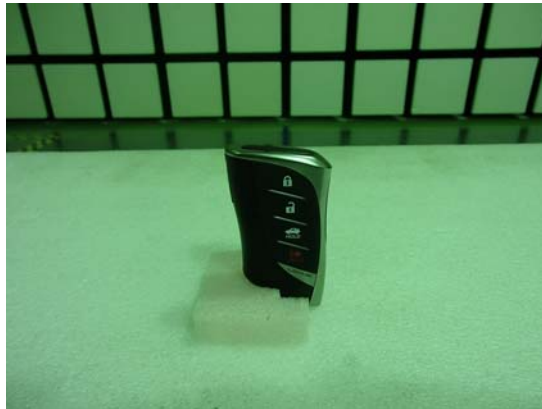
Y-axis

Above 1GHz (Horizontal: Z-axis / Vertical: Y-axis)

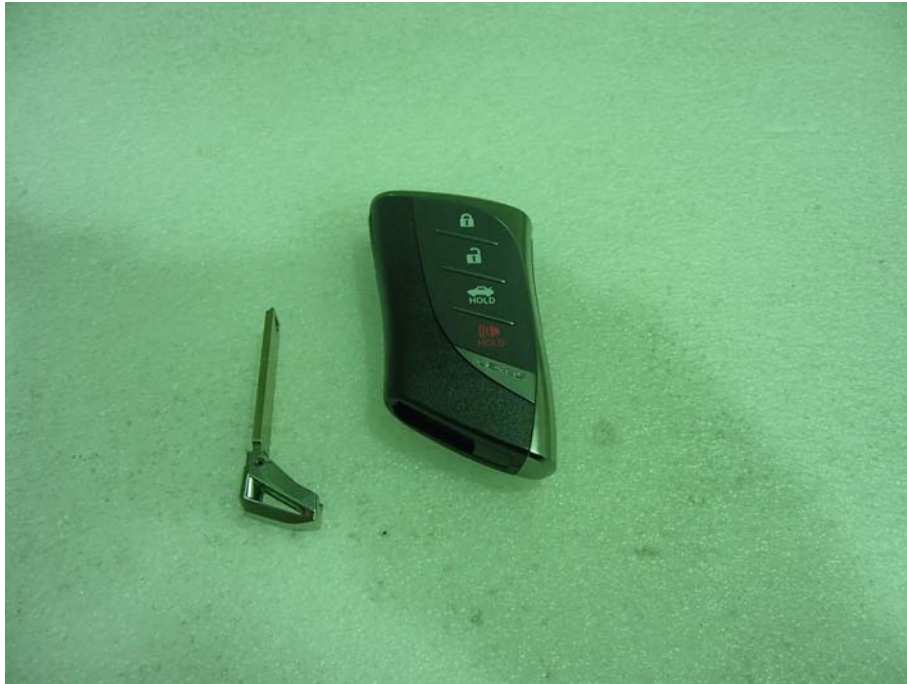
Mechanical Key (Not Inserted)

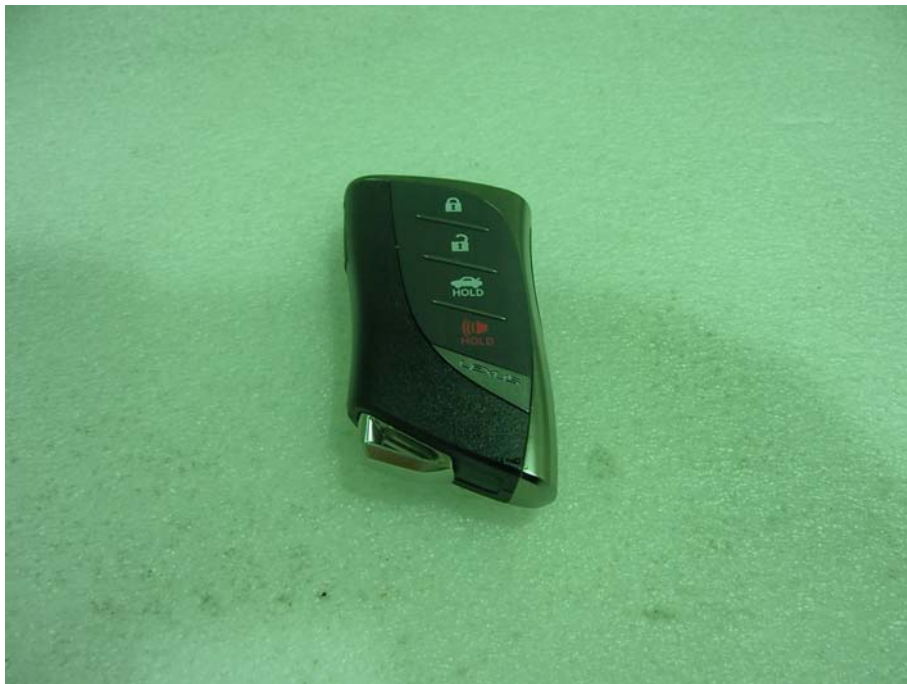
Mechanical Key (Inserted) Worst
