APPENDIX 3: Photographs of test setup

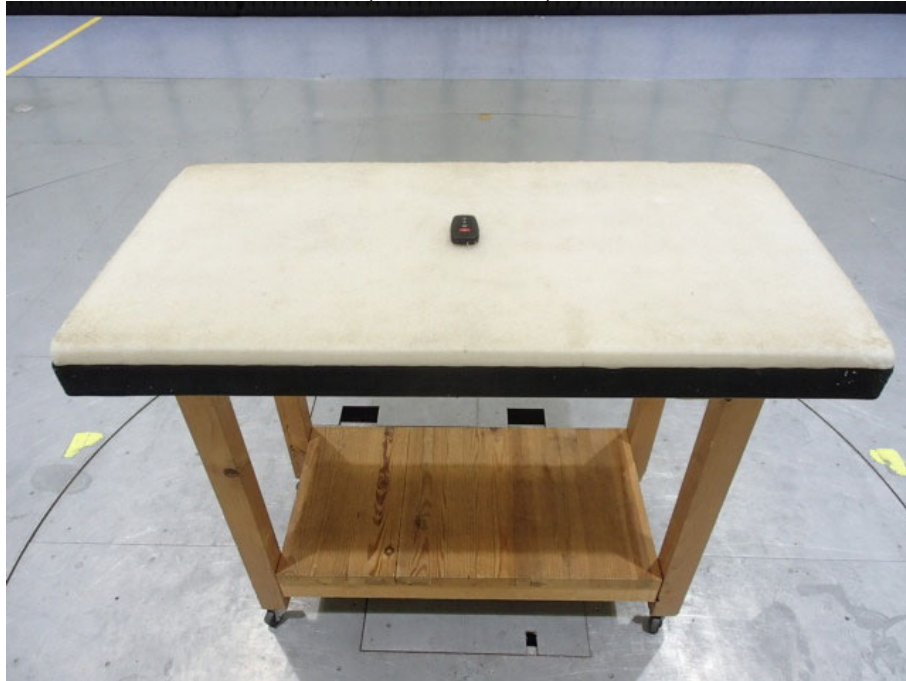
Photo 1

Radiated emission
(Below 1GHz)

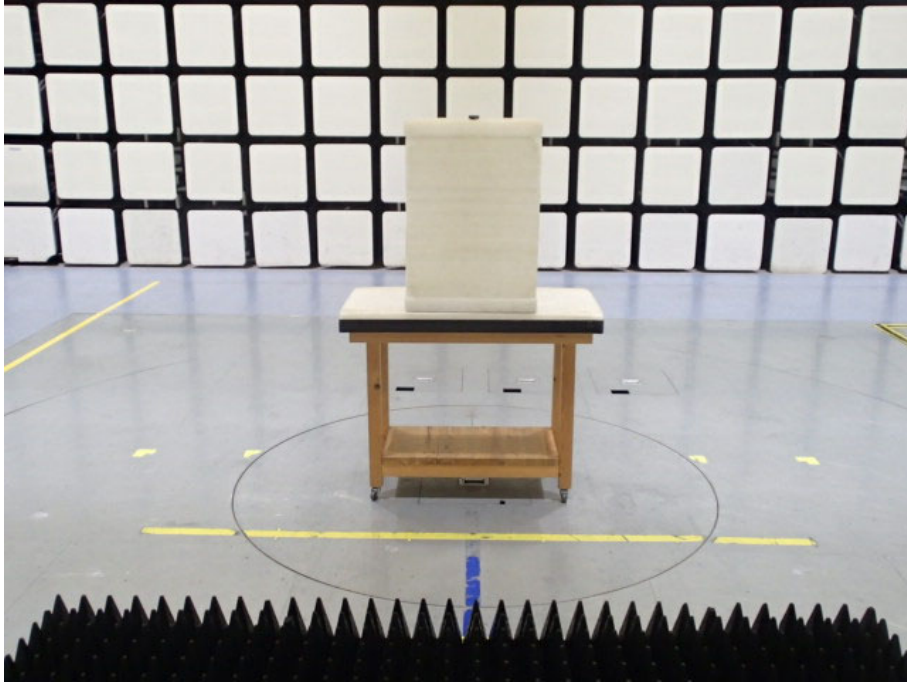
Photo 1

Radiated emission
(Above 1GHz)

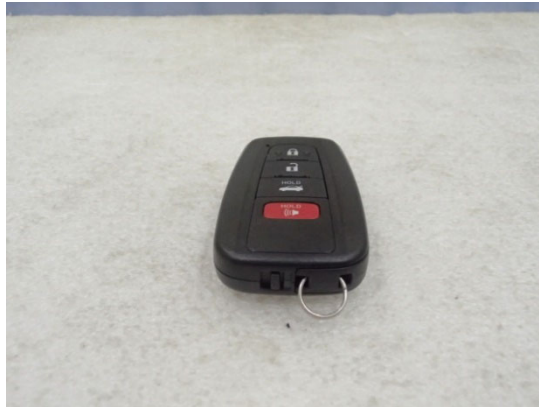
Worst case position

Below 1 GHz: (Horizontal: X-axis / Vertical: Y-axis)

Above 1 GHz: (Horizontal: X-axis / Vertical: X-axis)

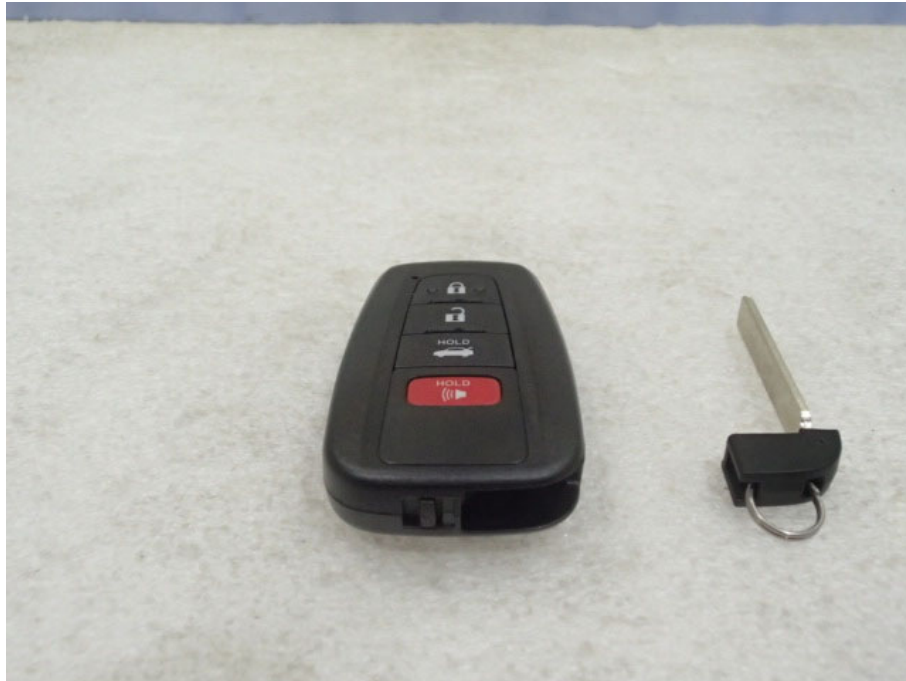
Mechanical Key (Not Inserted)

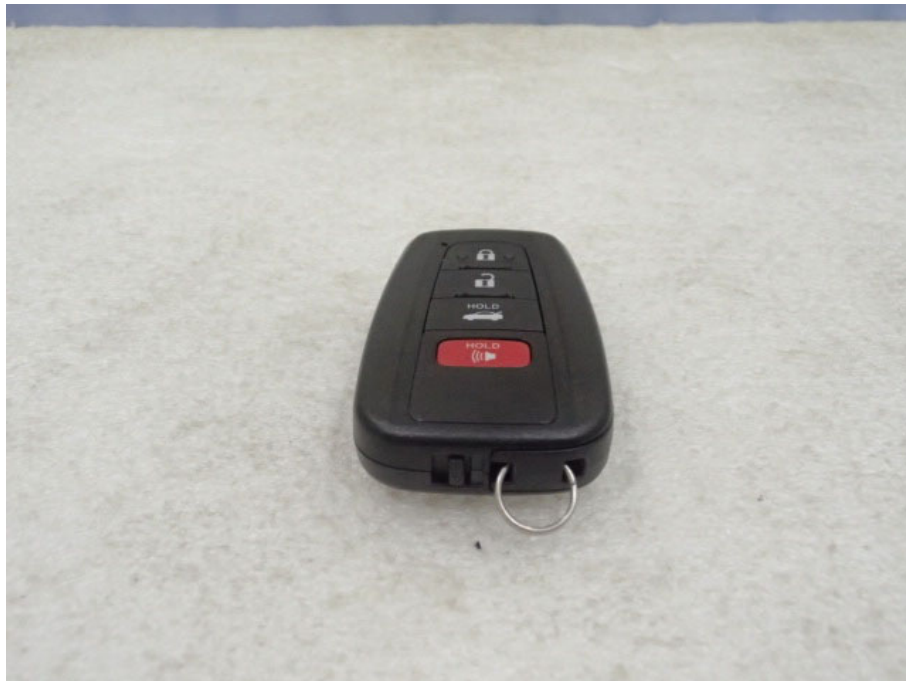
Mechanical Key (Inserted) Worst
