APPENDIX 1: Photographs of test setup

Radiated Emission Internal Antenna

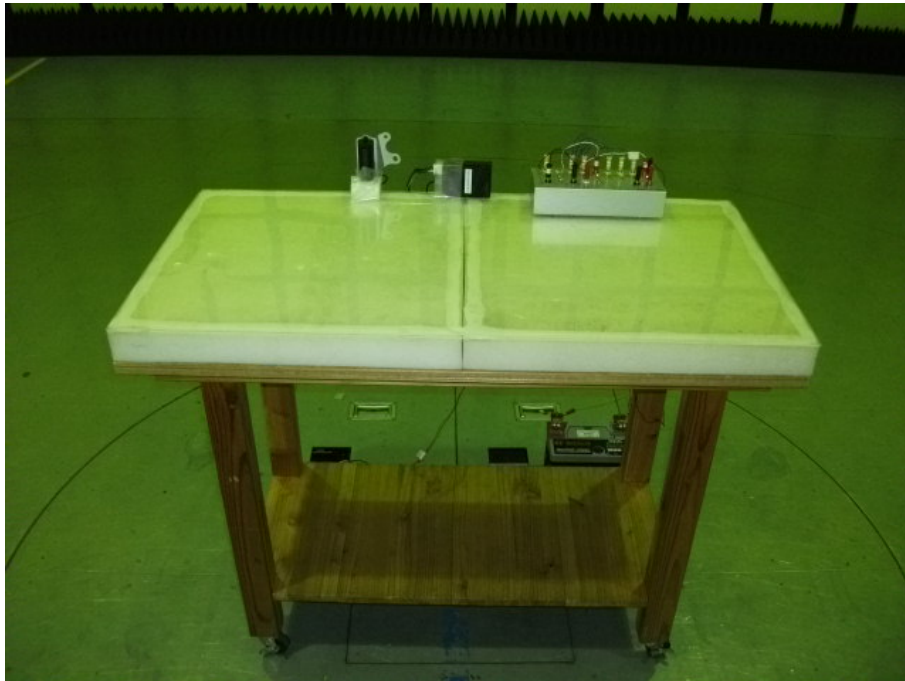
Photo 1

Radiated Emission
External Antenna

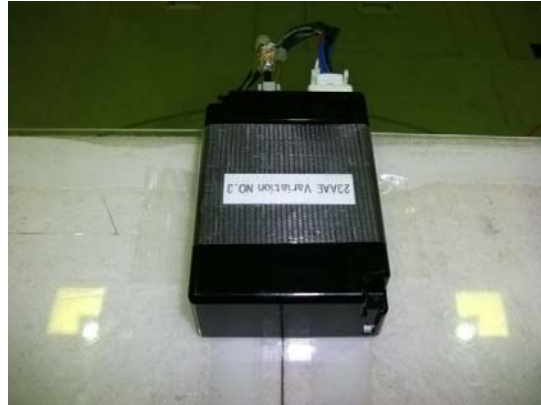
X-axis

Worst Case Position(Internal Antenna)

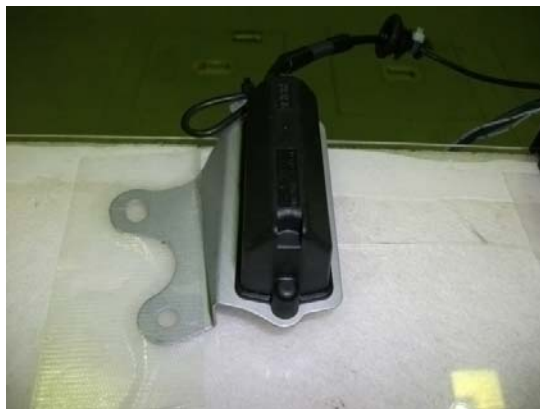
X-axis

Worst Case Position(External Antenna)
