5. Conducted Band Edges

5.1. Test Plots

n77A / 30KHz / 60MHz

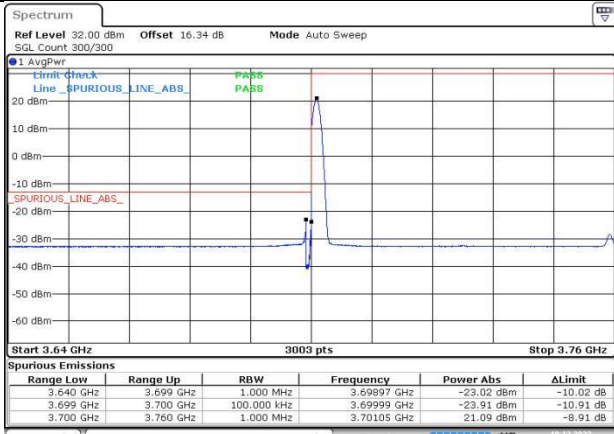
LCH / DFT-Pi2BPSK / Edge_1RB_Left

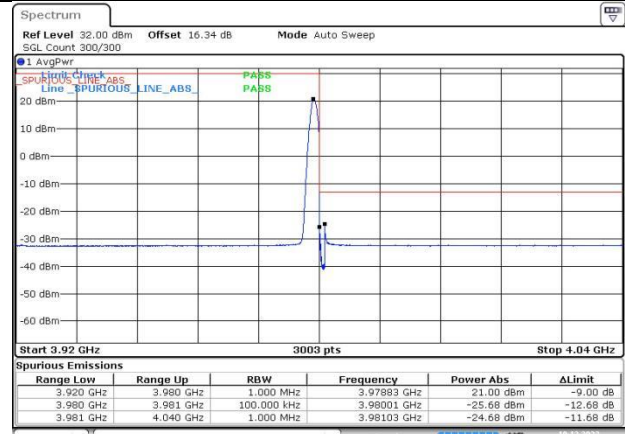
HCH / DFT-Pi2BPSK / Edge_1RB_Right

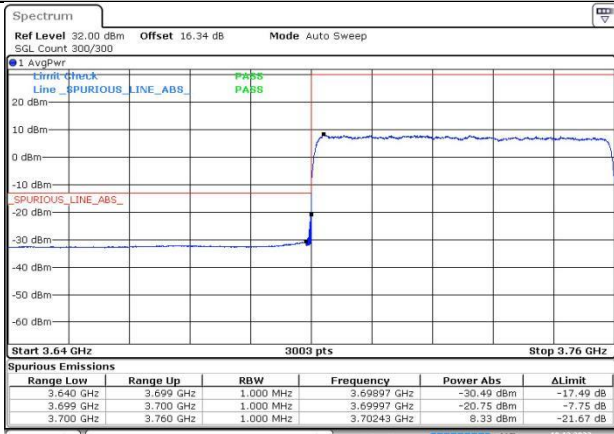
LCH / DFT-Pi2BPSK / Outer_Full

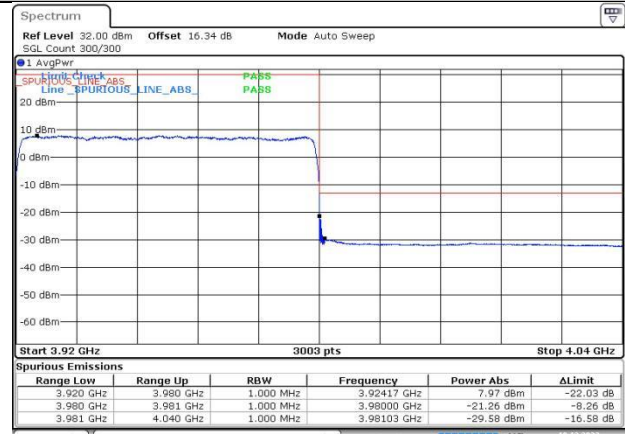
HCH / DFT-Pi2BPSK / Outer_Full

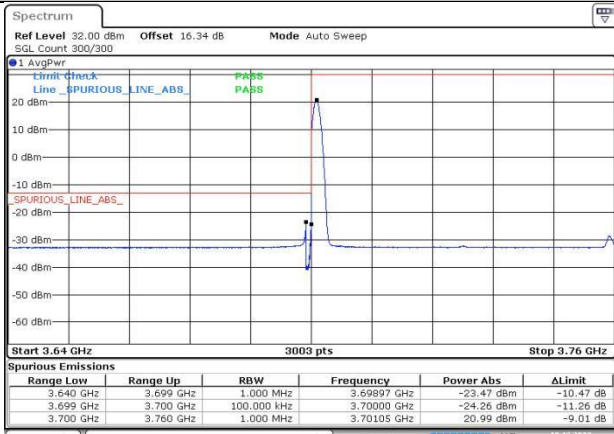
LCH / DFT-QPSK / Edge_1RB_Left

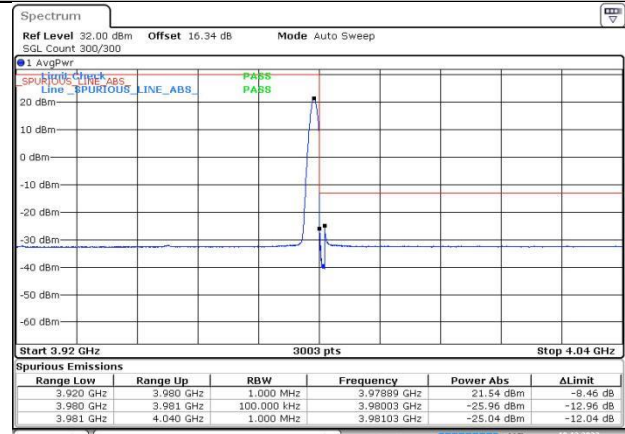
HCH / DFT-QPSK / Edge_1RB_Right
