**ANNEX 1 - PLOTS OF MEASUREMENTS**  
**TRANSIENT FREQUENCY BEHAVIOR**

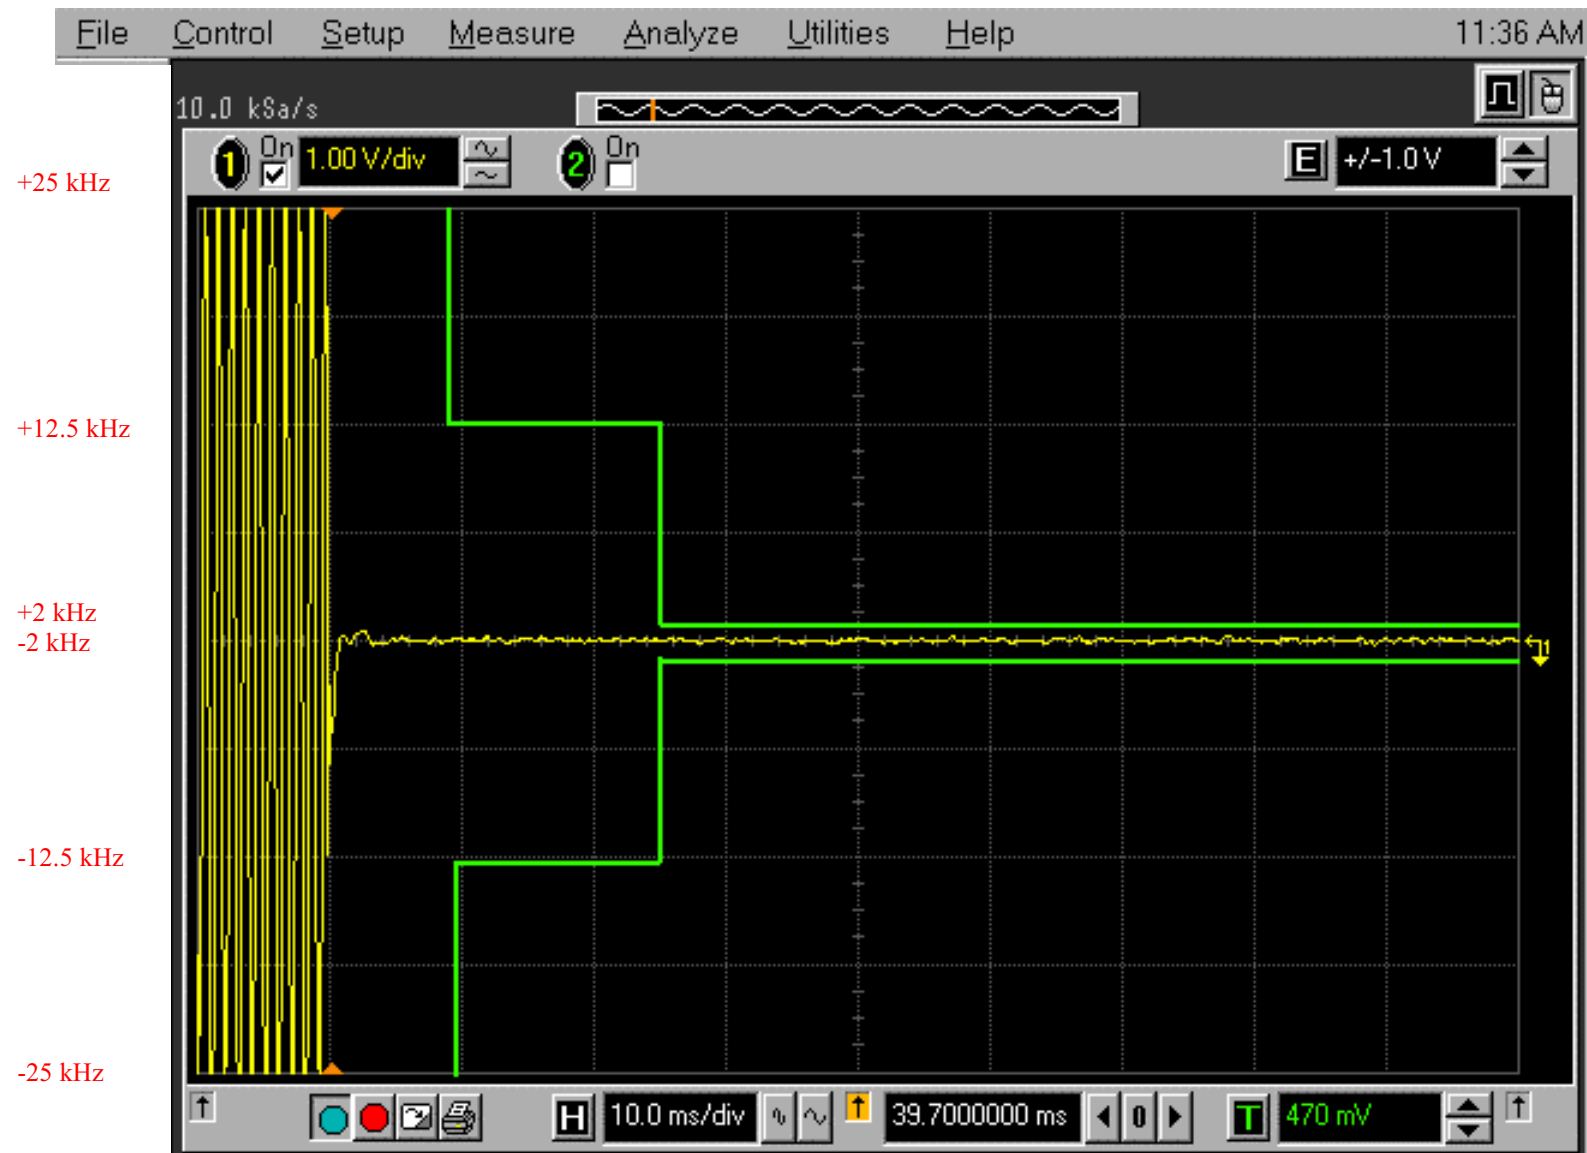
**PLOT # 34**

**25 kHz Channel Spacing, Transmitter was being turned ON, NO MODULATION**

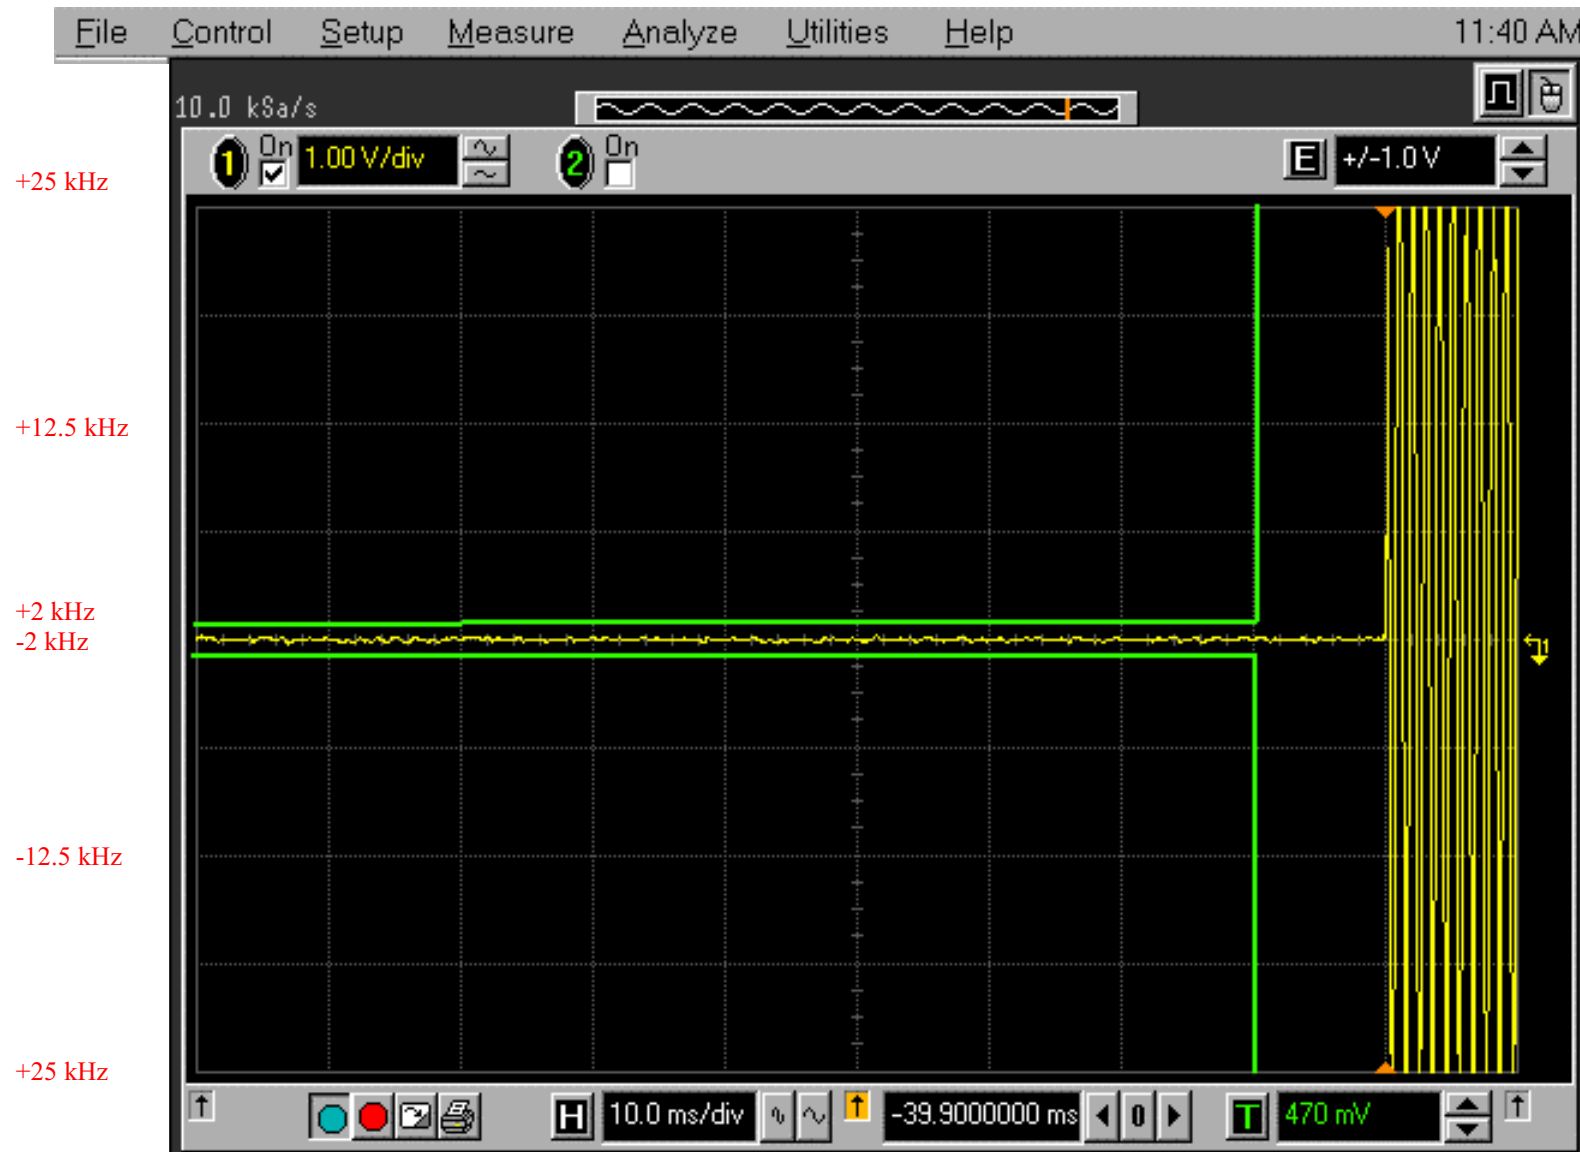
**PLOT # 35**

**25 kHz Channel Spacing, Transmitter was being turned OFF, NO MODULATION**

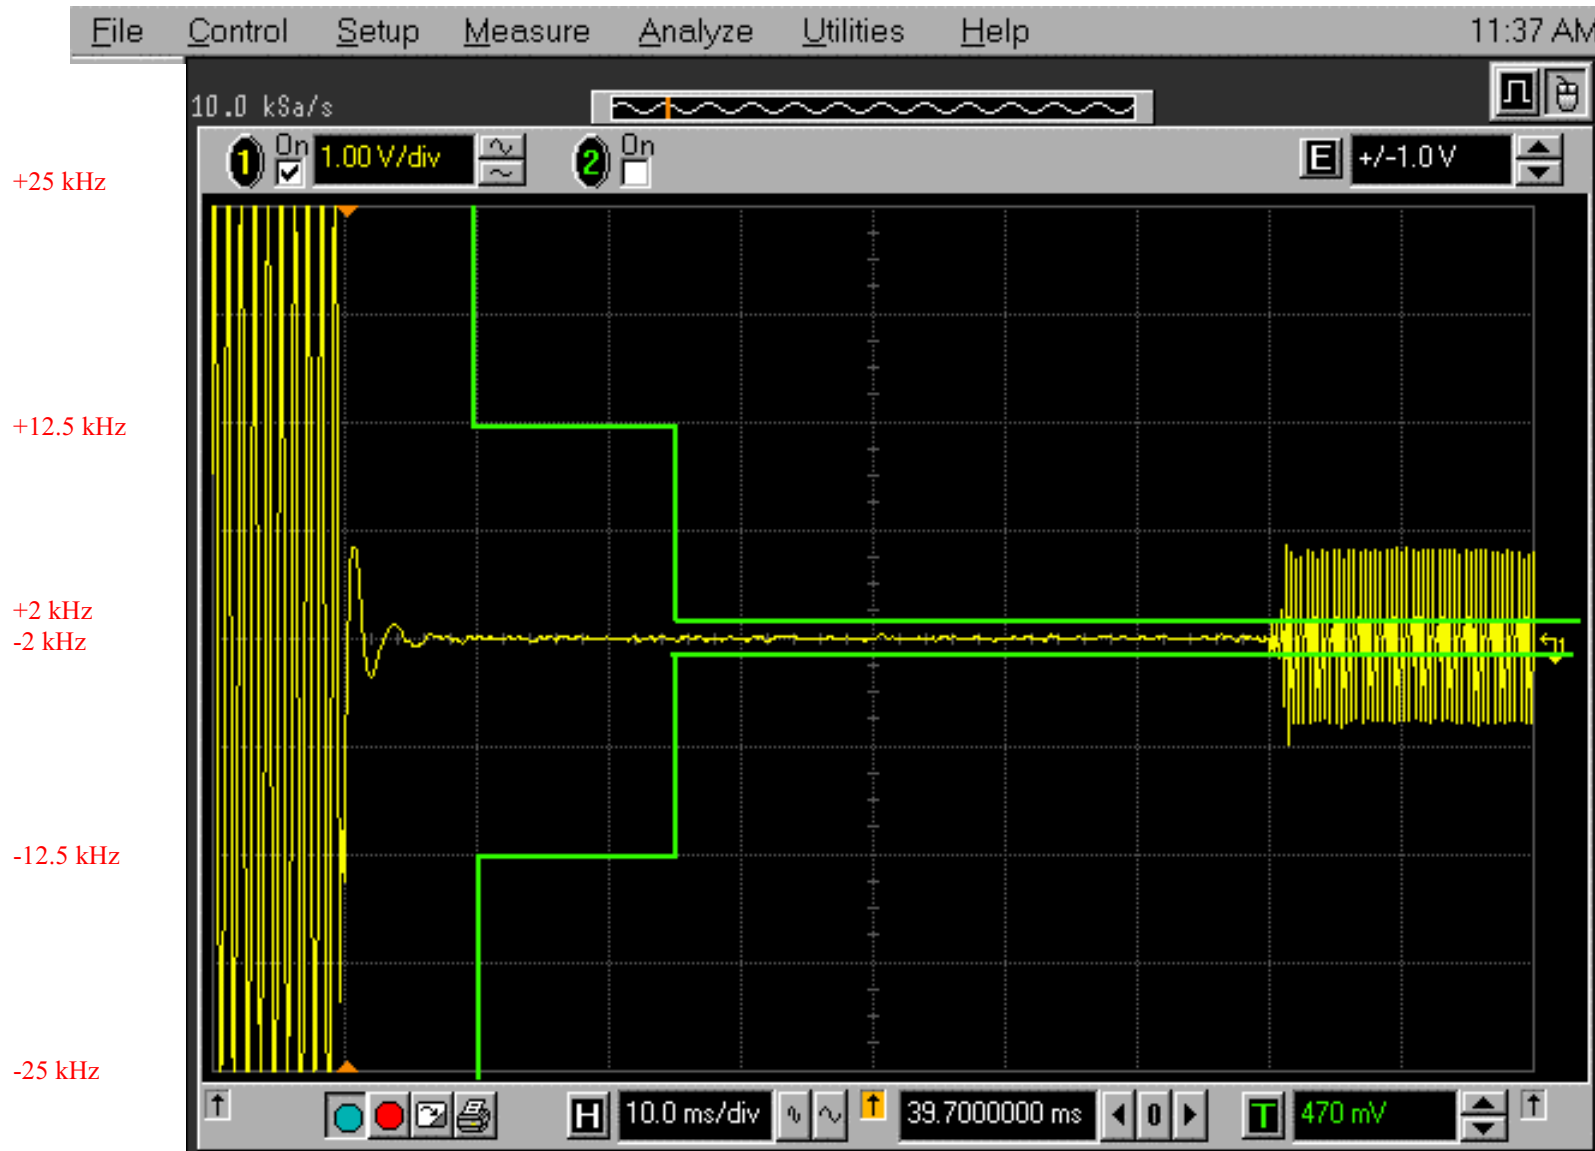
PLOT # 36

**25 kHz Channel Spacing, Transmitter was being turned ON, FM MODULATION WITH 1 kHz Sine Wave Signal**

The modulation of this transmitter is delayed by approximately 70 mS after the transmitter is turned on

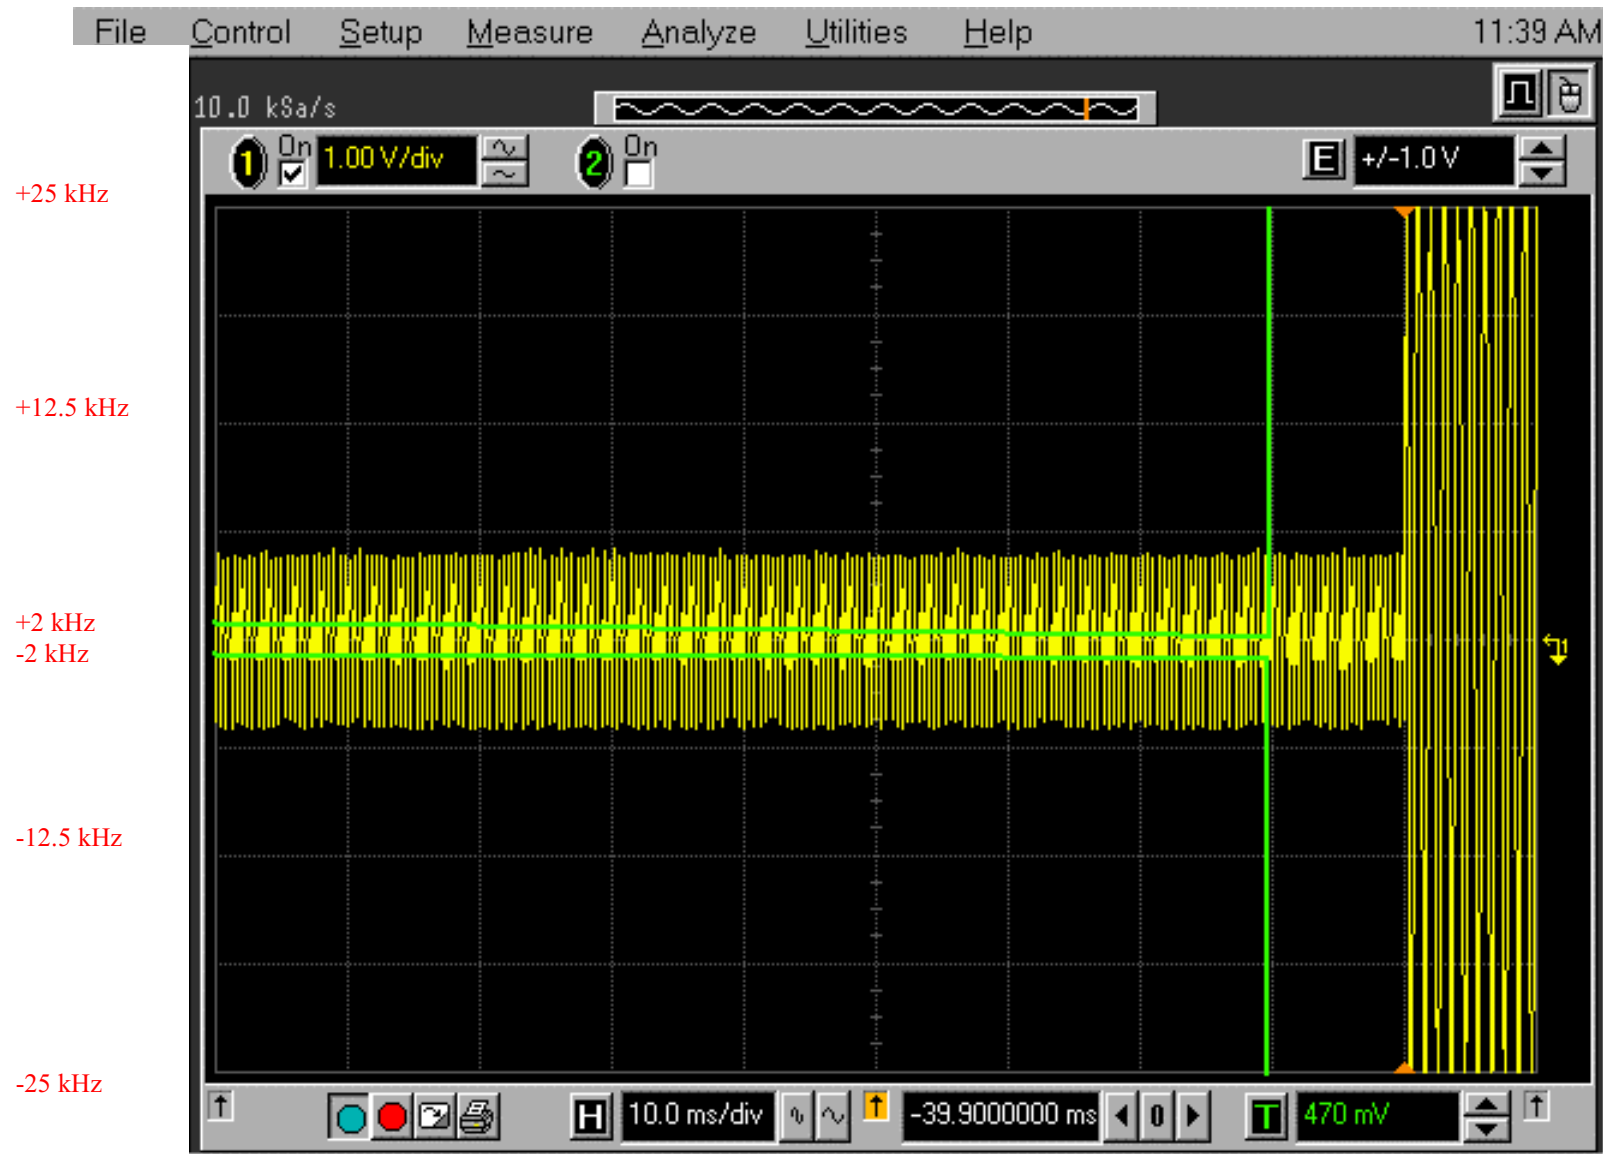
**PLOT # 37**

**25 kHz Channel Spacing, Transmitter was being turned OFF, FM MODULATION with 1 kHz Sine Wave Signal**
