Radiated Emission Measurement

Condition : FCC_part 15E RE_Above 1GHz_PK

EUT : W6M21906-19108

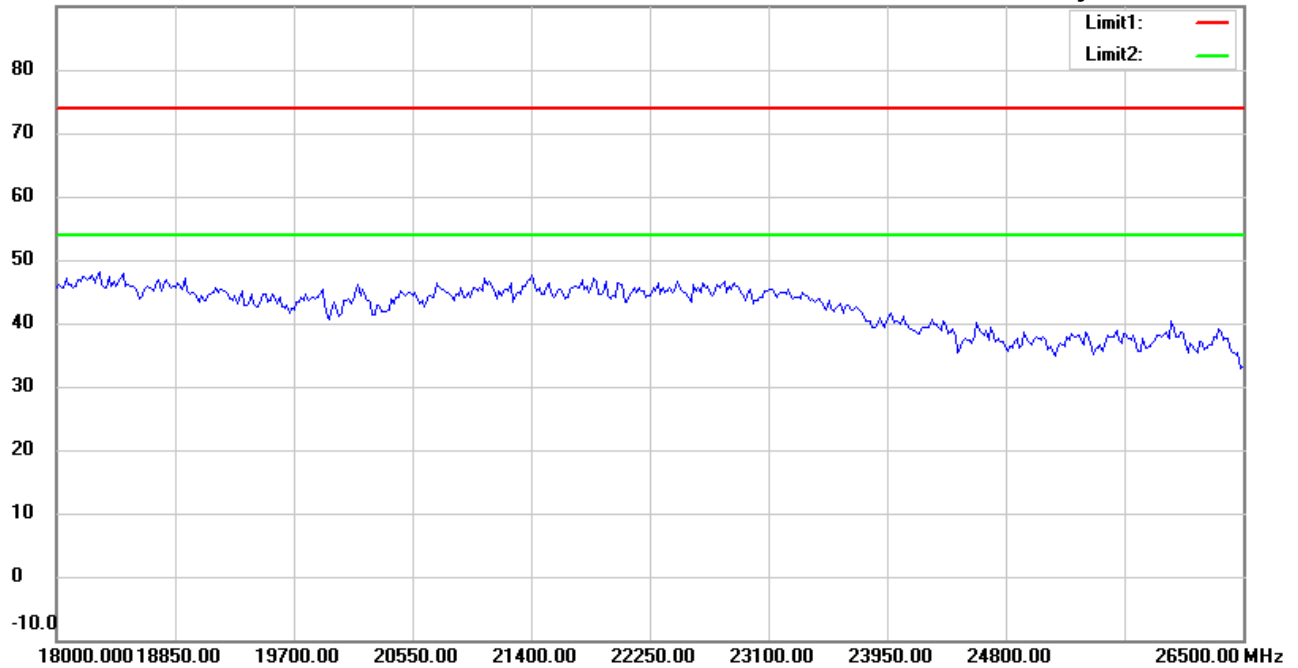
Test Mode : TX 802.11n40 CH159

Polarization: *Horizontal*

Mk.	Frequency (MHz)	Reading (dBuV)	Detector	Corr. factor (dB/m)	Result (dBuV/m)	Limit (dBuV/m)	Ant.Pos (cm)	Tab.Pos (deg.)	Margin (dB)	Comment
-----	-----------------	----------------	----------	---------------------	-----------------	----------------	--------------	----------------	-------------	---------

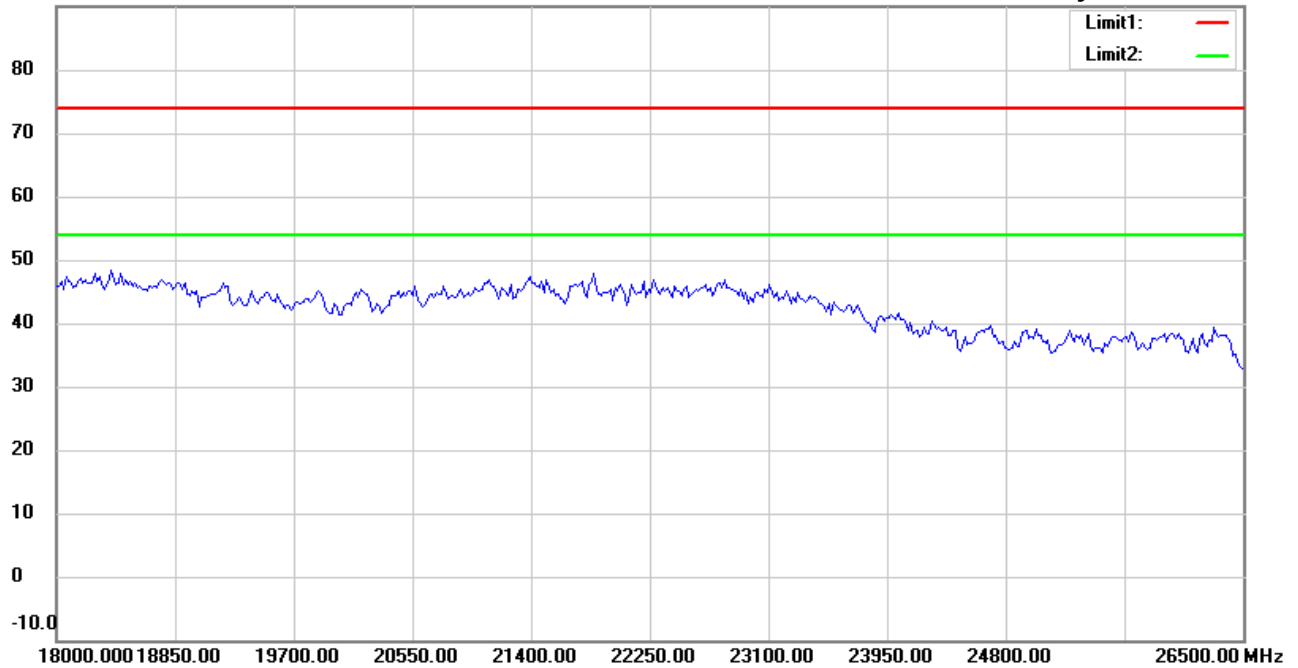
Condition : FCC_part 15E RE_Above 1GHz_PK

Polarization: *Vertical*

Test Mode : TX 802.11n40 CH159

Mk.	Frequency (MHz)	Reading (dBuV)	Detector	Corr. factor (dB/m)	Result (dBuV/m)	Limit (dBuV/m)	Ant.Pos (cm)	Tab.Pos (deg.)	Margin (dB)	Comment
-----	-----------------	----------------	----------	---------------------	-----------------	----------------	--------------	----------------	-------------	---------

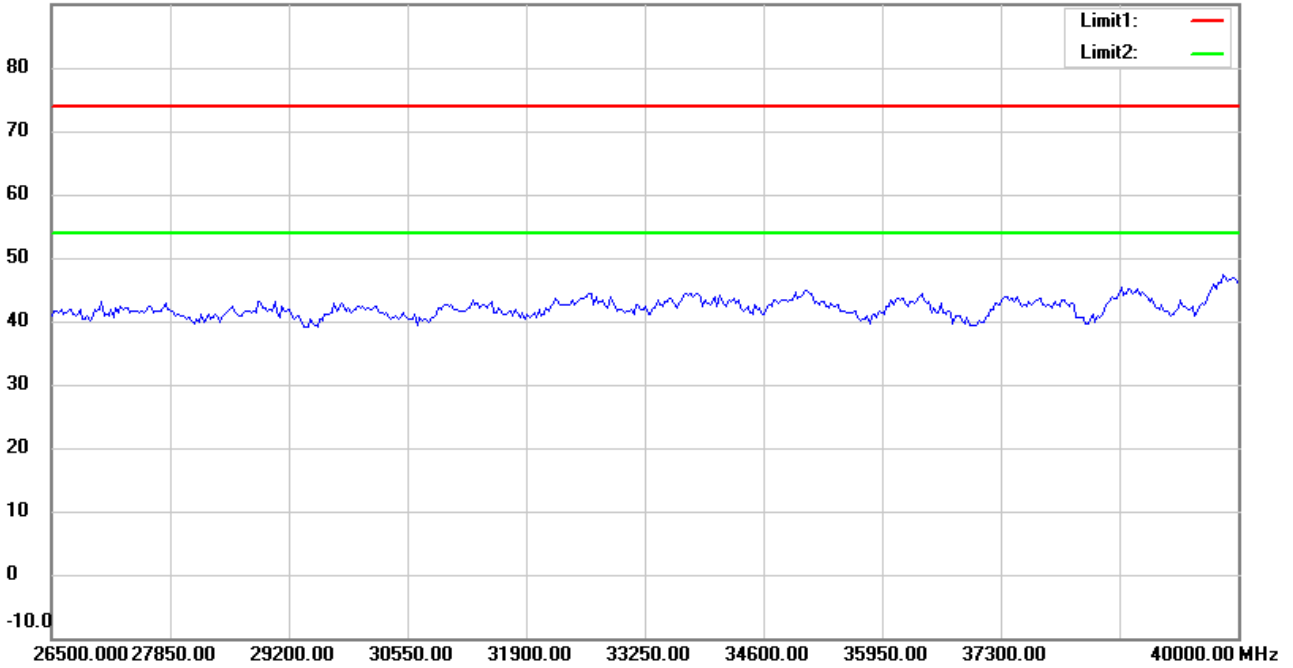
Condition : FCC_part 15E RE_Above 1GHz_PK

Test Mode : TX 802.11n40 CH159

Polarization: *Horizontal*

Mk.	Frequency (MHz)	Reading (dBuV)	Detector	Corr. factor (dB/m)	Result (dBuV/m)	Limit (dBuV/m)	Ant.Pos (cm)	Tab.Pos (deg.)	Margin (dB)	Comment
-----	-----------------	----------------	----------	---------------------	-----------------	----------------	--------------	----------------	-------------	---------

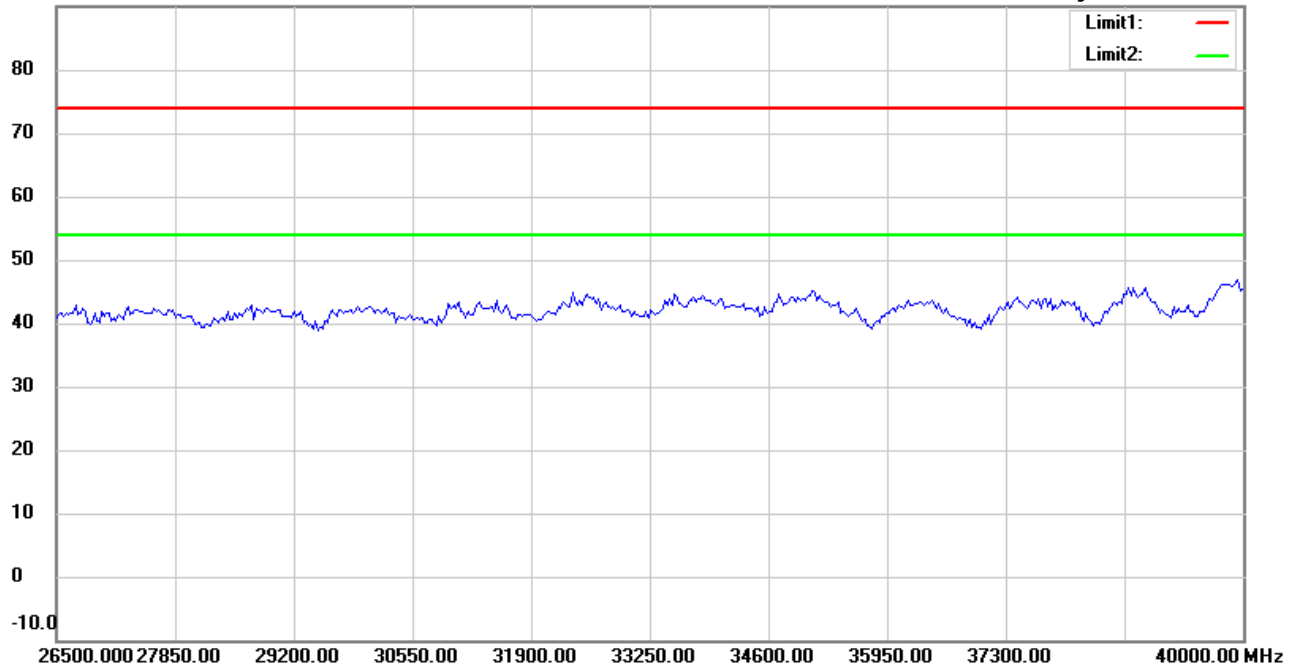
Condition : FCC_part 15E RE_Above 1GHz_PK

Test Mode : TX 802.11n40 CH159

Polarization: **Vertical**

Mk.	Frequency (MHz)	Reading (dBuV)	Detector	Corr. factor (dB/m)	Result (dBuV/m)	Limit (dBuV/m)	Ant.Pos (cm)	Tab.Pos (deg.)	Margin (dB)	Comment
-----	-----------------	----------------	----------	---------------------	-----------------	----------------	--------------	----------------	-------------	---------

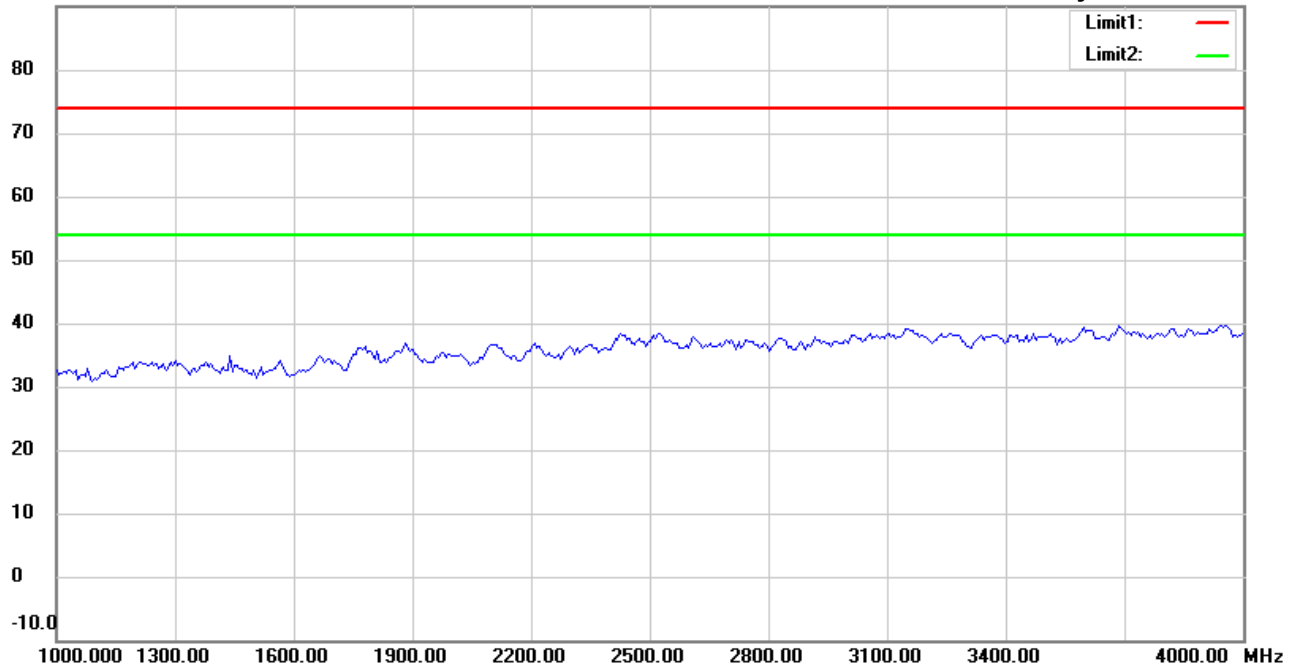
Condition : FCC_part 15E RE_Above 1GHz_PK

Test Mode : TX 802.11ac CH42

Polarization: *Horizontal*

Mk.	Frequency (MHz)	Reading (dBuV)	Detector	Corr. factor (dB/m)	Result (dBuV/m)	Limit (dBuV/m)	Ant.Pos (cm)	Tab.Pos (deg.)	Margin (dB)	Comment
-----	-----------------	----------------	----------	---------------------	-----------------	----------------	--------------	----------------	-------------	---------

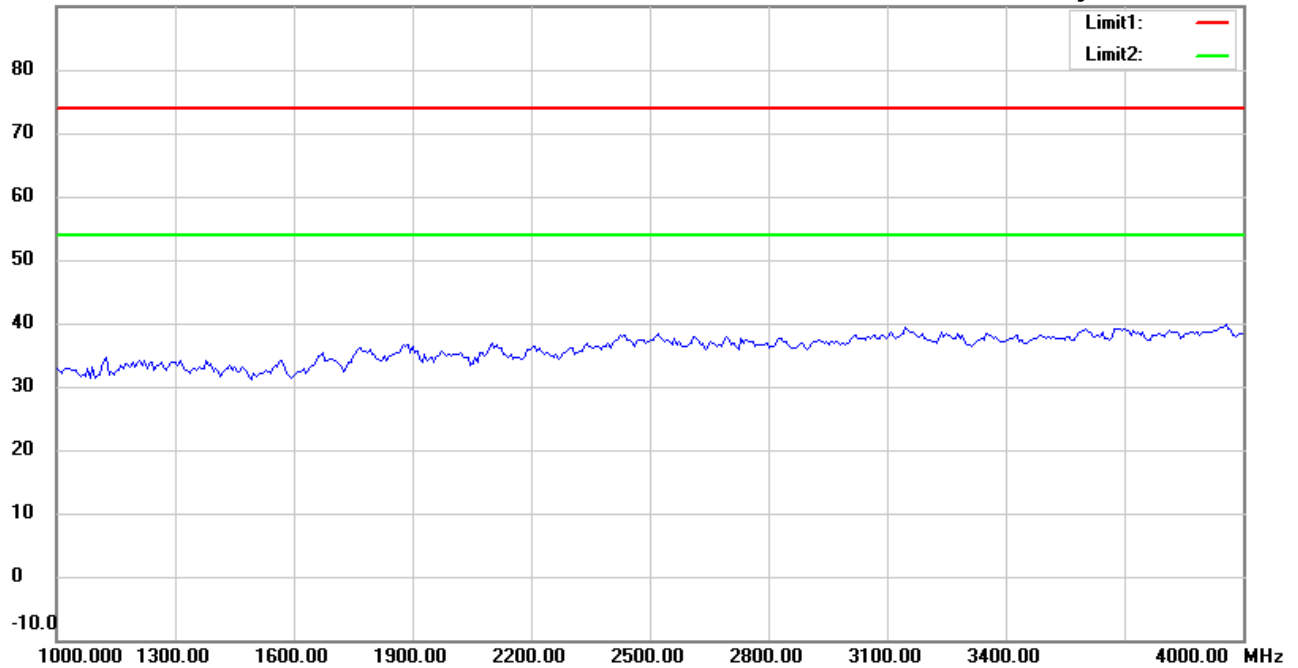
Condition : FCC_part 15E RE_Above 1GHz_PK

Polarization: *Vertical*

Test Mode : TX 802.11ac CH42

Mk.	Frequency (MHz)	Reading (dBuV)	Detector	Corr. factor (dB/m)	Result (dBuV/m)	Limit (dBuV/m)	Ant.Pos (cm)	Tab.Pos (deg.)	Margin (dB)	Comment
-----	-----------------	----------------	----------	---------------------	-----------------	----------------	--------------	----------------	-------------	---------

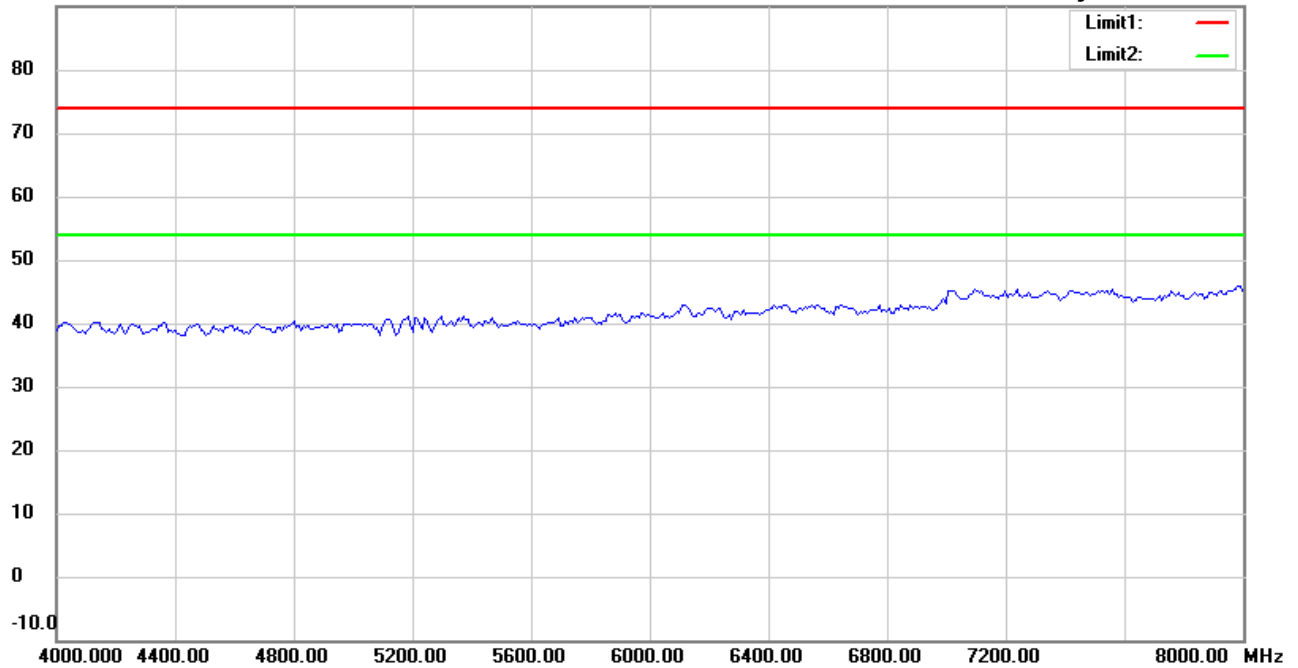
Condition : FCC_part 15E RE_Above 1GHz_PK

Polarization: *Horizontal*

Test Mode : TX 802.11ac CH42

Mk.	Frequency (MHz)	Reading (dBuV)	Detector	Corr. factor (dB/m)	Result (dBuV/m)	Limit (dBuV/m)	Ant.Pos (cm)	Tab.Pos (deg.)	Margin (dB)	Comment
-----	-----------------	----------------	----------	---------------------	-----------------	----------------	--------------	----------------	-------------	---------

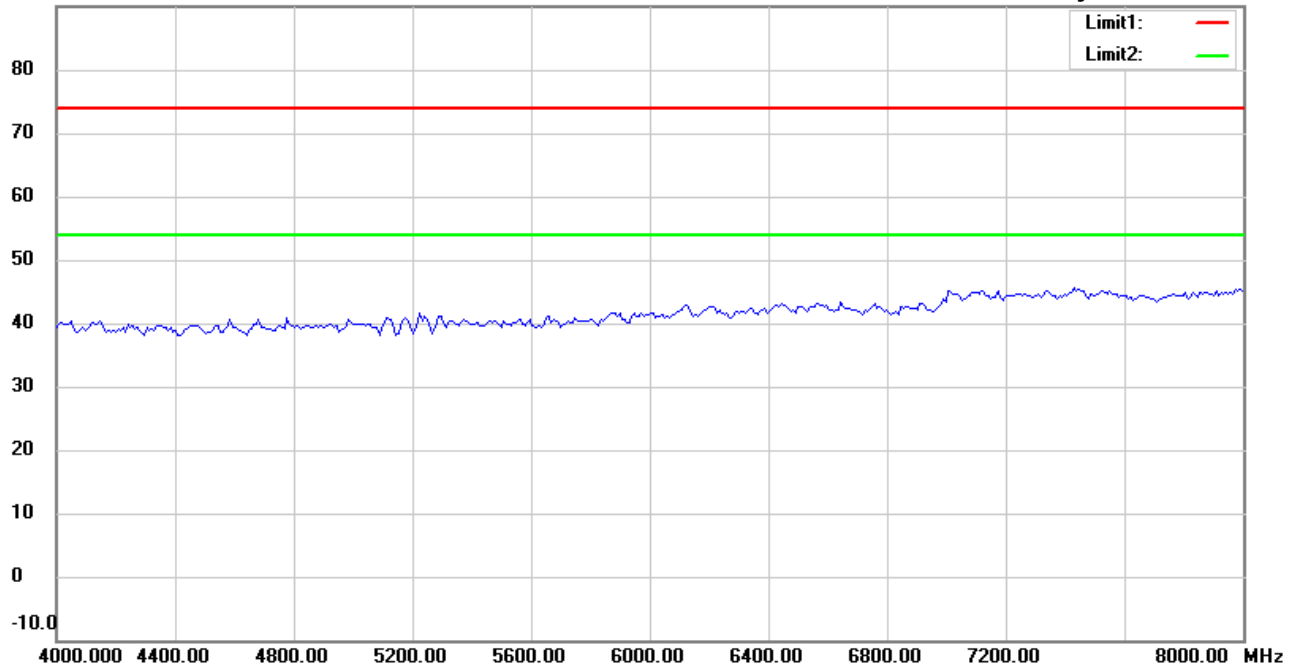
Condition : FCC_part 15E RE_Above 1GHz_PK

Polarization: *Vertical*

Test Mode : TX 802.11ac CH42

Mk.	Frequency (MHz)	Reading (dBuV)	Detector	Corr. factor (dB/m)	Result (dBuV/m)	Limit (dBuV/m)	Ant.Pos (cm)	Tab.Pos (deg.)	Margin (dB)	Comment
-----	-----------------	----------------	----------	---------------------	-----------------	----------------	--------------	----------------	-------------	---------

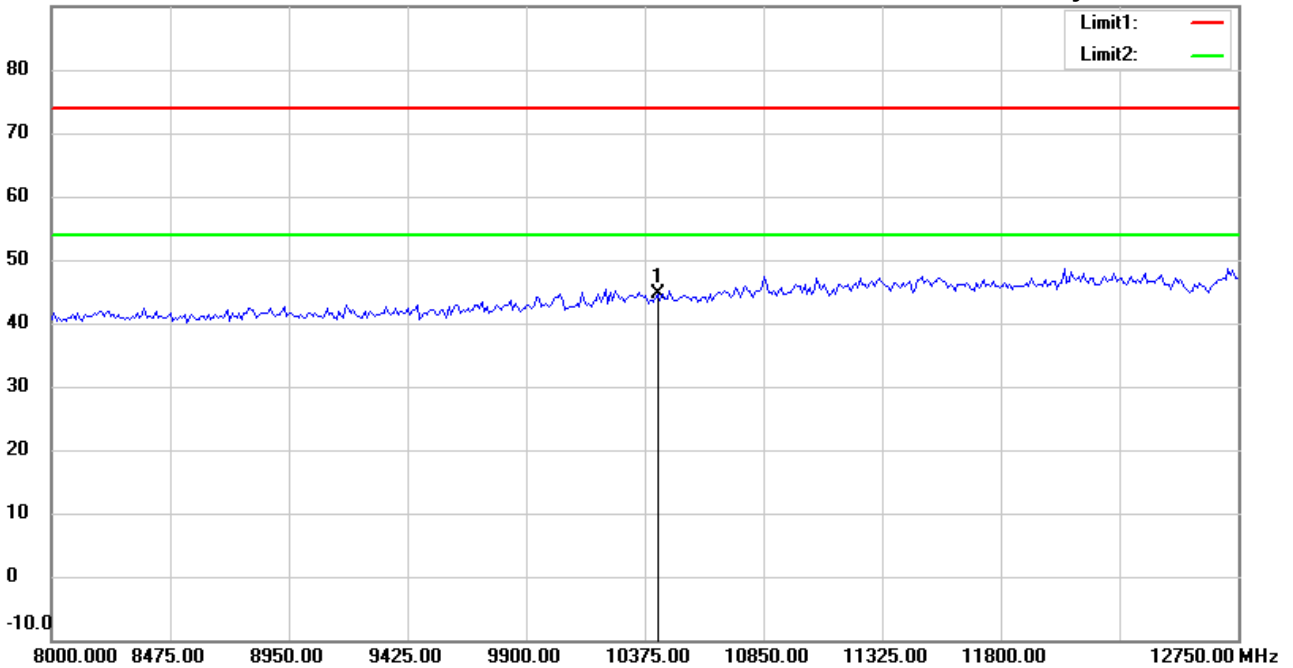
Condition : FCC_part 15E RE_Above 1GHz_PK

Polarization: *Horizontal*

Test Mode : TX 802.11ac CH42

Mk.	Frequency (MHz)	Reading (dBuV)	Detector	Corr. factor (dB/m)	Result (dBuV/m)	Limit (dBuV/m)	Ant.Pos (cm)	Tab.Pos (deg.)	Margin (dB)	Comment
*	10420.000	36.41	peak	8.27	44.68	74.00	150	105	-29.32

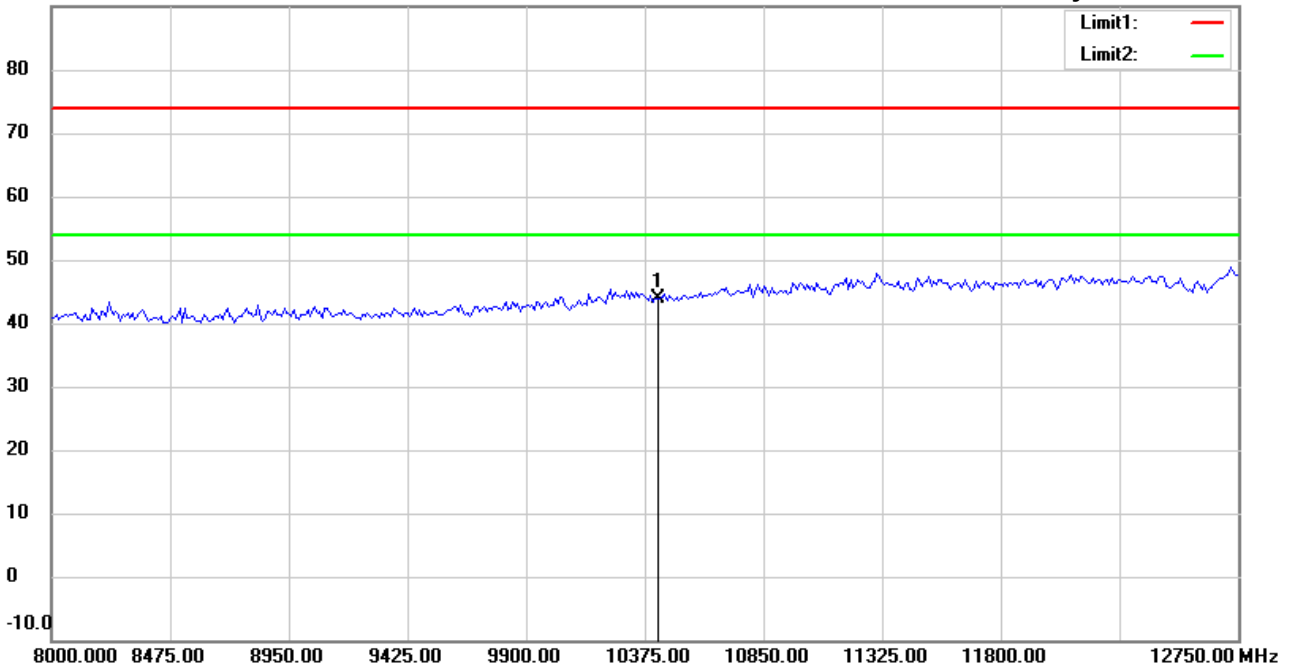
Condition : FCC_part 15E RE_Above 1GHz_PK

Polarization: *Vertical*

Test Mode : TX 802.11ac CH42

Mk.	Frequency (MHz)	Reading (dBuV)	Detector	Corr. factor (dB/m)	Result (dBuV/m)	Limit (dBuV/m)	Ant.Pos (cm)	Tab.Pos (deg.)	Margin (dB)	Comment
*	10420.000	35.55	peak	8.27	43.82	74.00	150	245	-30.18

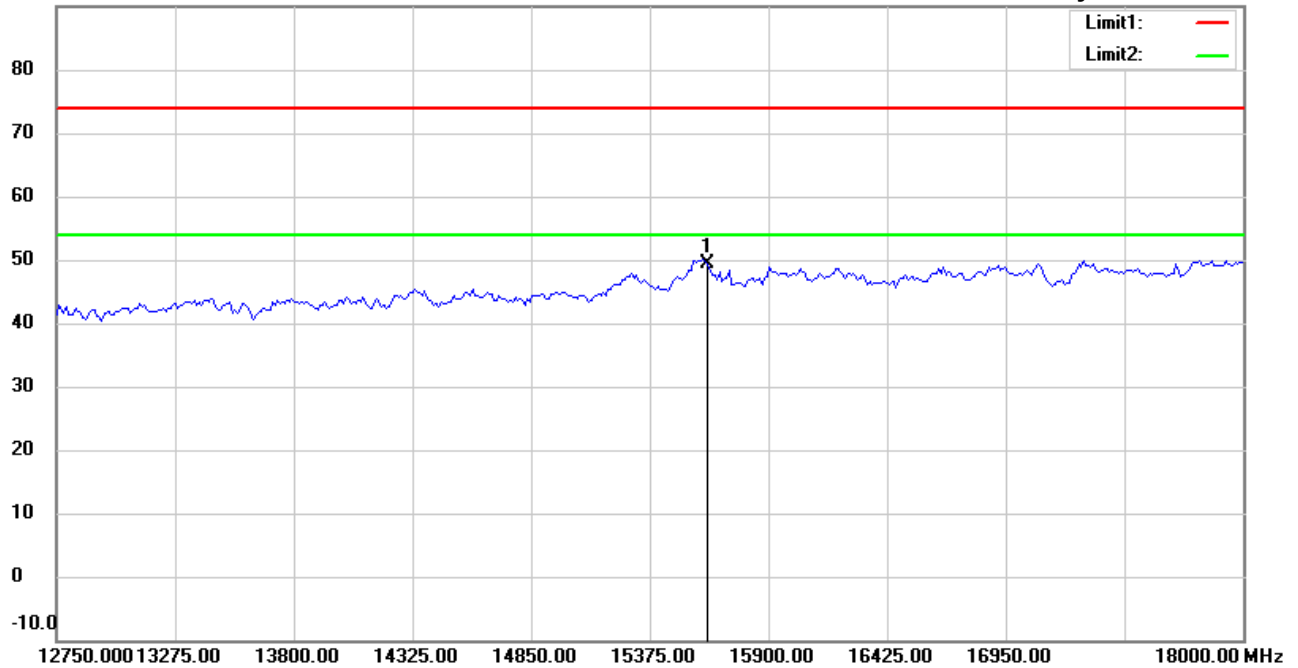
Condition : FCC_part 15E RE_Above 1GHz_PK

Polarization: *Horizontal*

Test Mode : TX 802.11ac CH42

Mk.	Frequency (MHz)	Reading (dBuV)	Detector	Corr. factor (dB/m)	Result (dBuV/m)	Limit (dBuV/m)	Ant.Pos (cm)	Tab.Pos (deg.)	Margin (dB)	Comment
*	15630.000	30.25	peak	19.06	49.31	74.00	150	140	-24.69

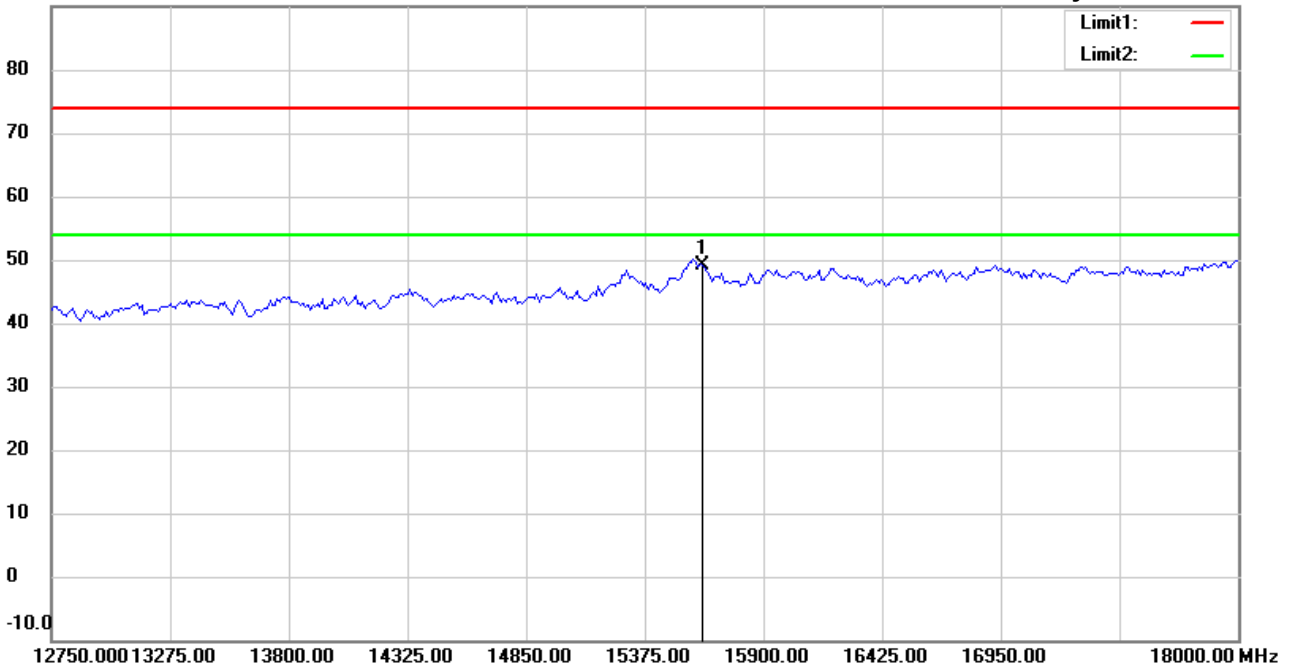
Condition : FCC_part 15E RE_Above 1GHz_PK

Polarization: *Vertical*

Test Mode : TX 802.11ac CH42

Mk.	Frequency (MHz)	Reading (dBuV)	Detector	Corr. factor (dB/m)	Result (dBuV/m)	Limit (dBuV/m)	Ant.Pos (cm)	Tab.Pos (deg.)	Margin (dB)	Comment
*	15630.000	30.01	peak	19.06	49.07	74.00	150	20	-24.93

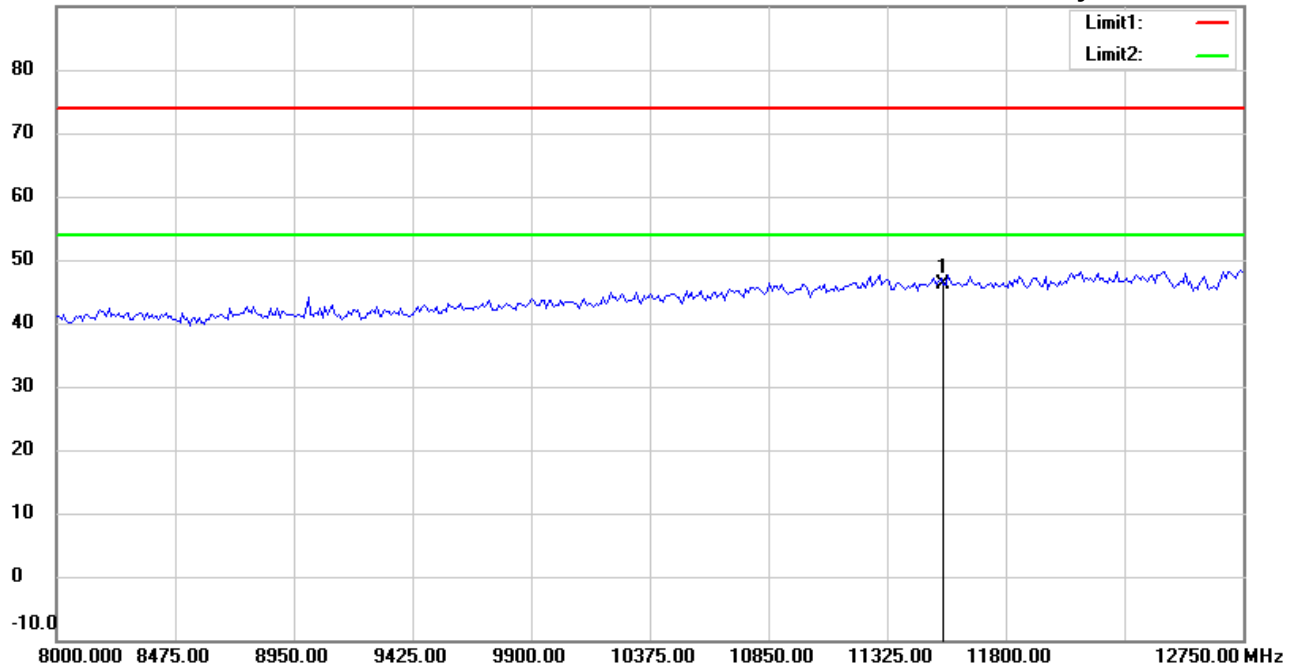
Condition : FCC_part 15E RE_Above 1GHz_PK

Polarization: *Horizontal*

Test Mode : TX 802.11ac CH155

Mk.	Frequency (MHz)	Reading (dBuV)	Detector	Corr. factor (dB/m)	Result (dBuV/m)	Limit (dBuV/m)	Ant.Pos (cm)	Tab.Pos (deg.)	Margin (dB)	Comment
*	11550.000	34.89	peak	11.21	46.10	74.00	150	280	-27.90

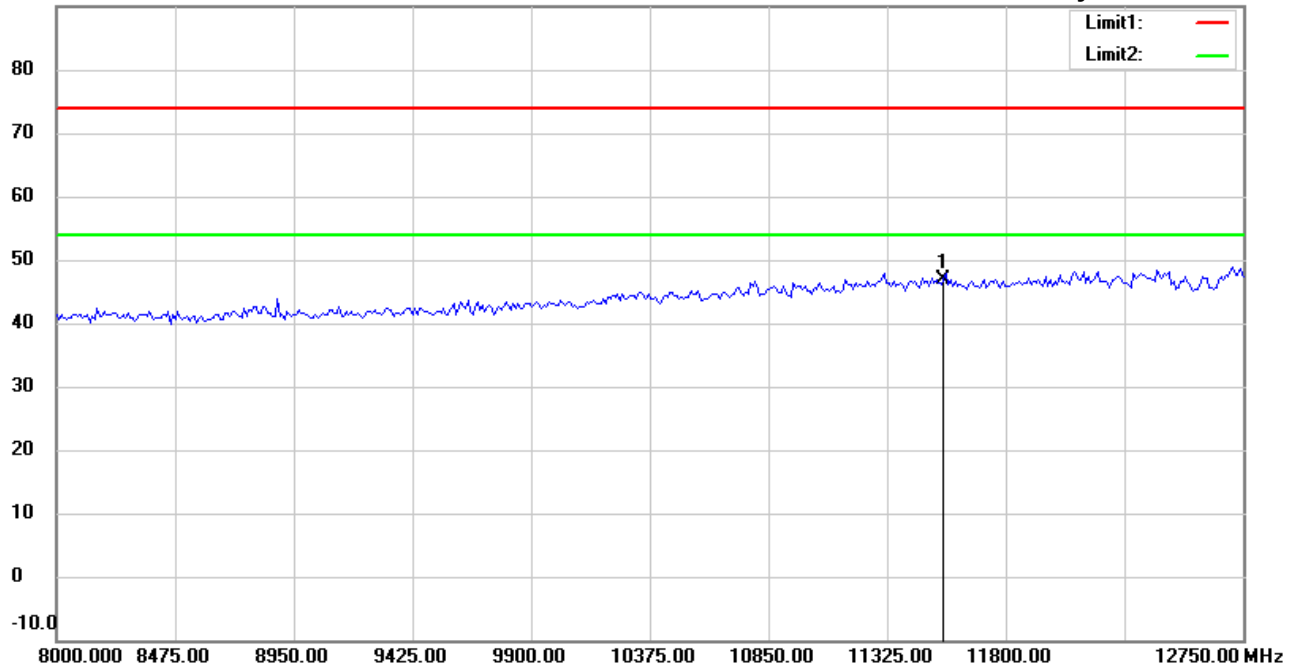
Condition : FCC_part 15E RE_Above 1GHz_PK

Polarization: **Vertical**

Test Mode : TX 802.11ac CH155

Mk.	Frequency (MHz)	Reading (dBuV)	Detector	Corr. factor (dB/m)	Result (dBuV/m)	Limit (dBuV/m)	Ant.Pos (cm)	Tab.Pos (deg.)	Margin (dB)	Comment
*	11550.000	35.73	peak	11.21	46.94	74.00	150	60	-27.06

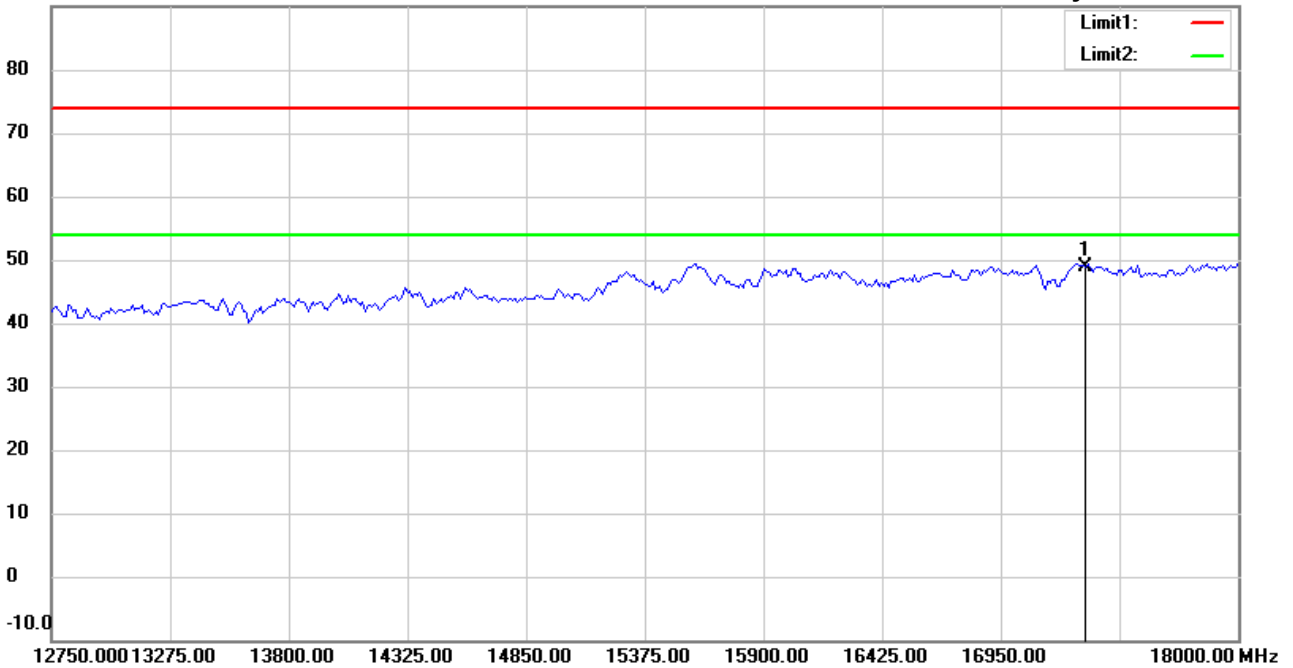
Condition : FCC_part 15E RE_Above 1GHz_PK

Polarization: *Horizontal*

Test Mode : TX 802.11ac CH155

Mk.	Frequency (MHz)	Reading (dBuV)	Detector	Corr. factor (dB/m)	Result (dBuV/m)	Limit (dBuV/m)	Ant.Pos (cm)	Tab.Pos (deg.)	Margin (dB)	Comment
*	17325.000	28.25	peak	20.72	48.97	74.00	150	5	-25.03

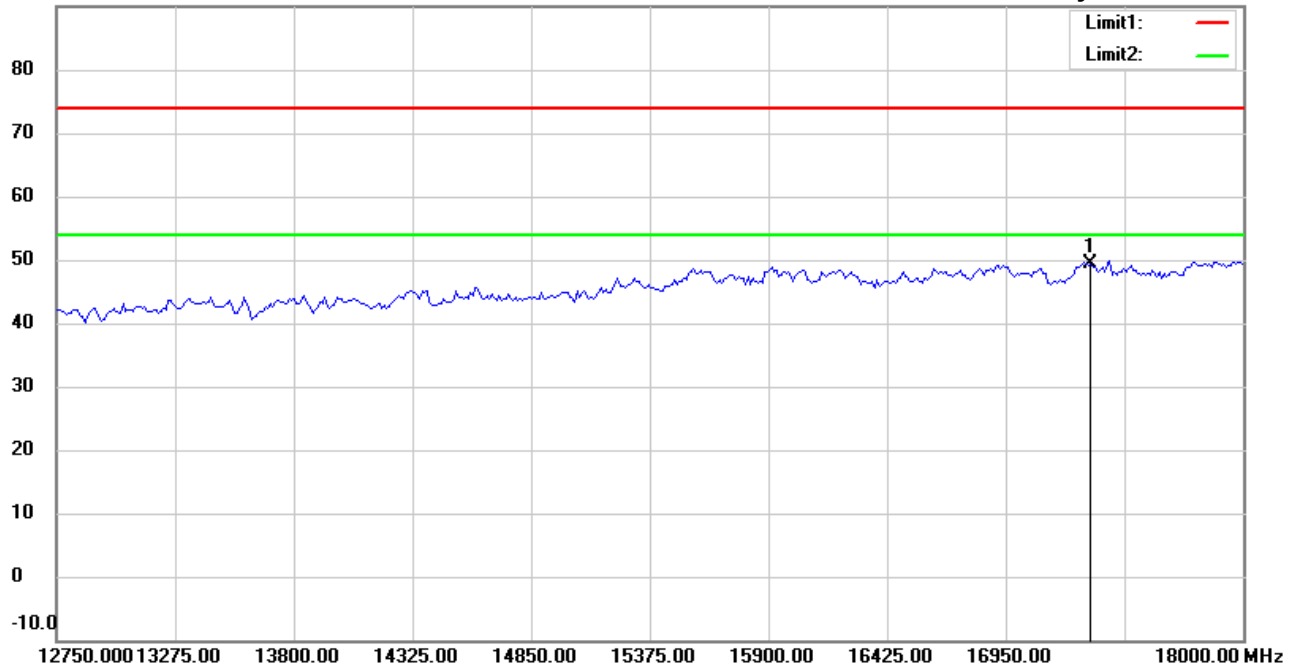
Condition : FCC_part 15E RE_Above 1GHz_PK

Polarization: *Vertical*

Test Mode : TX 802.11ac CH155

Mk.	Frequency (MHz)	Reading (dBuV)	Detector	Corr. factor (dB/m)	Result (dBuV/m)	Limit (dBuV/m)	Ant.Pos (cm)	Tab.Pos (deg.)	Margin (dB)	Comment
*	17325.000	28.76	peak	20.72	49.48	74.00	150	235	-24.52
