Radiated Emission Measurement

Condition : FCC_part 15 RE-Class C_Above 1GHz_PK

EUT : W6M22307-22823

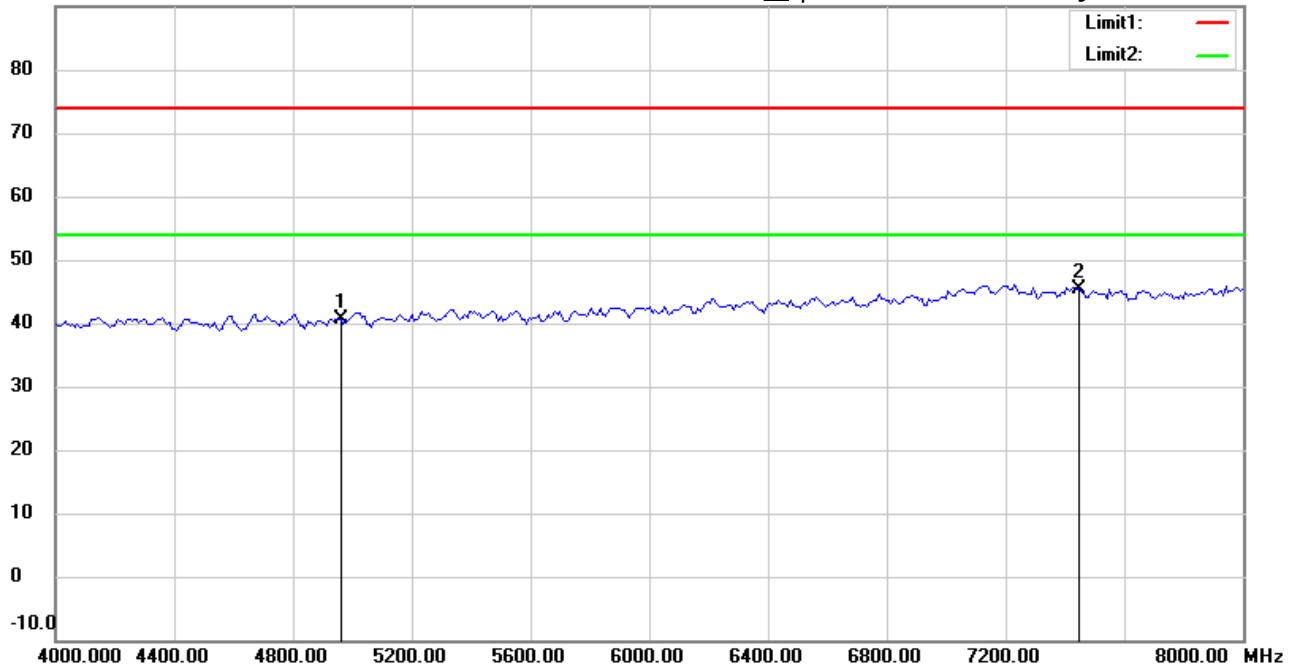
Data :#2

Polarization: *Horizontal*

Test Mode : TX 2480MHz

Mk.	Frequency (MHz)	Reading (dBuV)	Detector	Corr. factor (dB/m)	Result (dBuV/m)	Limit (dBuV/m)	Ant.Pos (cm)	Tab.Pos (deg.)	Margin (dB)	Comment
	4960.000	41.37	peak	-0.79	40.58	74.00	157	194	-33.42	
*	7440.000	41.62	peak	3.81	45.43	74.00	152	240	-28.57

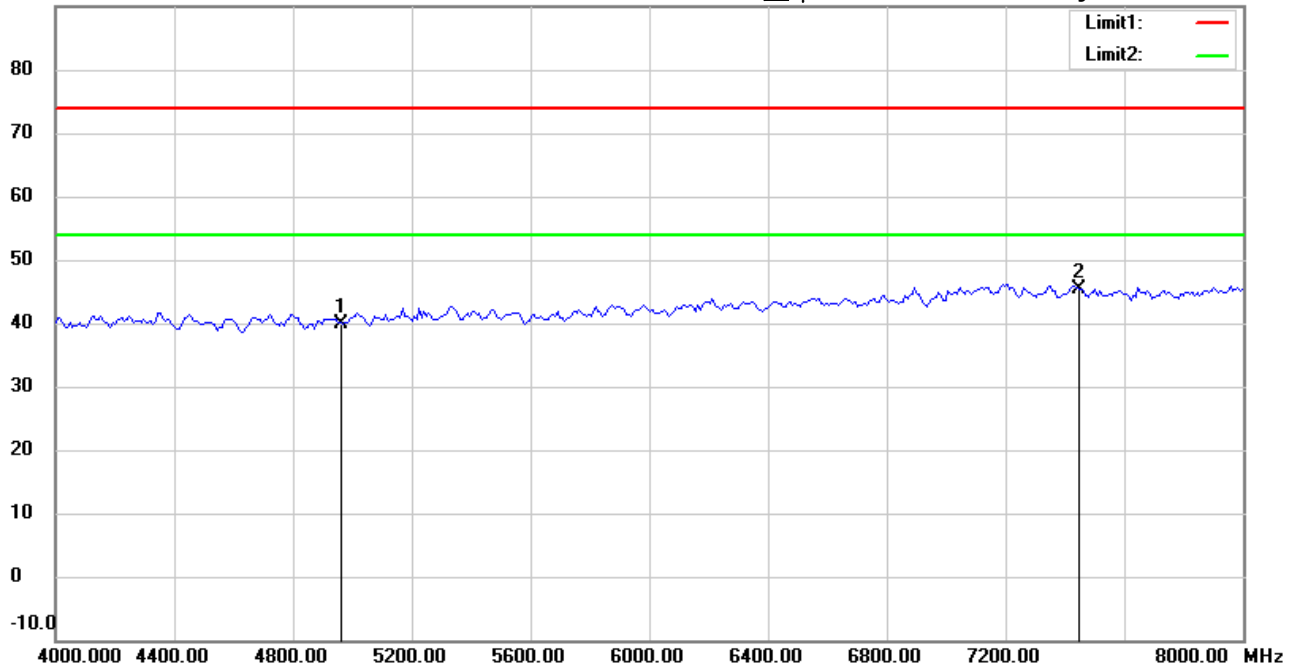
Data :#7

Condition : FCC_part 15 RE-Class C_Above 1GHz_PK

Polarization: **Vertical**

Test Mode : TX 2480MHz

Mk.	Frequency (MHz)	Reading (dBuV)	Detector	Corr. factor (dB/m)	Result (dBuV/m)	Limit (dBuV/m)	Ant.Pos (cm)	Tab.Pos (deg.)	Margin (dB)	Comment
	4960.000	40.79	peak	-0.79	40.00	74.00	153	228	-34.00	
*	7440.000	41.47	peak	3.81	45.28	74.00	150	191	-28.72

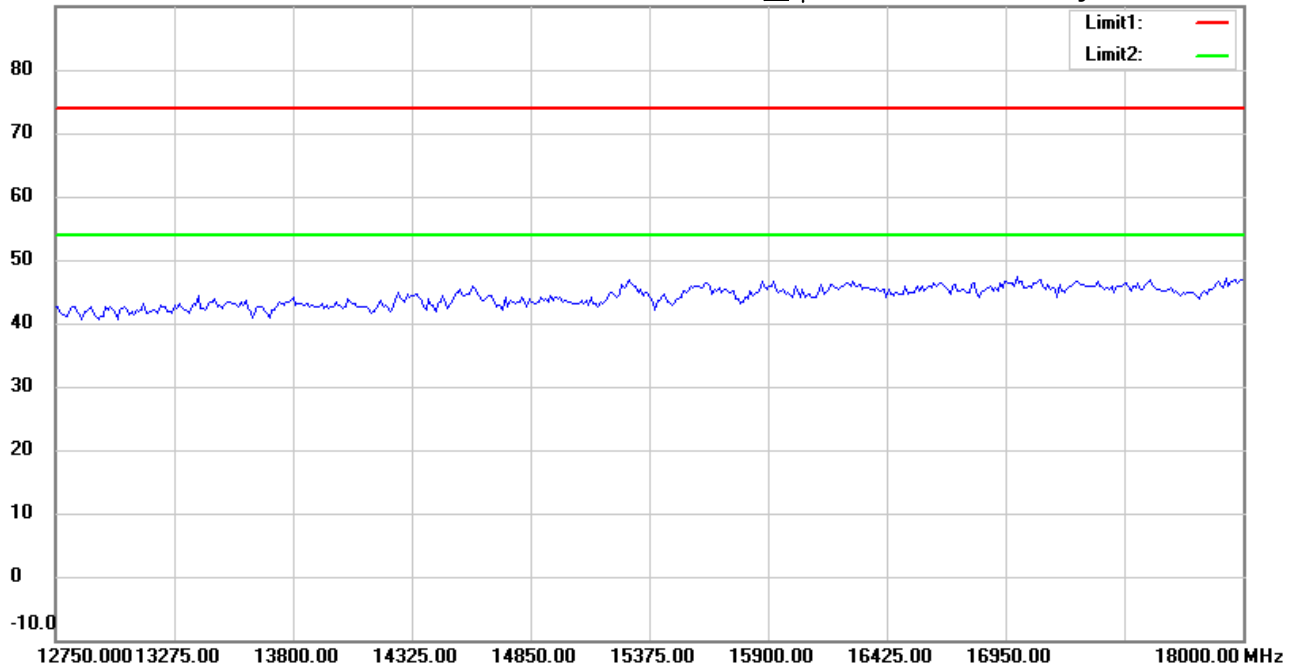
Data :#4

Condition : FCC_part 15 RE-Class C_Above 1GHz_PK

Polarization: *Horizontal*

Test Mode : TX 2480MHz

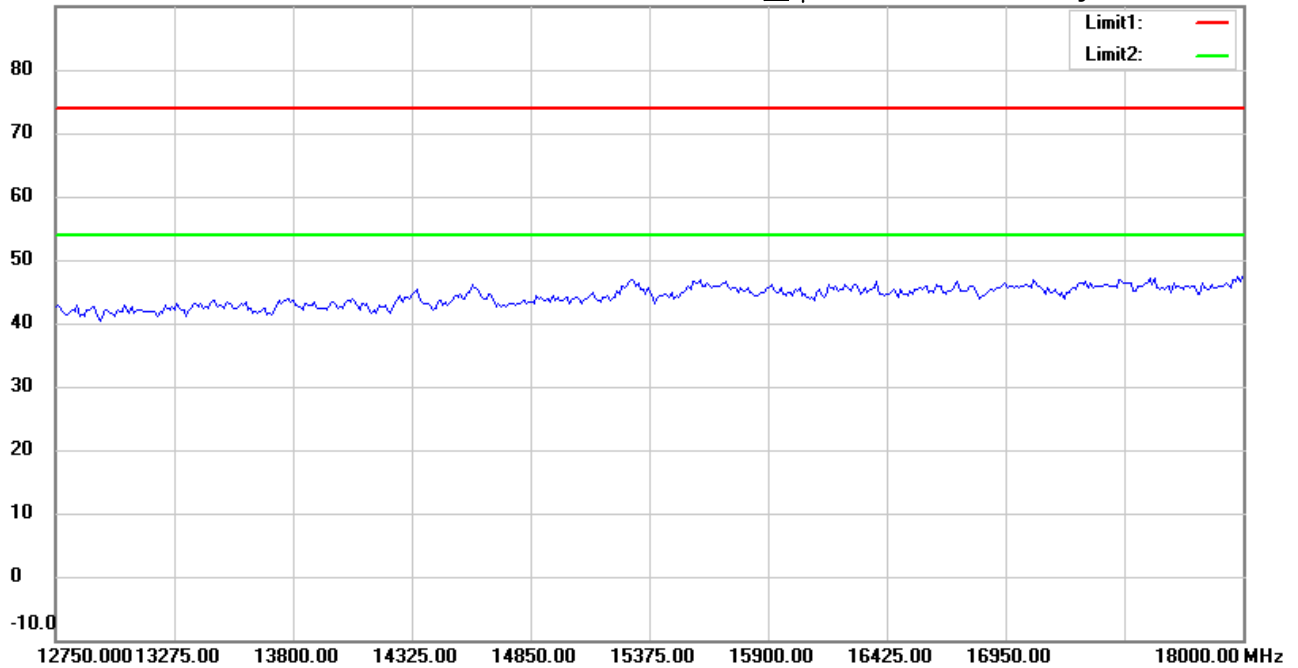
Data :#9

Condition : FCC_part 15 RE-Class C_Above 1GHz_PK

Polarization: *Vertical*

Test Mode : TX 2480MHz

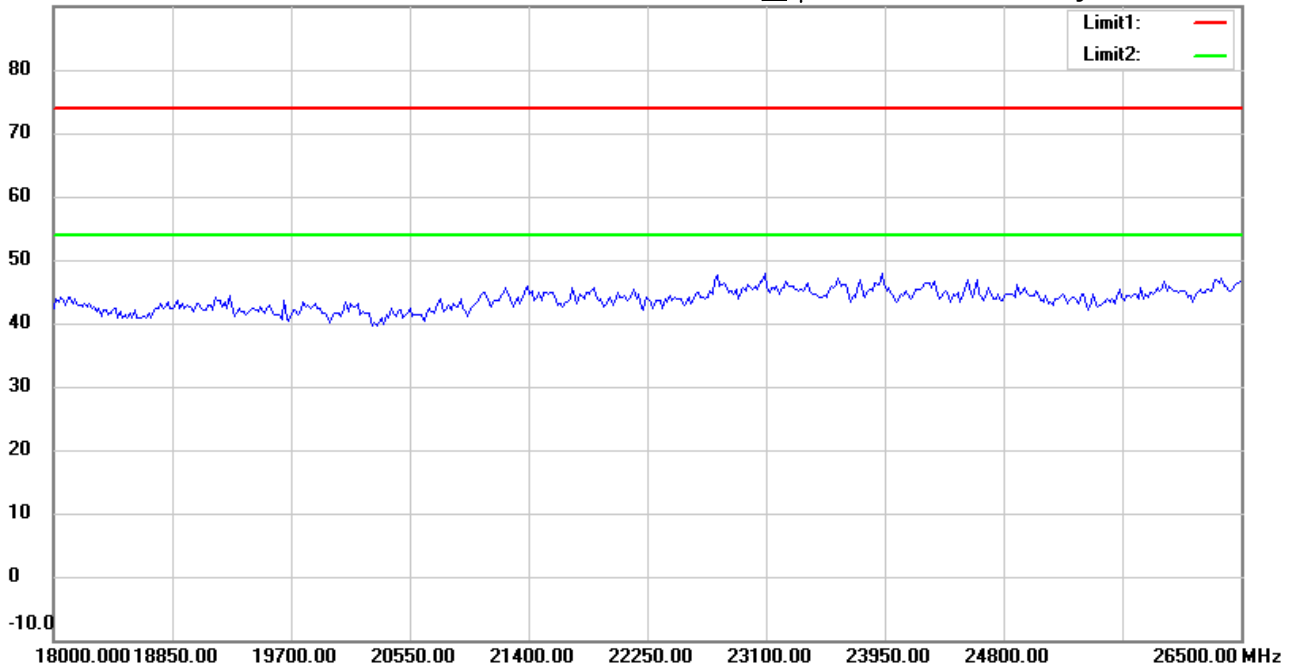
Data :#10

Condition : FCC_part 15 RE-Class C_Above 1GHz_PK

Polarization: *Vertical*

Test Mode : TX 2480MHz

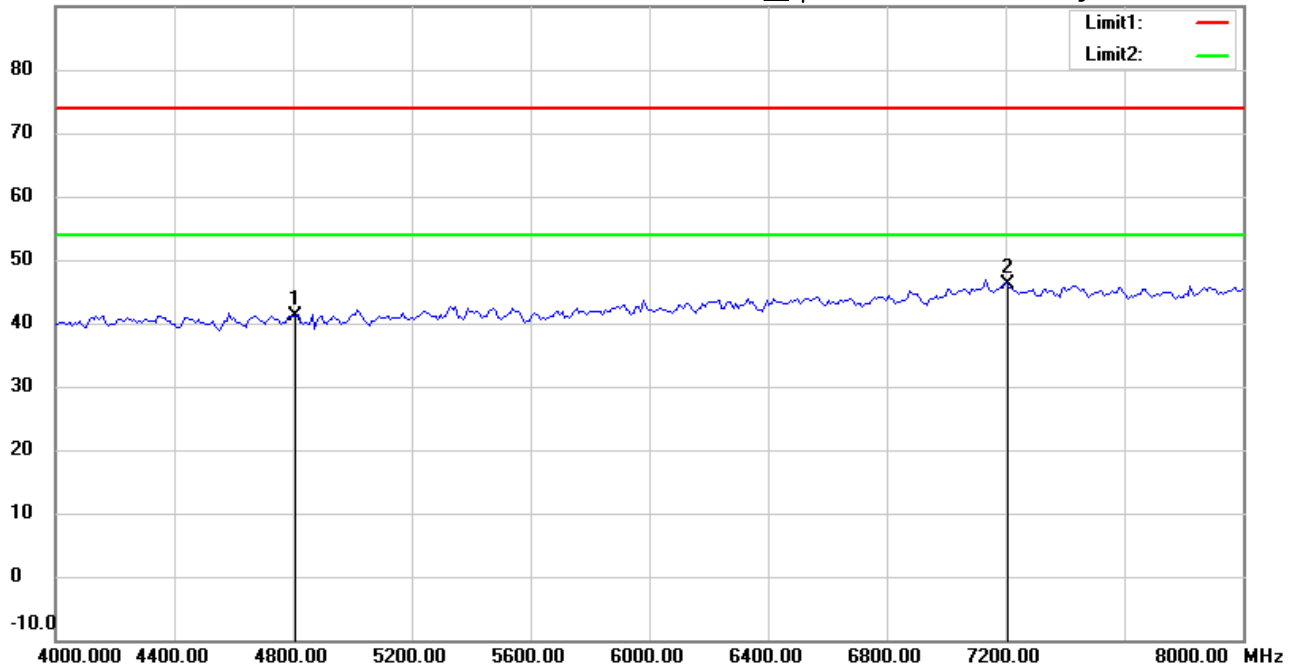
Data :#2

Condition : FCC_part 15 RE-Class C_Above 1GHz_PK

Polarization: *Horizontal*

Test Mode : TX 2402MHz

Mk.	Frequency (MHz)	Reading (dBuV)	Detector	Corr. factor (dB/m)	Result (dBuV/m)	Limit (dBuV/m)	Ant.Pos (cm)	Tab.Pos (deg.)	Margin (dB)	Comment
	4804.000	42.79	peak	-1.73	41.06	74.00	155	224	-32.94	
*	7206.000	42.03	peak	4.08	46.11	74.00	152	103	-27.89

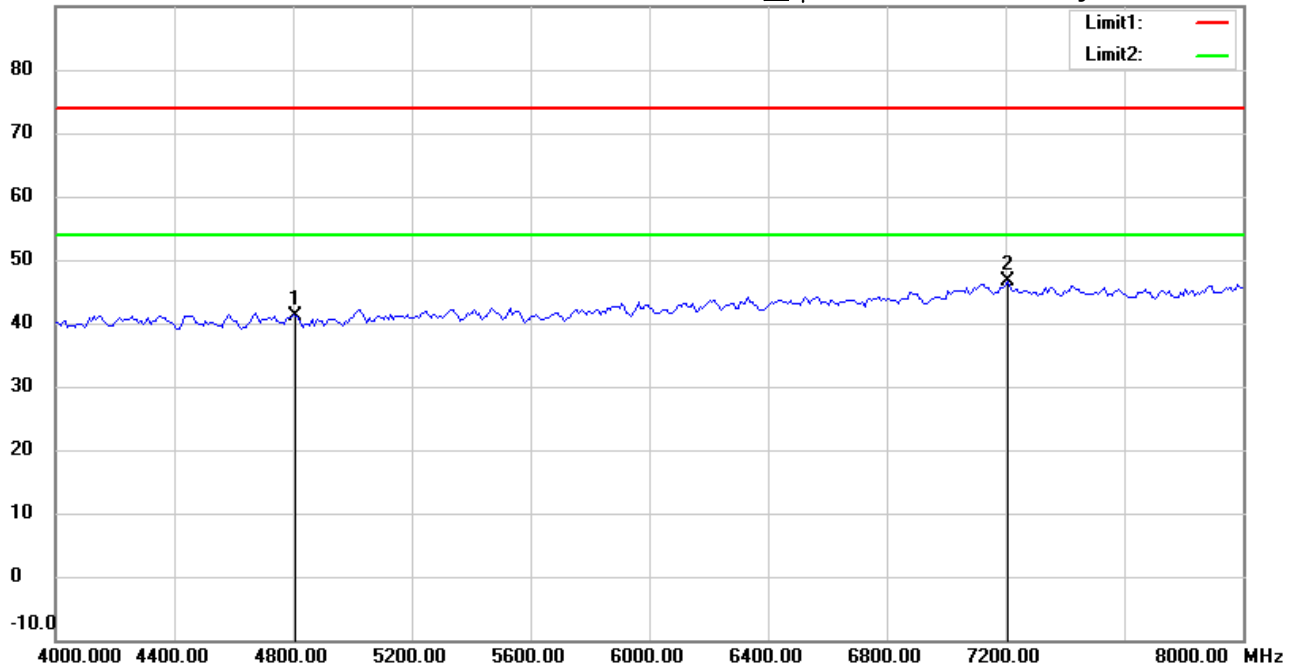
Data :#7

Condition : FCC_part 15 RE-Class C_Above 1GHz_PK

Polarization: **Vertical**

Test Mode : TX 2402MHz

Mk.	Frequency (MHz)	Reading (dBuV)	Detector	Corr. factor (dB/m)	Result (dBuV/m)	Limit (dBuV/m)	Ant.Pos (cm)	Tab.Pos (deg.)	Margin (dB)	Comment
	4804.000	42.96	peak	-1.73	41.23	74.00	153	285	-32.77	
*	7206.000	42.55	peak	4.08	46.63	74.00	155	237	-27.37
