Registration number: W6M22307-22823-C-2
FCC ID: IR5RK15

Site : Chamber_03
 Condition : FCC Part 15 Class B Conduction (QP)
 EUT : W6M22307-22823
 M/N:
 Test Mode : 1
 Note :

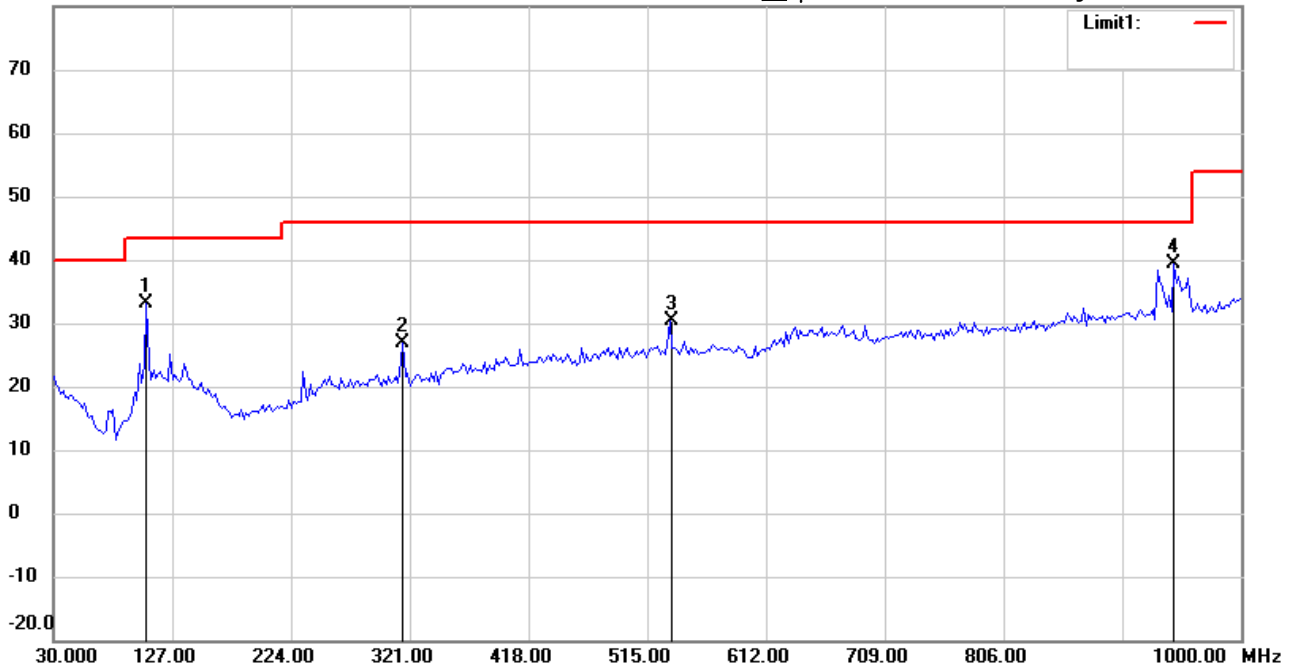
Site : Chamber

Condition : FCC_part 15 RE-Class C_30-1000MHz

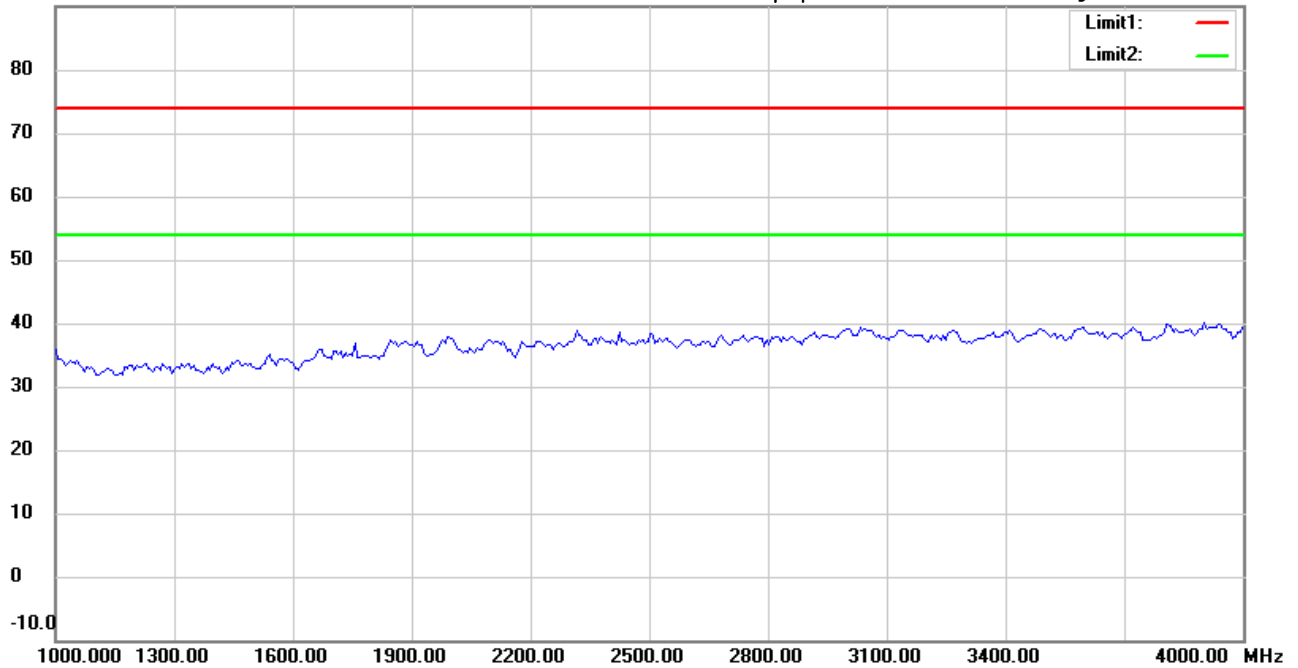
Site : Chamber

Condition : FCC_part 15E RE_Above 1GHz_PK

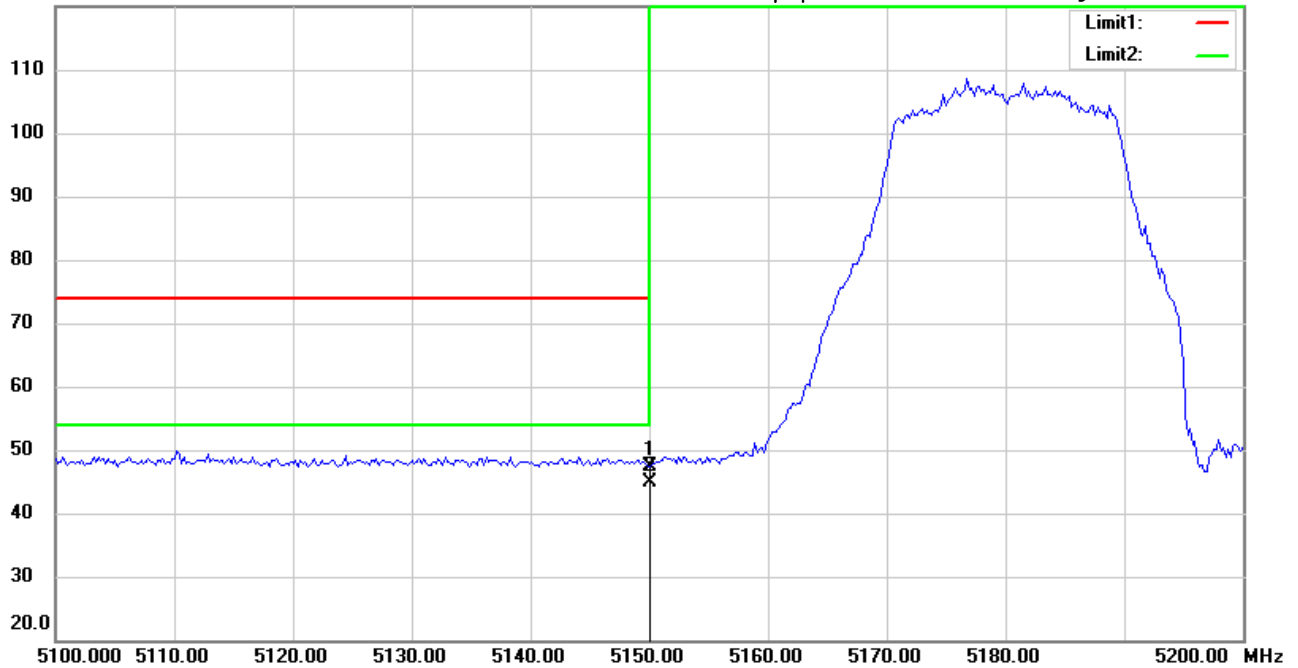
Site : Chamber

Condition : FCC 15.407 PK (Bandedge)(B1_5150_5250)

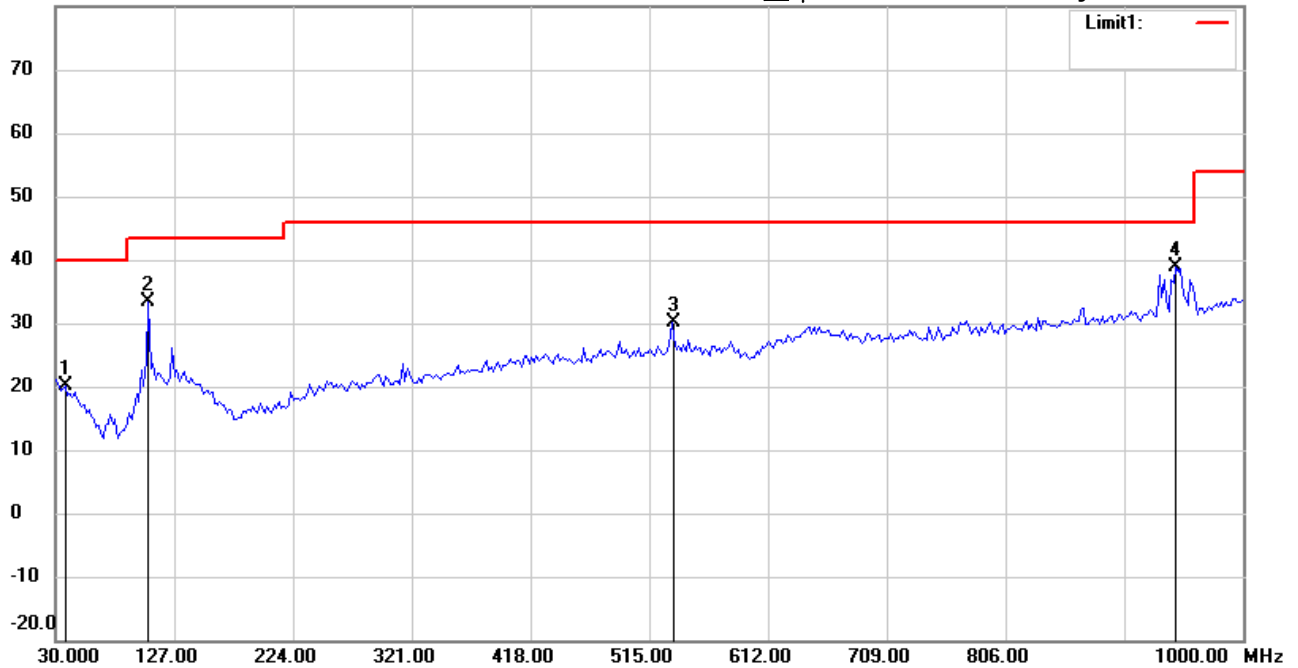
Site : Chamber

Condition : FCC_part 15 RE-Class C_30-1000MHz
