6. PHOTOGRAPHS

6.1. Photos of Powerline Conducted Measurement

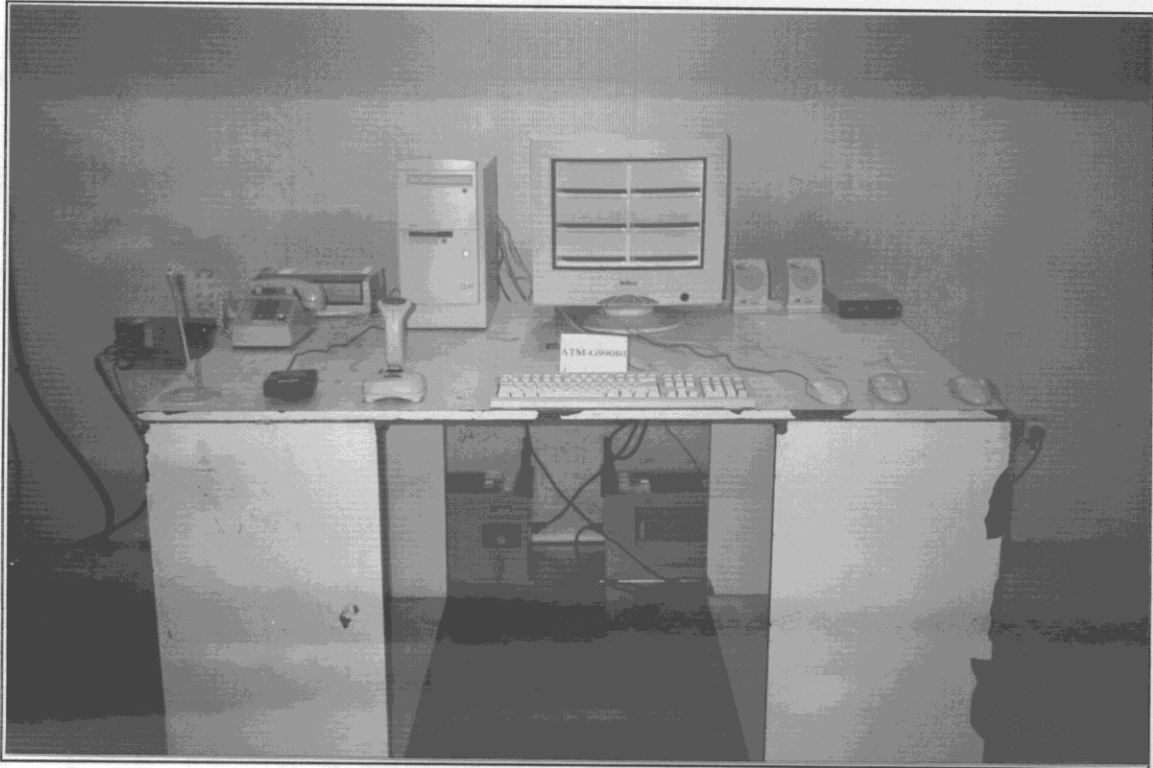
FRONT VIEW OF CONDUCTED TEST

w/D-Sub Cable

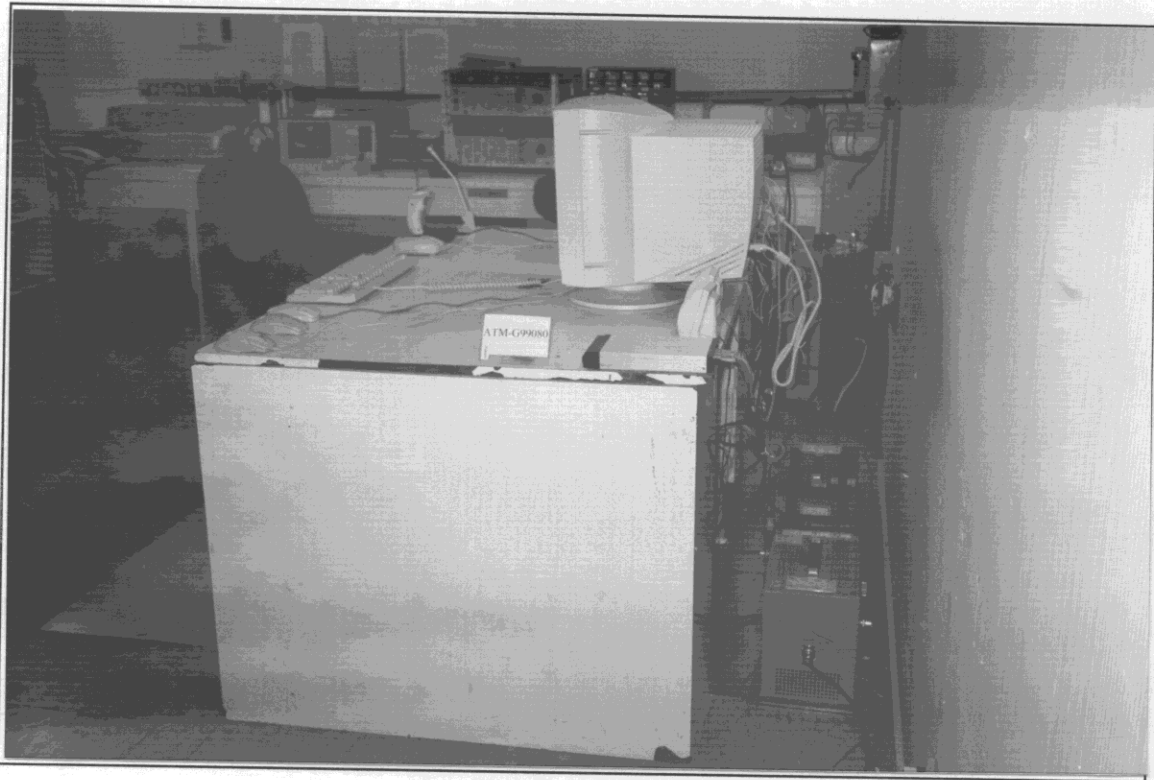
BACK VIEW OF CONDUCTED TEST

w/BNC Cable

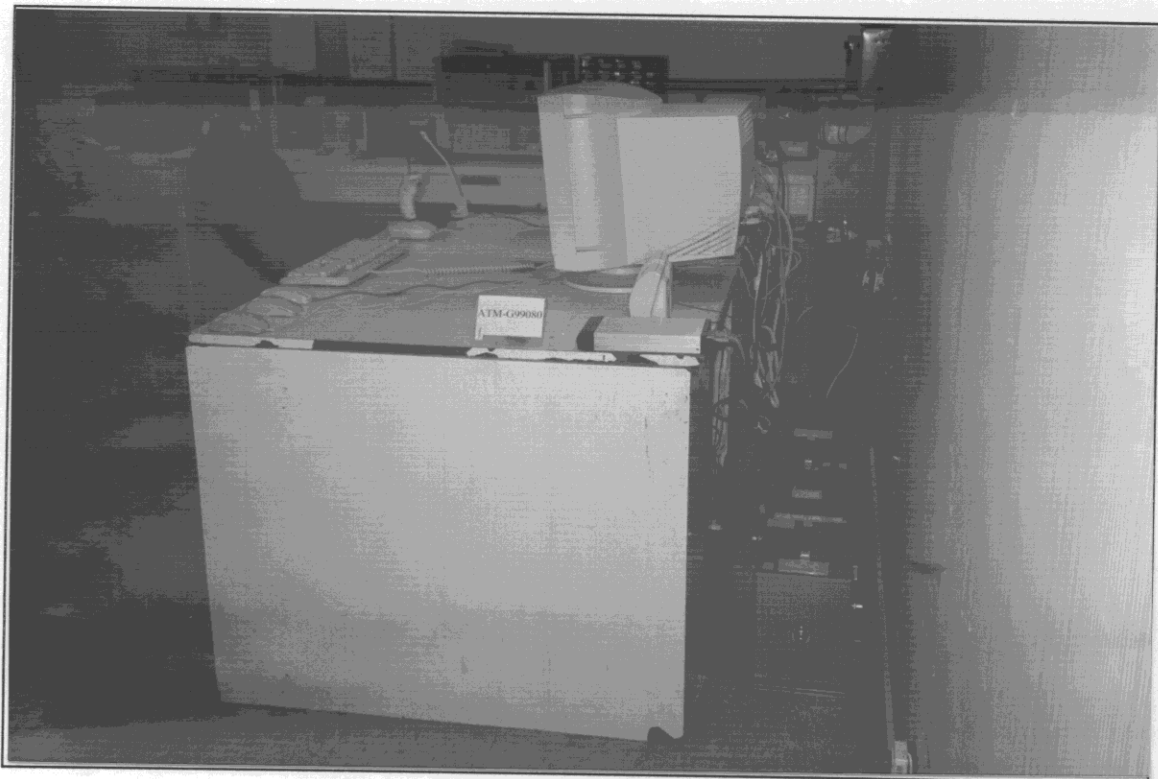
BACK VIEW OF CONDUCTED TEST

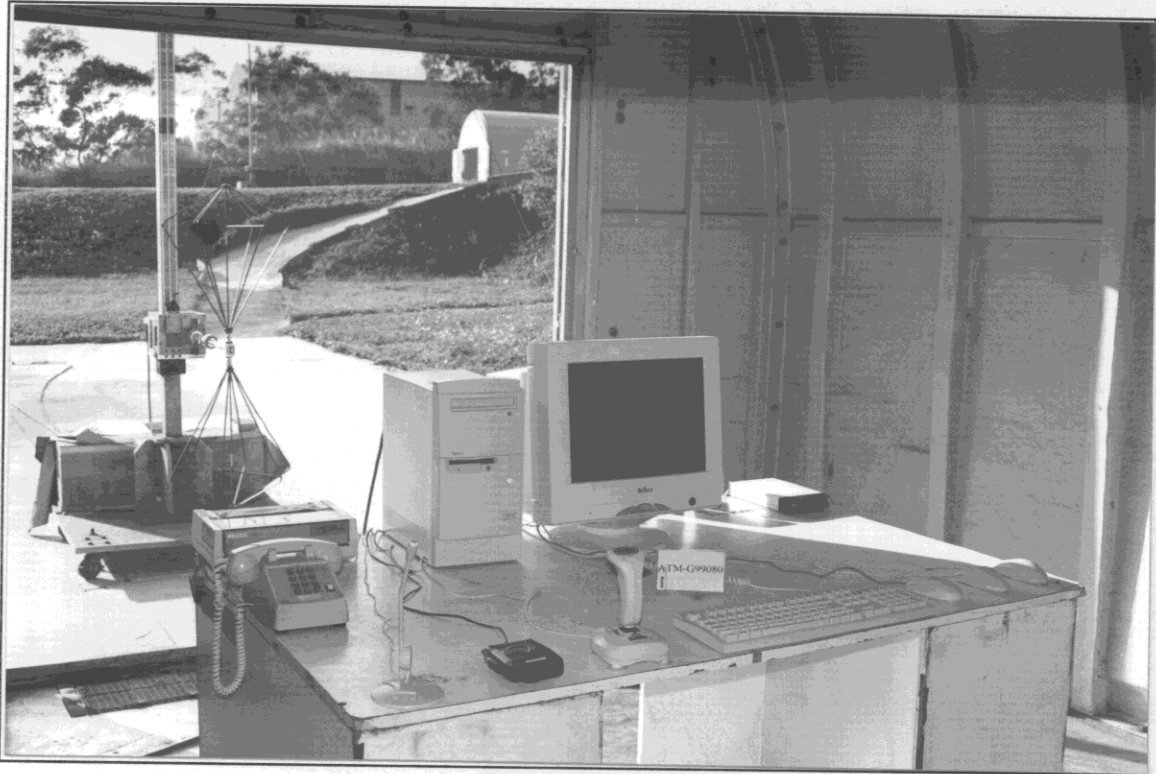
Test Mode: 91.146KHz/1280X1024, 85.024Hz; D-Sub Cable

FRONT VIEW OF RADIATED TEST

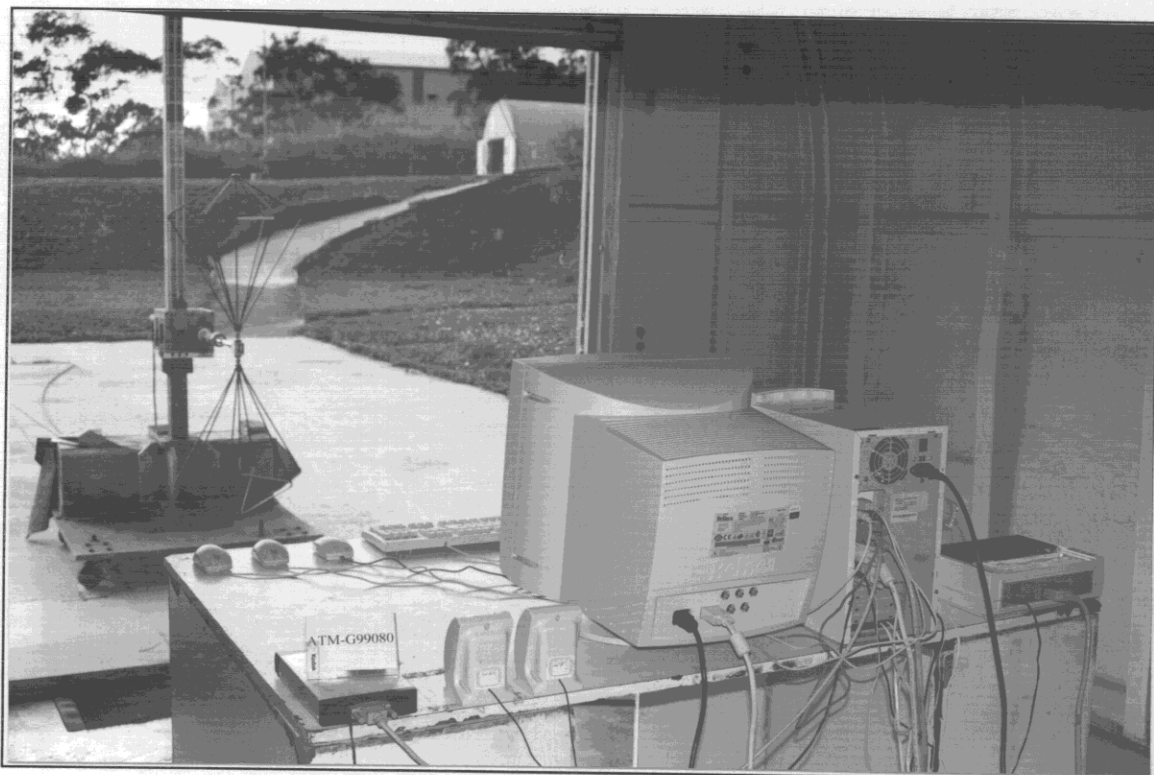
BACK VIEW OF RADIATED TEST

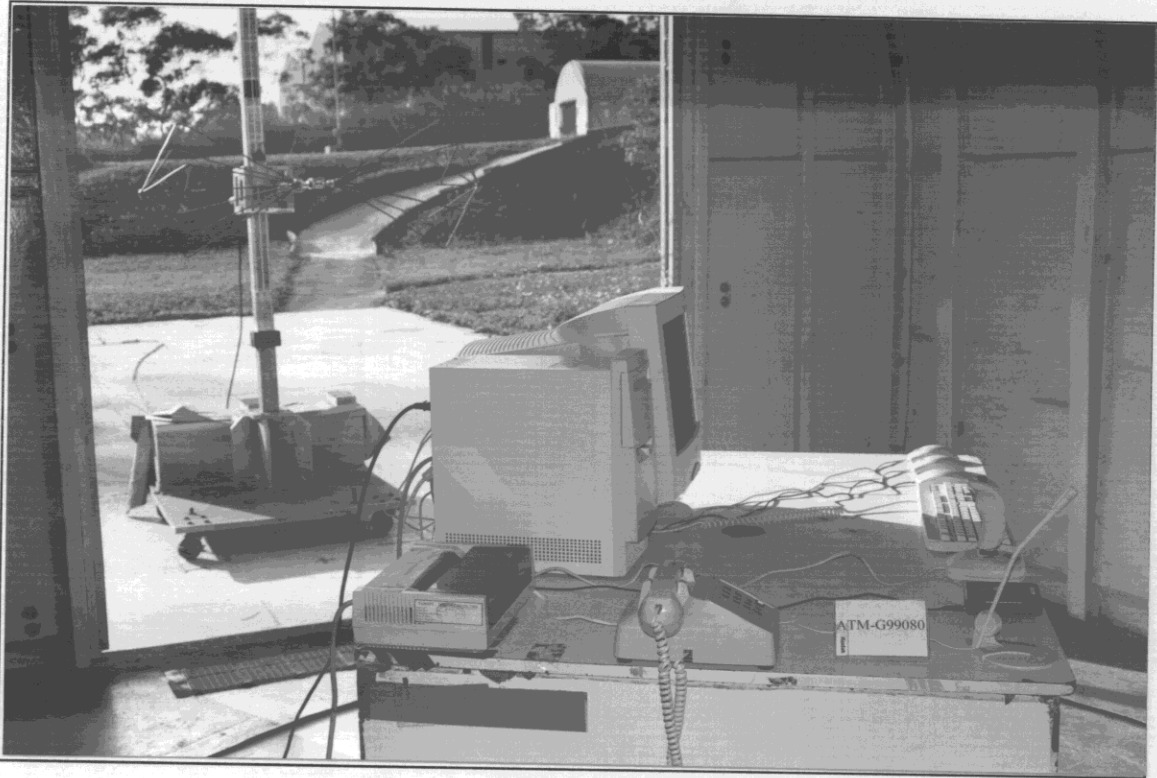
Test Mode: 91.146KHz/1280X1024, 85.024Hz; D-Sub Cable

SETUP WITH MAXIMUM DETECTED EMISSION AT HORIZONTAL POLARIZATION

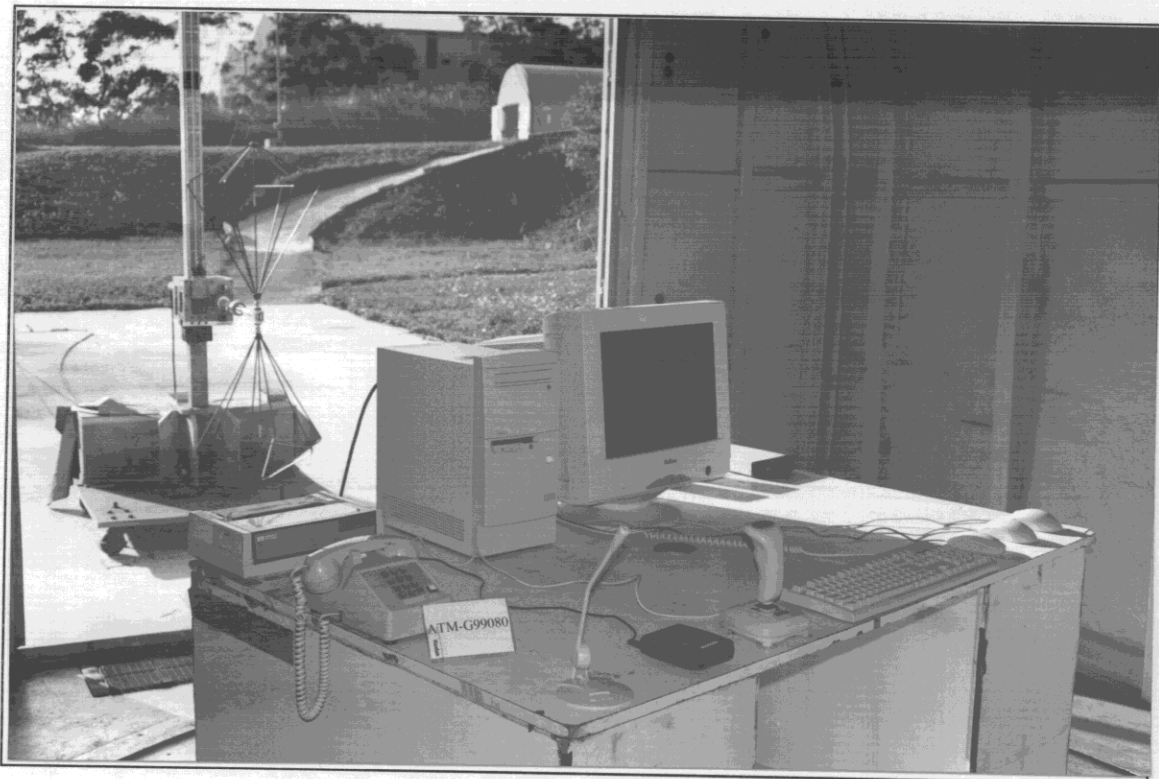
SETUP WITH MAXIMUM DETECTED EMISSION AT VERTICAL POLARIZATION

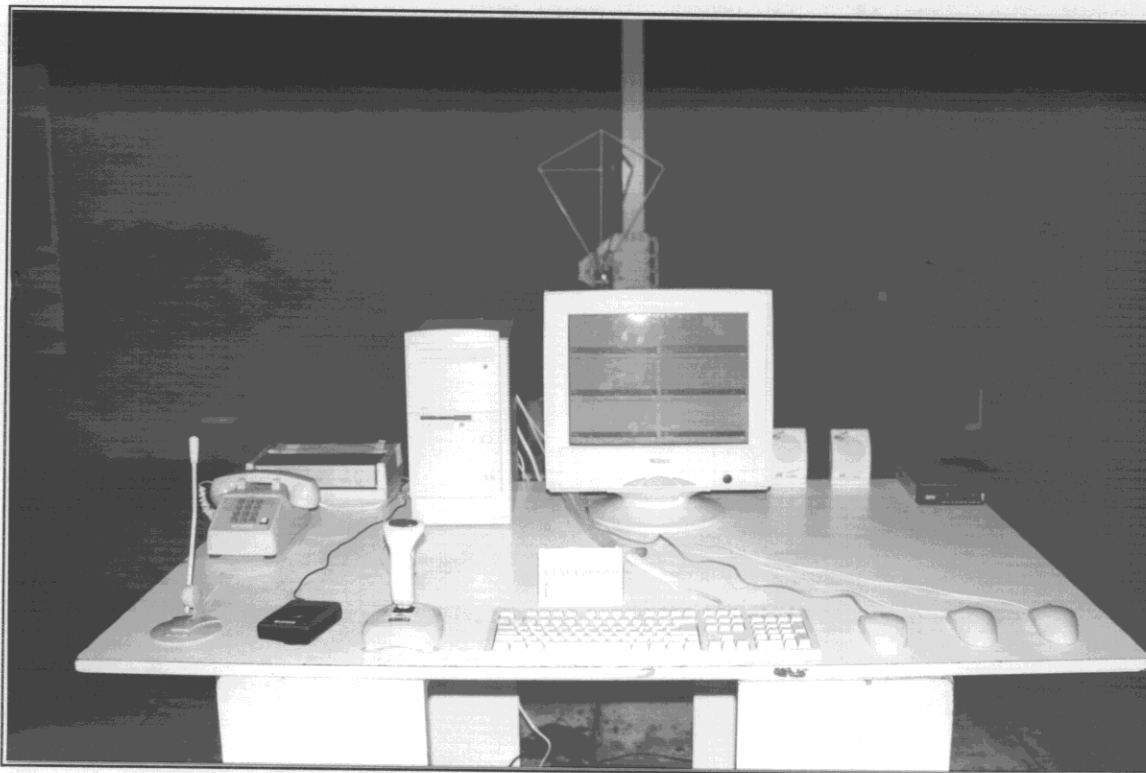
w/D-Sub Cable

FRONT VIEW OF RADIATED TEST

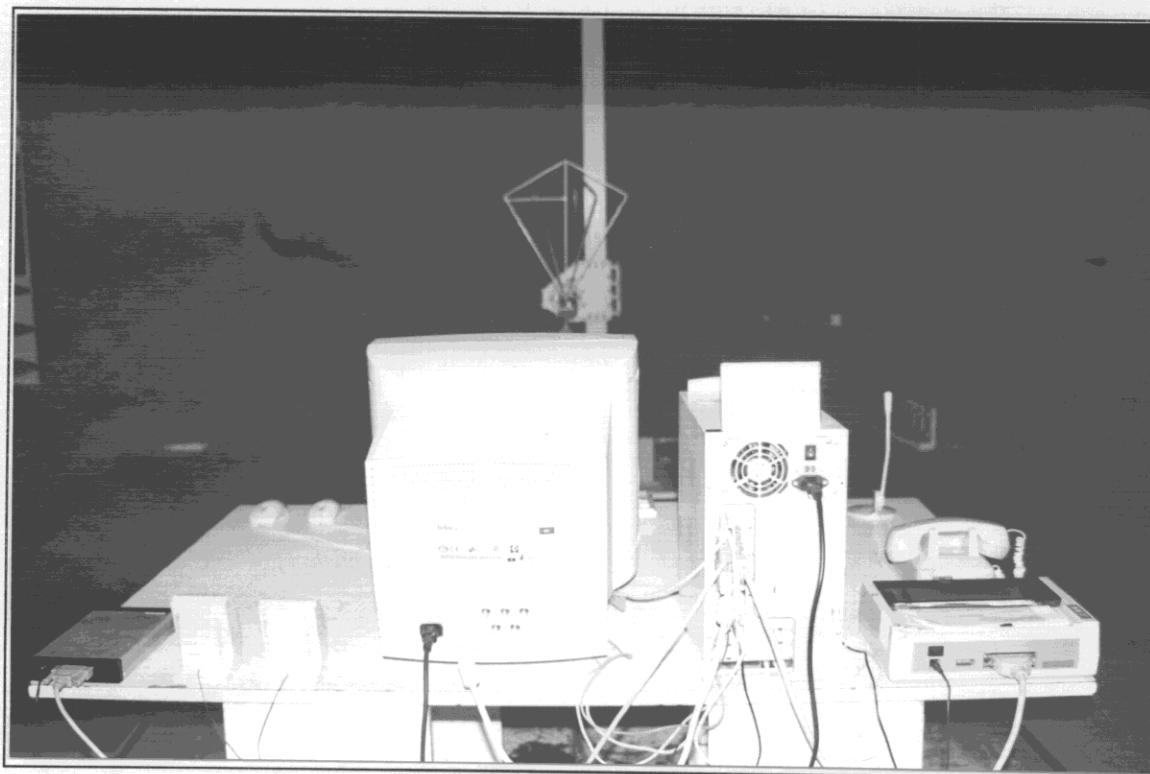
BACK VIEW OF RADIATED TEST

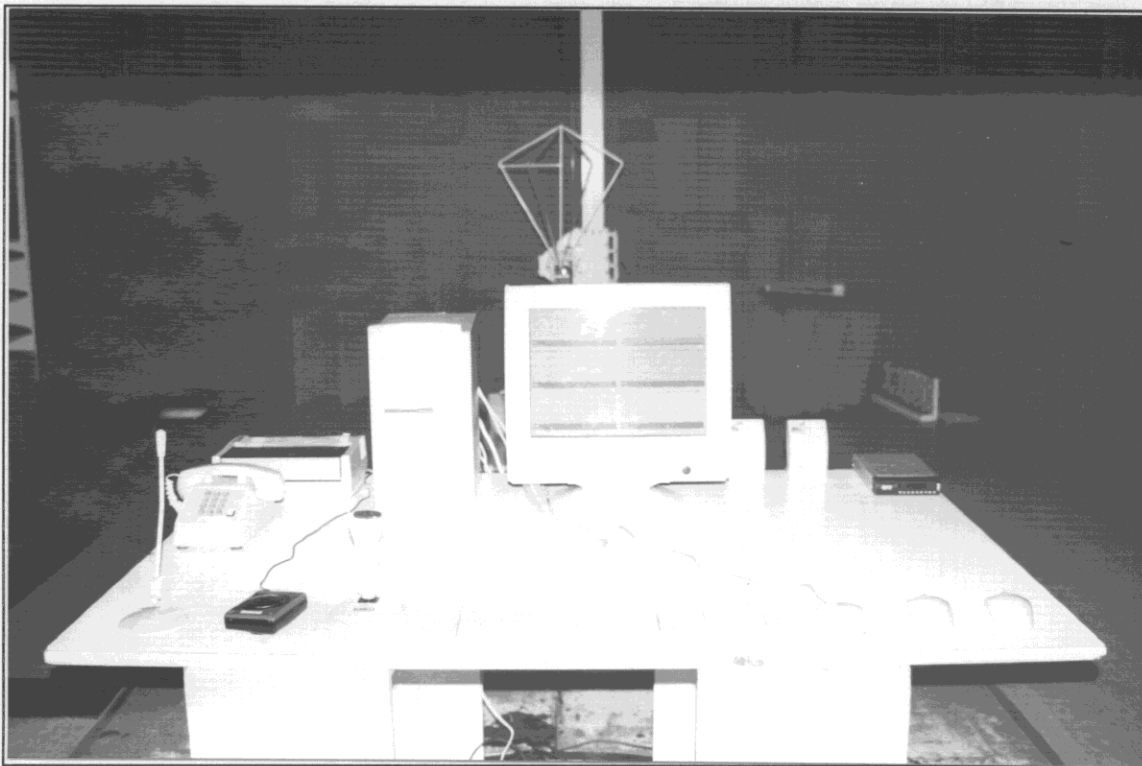
w/BNC Cable

FRONT VIEW OF RADIATED TEST

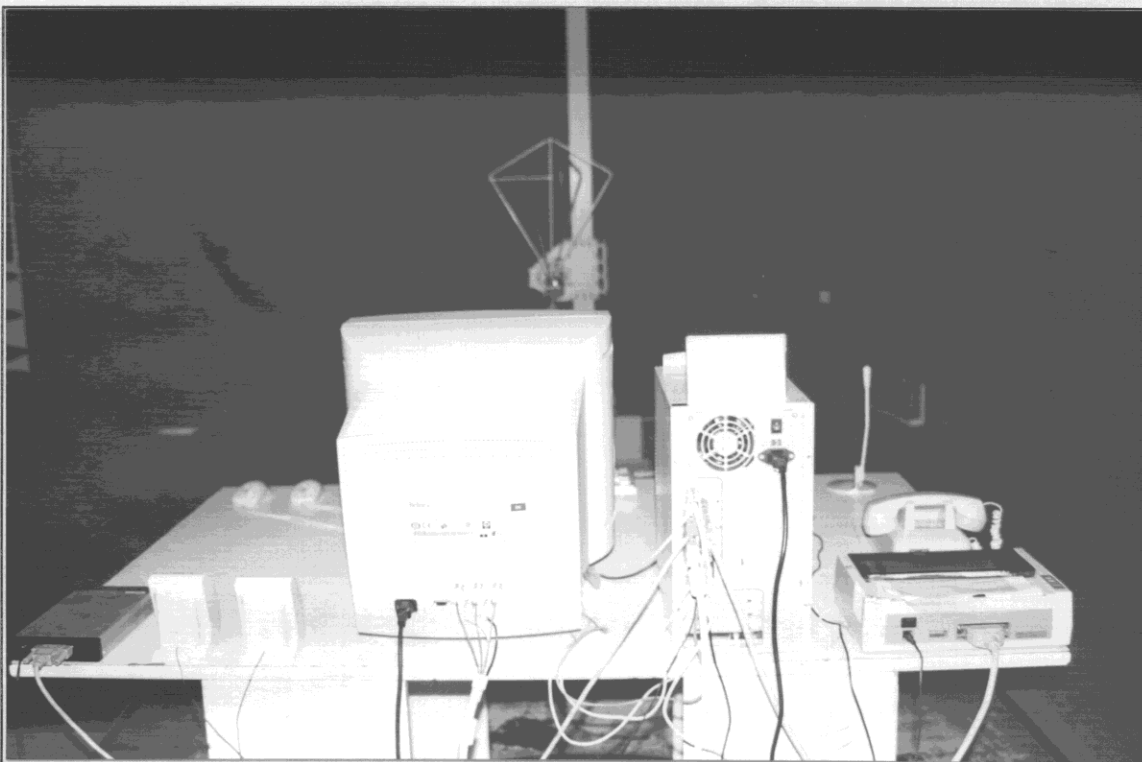
BACK VIEW OF RADIATED TEST
