## INTERTEK TESTING SERVICES

### The Worst Case Configuration Photographs

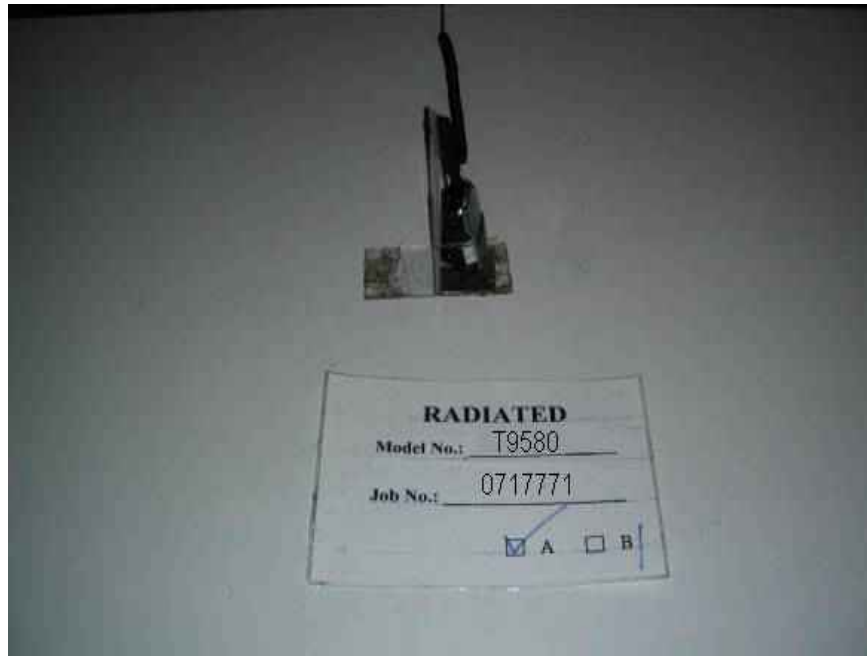
Front View

Radiated Emission – without Headset and Charging using Car Plug Charger

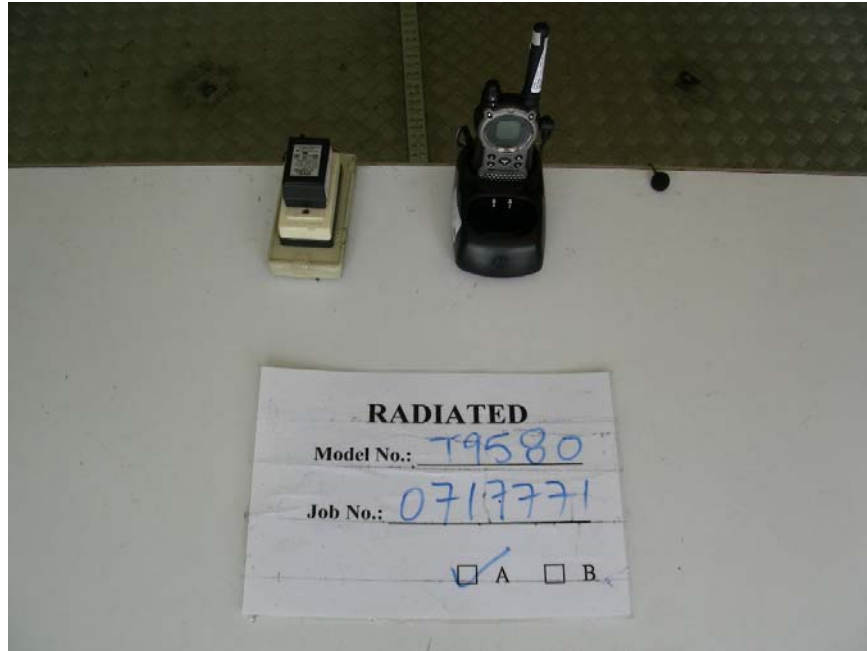
Front View

Radiated Emission – with Headset and Charging in Charging Tray

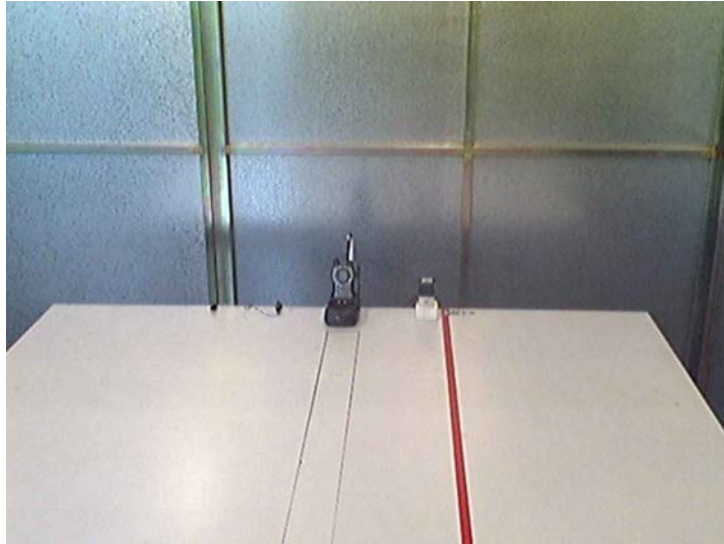
Front View

#### Conducted Emission

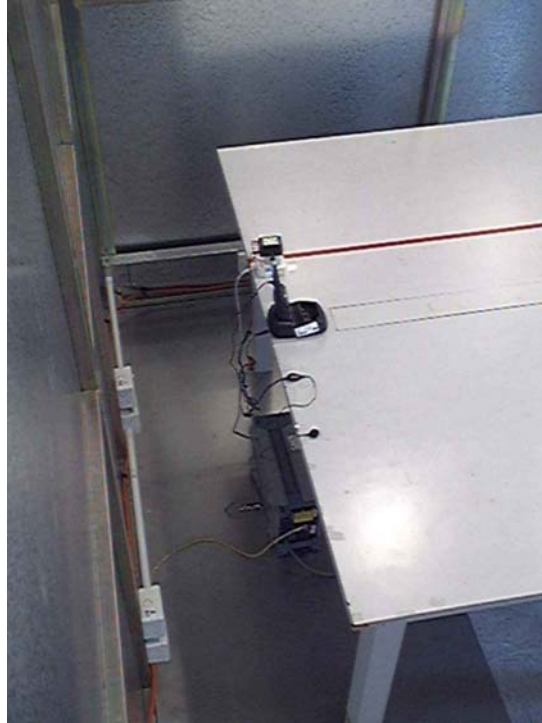
Left Side View

Conducted Emission
