### **APPENDIX 3: Photographs of test setup**

#### **Radiated Emission** (Below 1GHz)

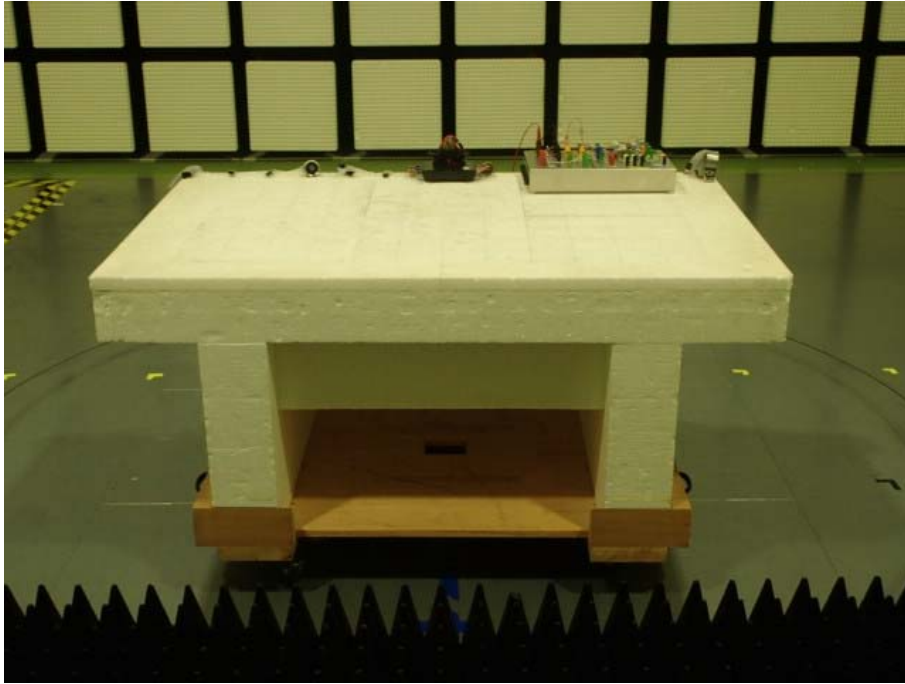
**Photo 1**

**Radiated Emission**  
(Above 1GHz)

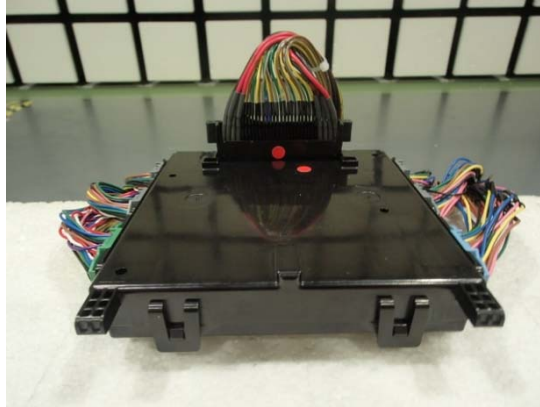
**X-axis**

### **Worst Case Position**

**Above 1GHz: Horizontal: X-axis / Vertical: X-axis**  
**Below 1GHz: Horizontal: X-axis / Vertical: X-axis**
