Limited EN 60945 and IEC 61097-2 Testing of the  
McMurdo Limited  
G5 Smartfind Plus (a) & (m)

Document 75911555 Report 01 Issue 2

The information contained in this report is intended to show verification of the McMurdo Limited G5 Smartfind Plus (a) & (m) to the requirements of EN 60945 and IEC 61097-2.

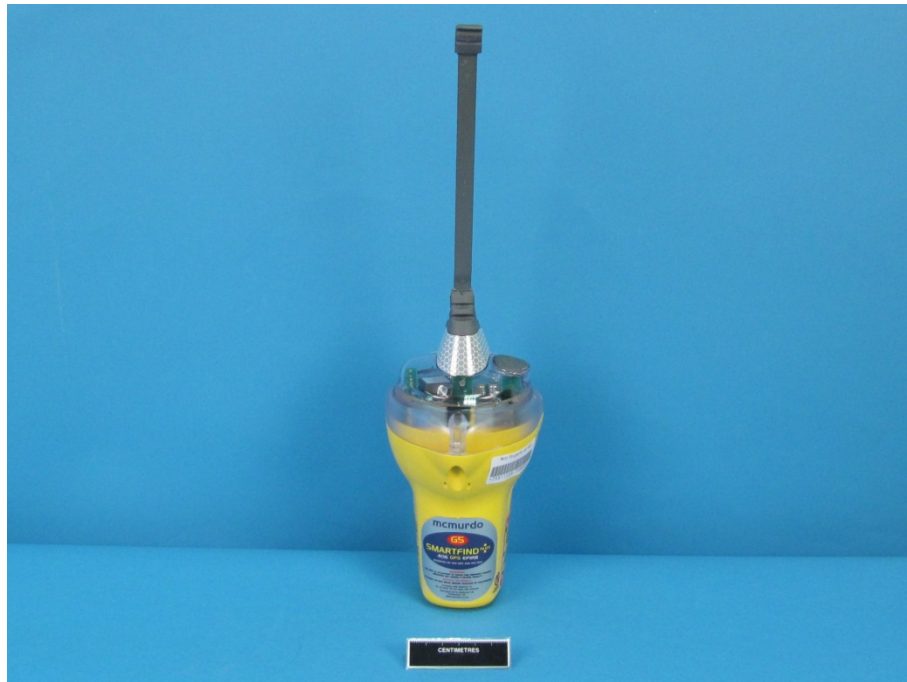
The Equipment Under Test (EUT) was a McMurdo Limited, G5 Smartfind Plus (a) & (m) as shown in the photograph below. A full technical description can be found in the manufacturer's documentation.

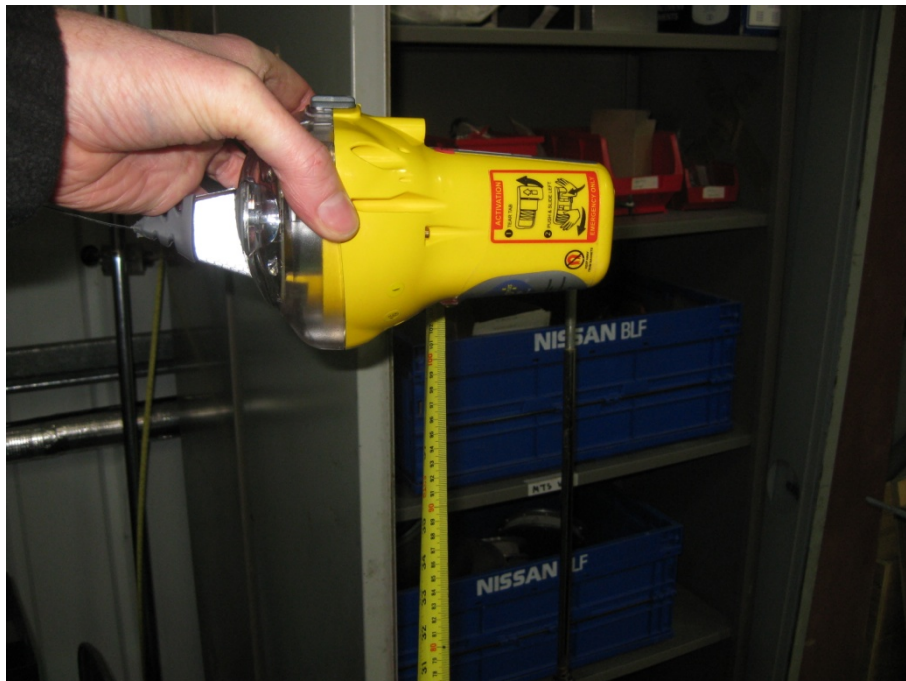
Test Set-up – Drop Test

The test was performed with the EUT in the following mode(s): Idle. The EUT was not fixed to the mounting bracket.

The EUT was dropped from a height of 1m onto a piece of solid hardwood as described in EN 60945. The EUT was dropped 6 times, one on each face. The performance check was carried out following the drop test.

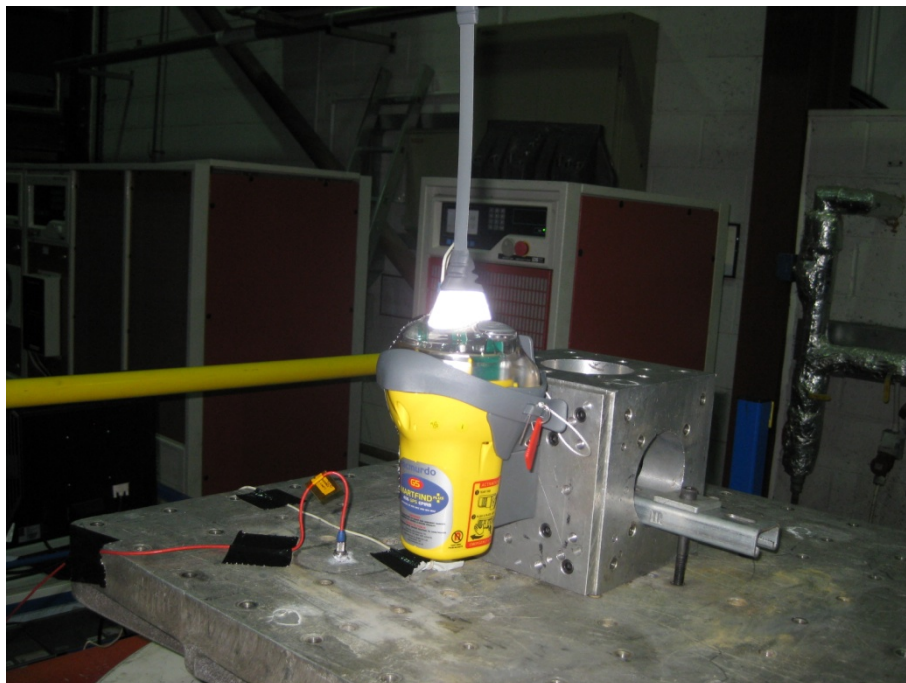
Test Set-up – Vibration

The test was performed with the EUT in the following mode(s): Idle. The EUT was positioned on the vibration table in accordance with EN 60945. The EUT was mounted via the mounting bracket provided by McMurdo.

The EUT was fixed to the vibration table via a clamping arrangement. The system was subject to the following vibration profile:

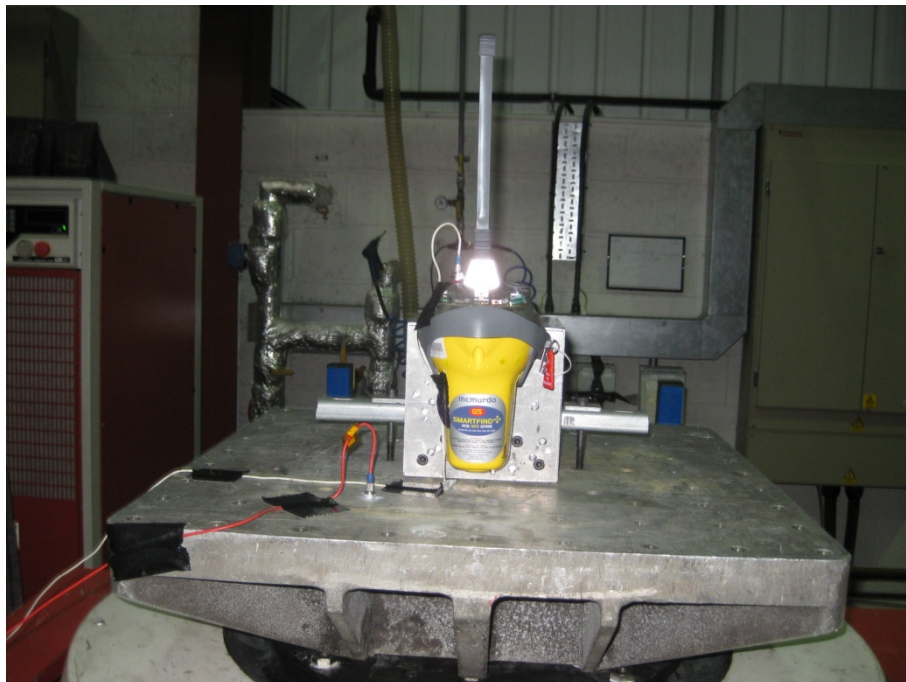
Test Set-up – Ruggedness

The test was performed with the EUT in the following mode(s): Idle. The EUT was mounted via the mounting bracket provided by McMurdo.

The EUT was secured to the test table via the mounting bracket supplied by McMurdo. The EUT was then subject to the ruggedness test in accordance with the following profile (see also plot below):

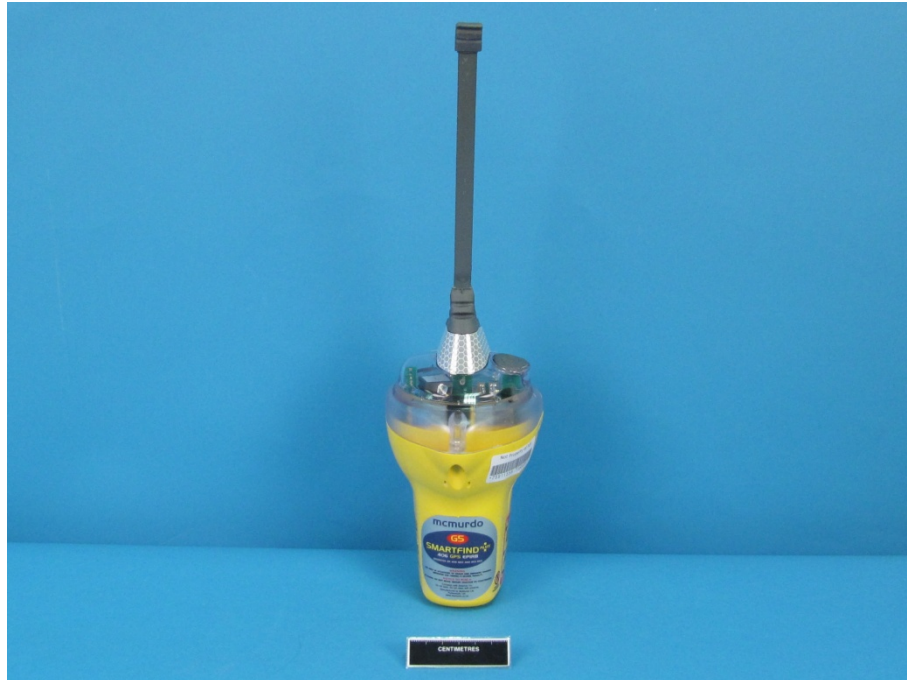
Equipment Under Test - Front

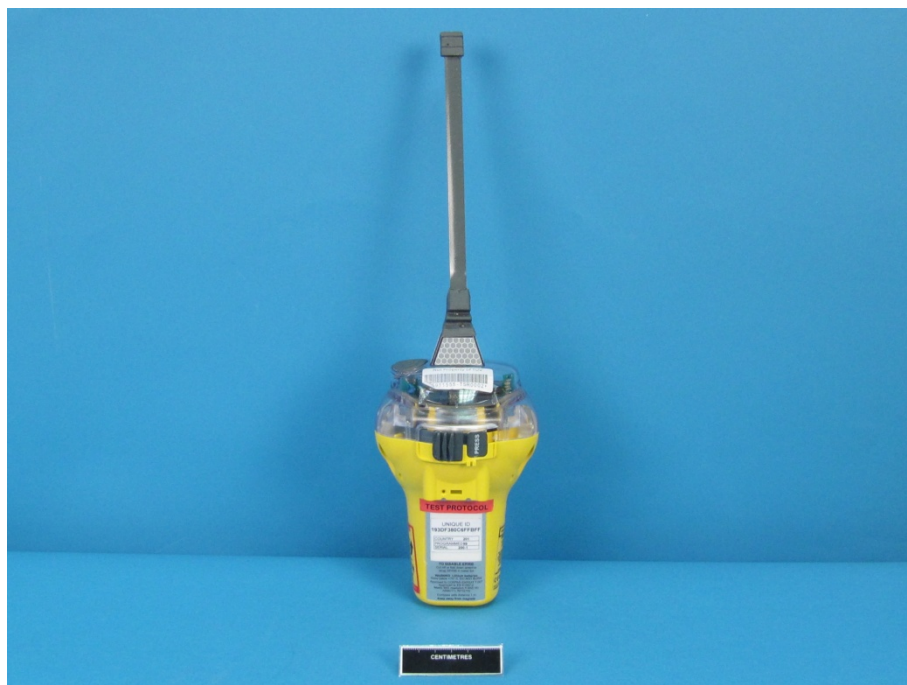
Equipment Under Test – Rear View

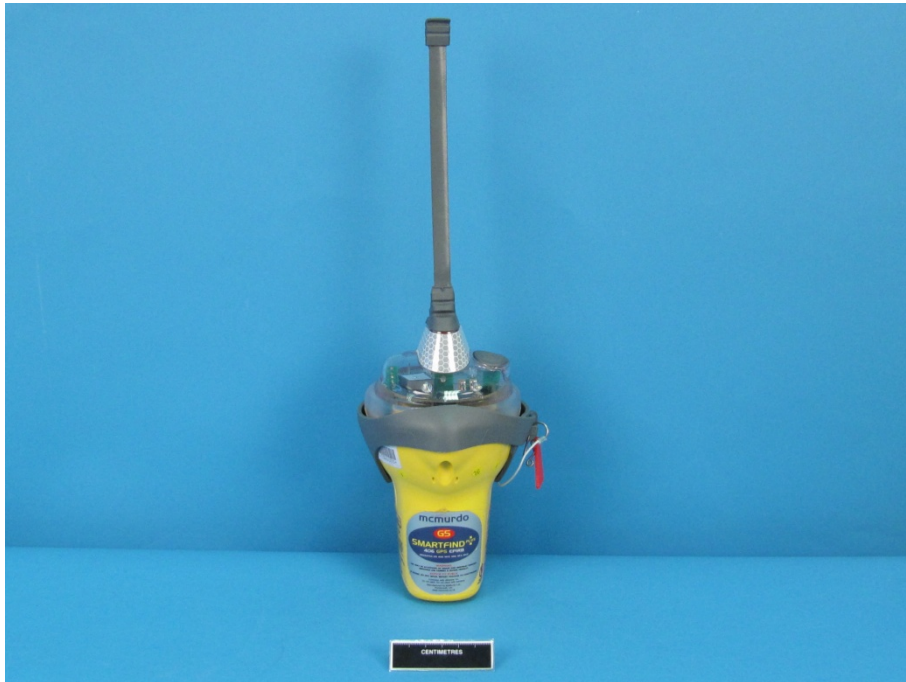
Equipment Under Test – In Mounting Bracket
