Annex C Photo documentation

Appendix to Test Report No.: 1-6234/13-08-14-A

CETECOM ICT Services GmbH

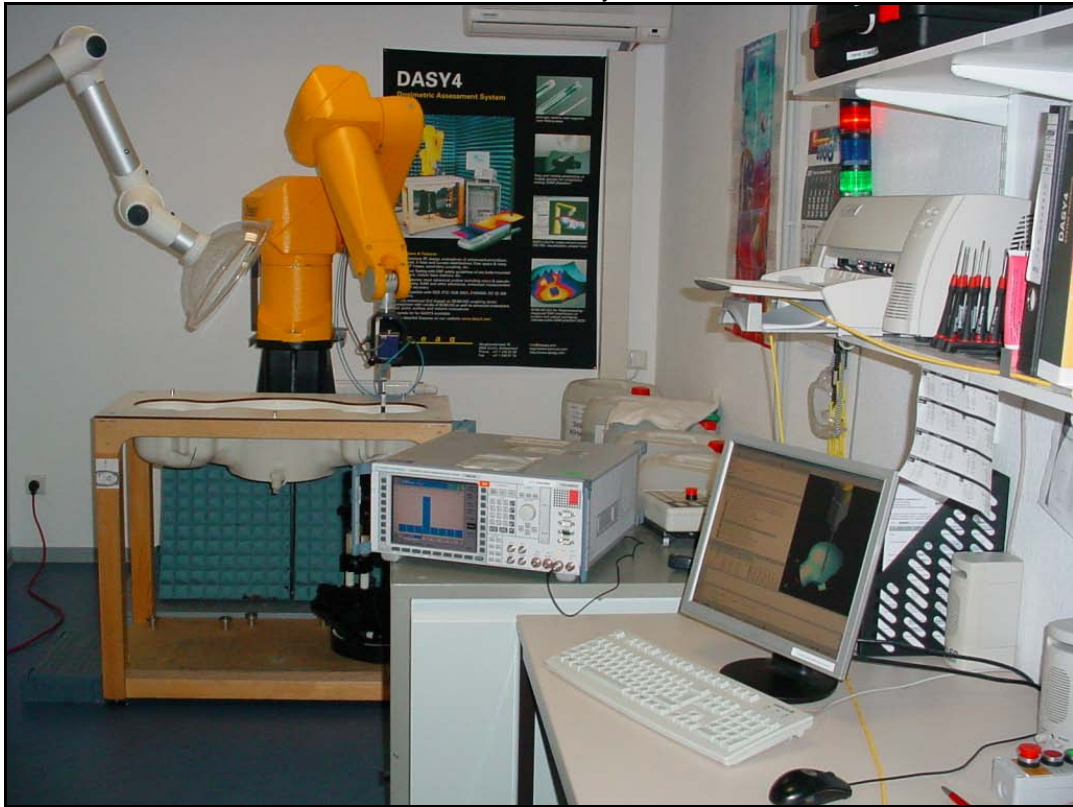
Photo 1: Measurement System DASY 5

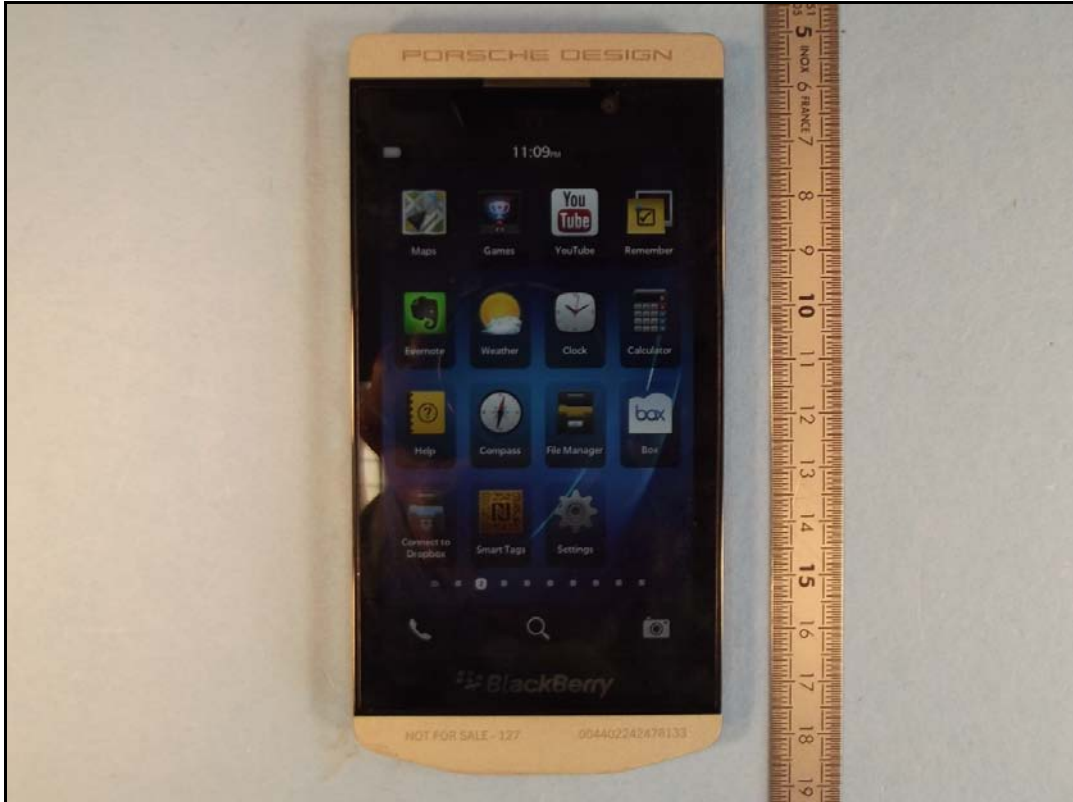
Photo 2: DUT - front view

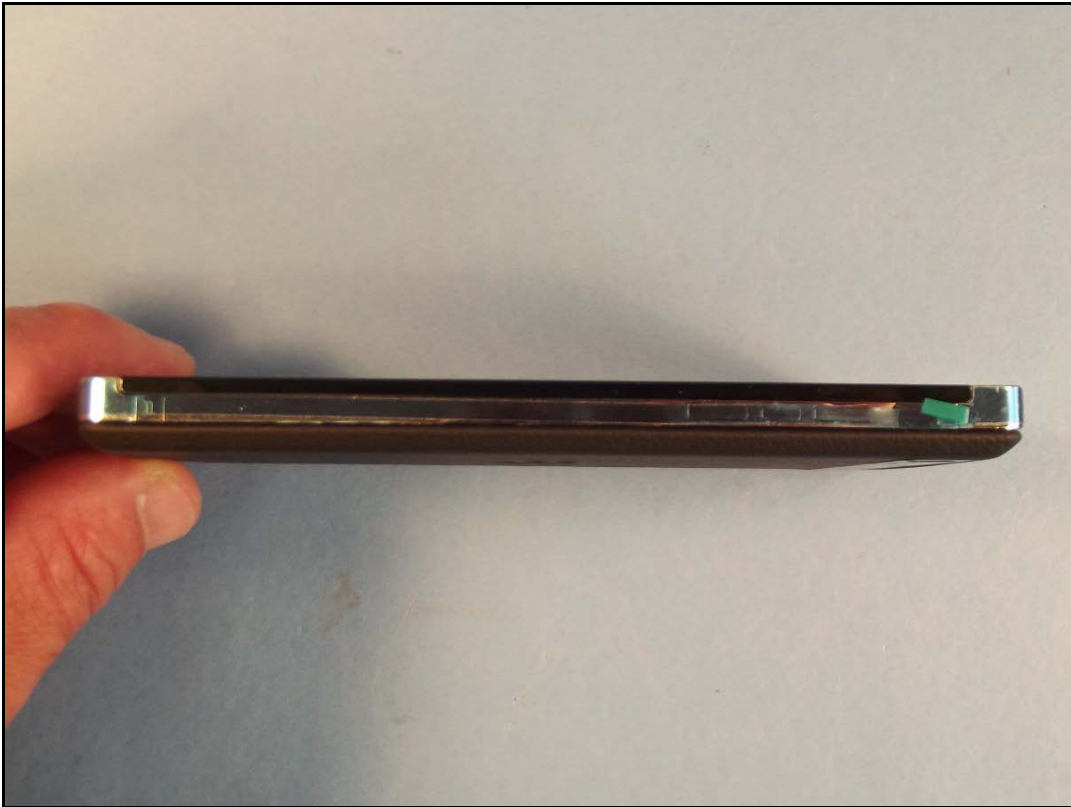
Photo 3: DUT - side view

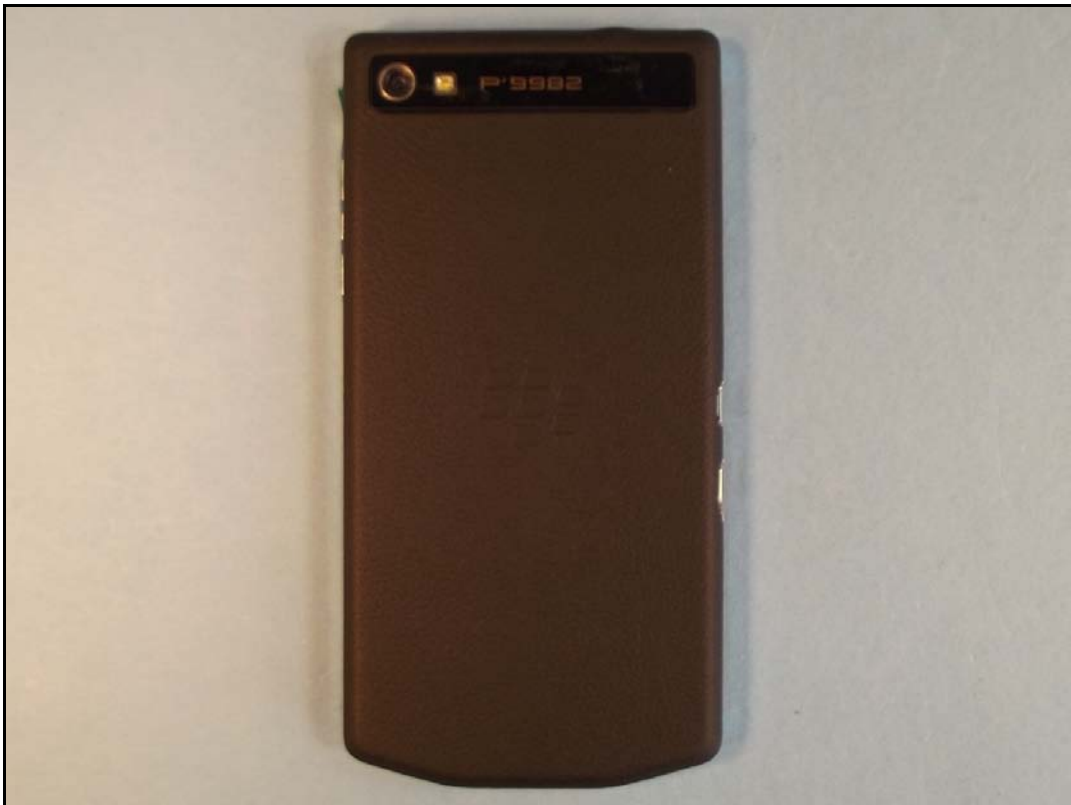
Photo 4: DUT - rear view

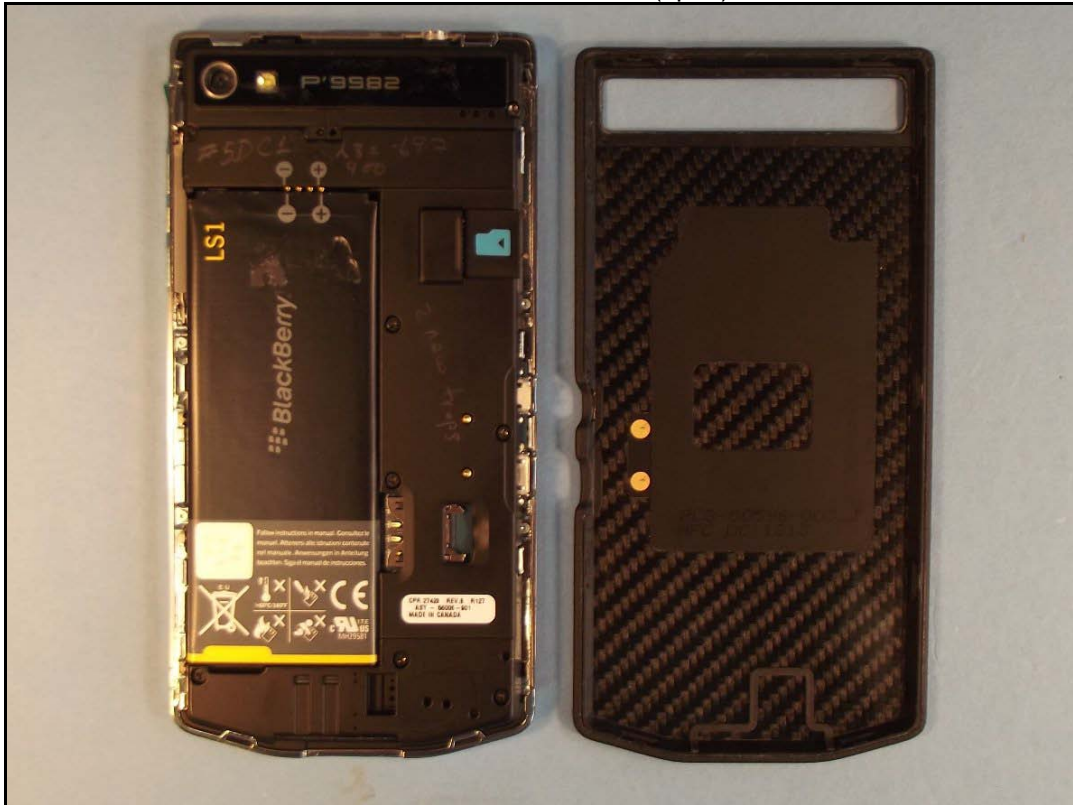
Photo 5: DUT - rear view (open)

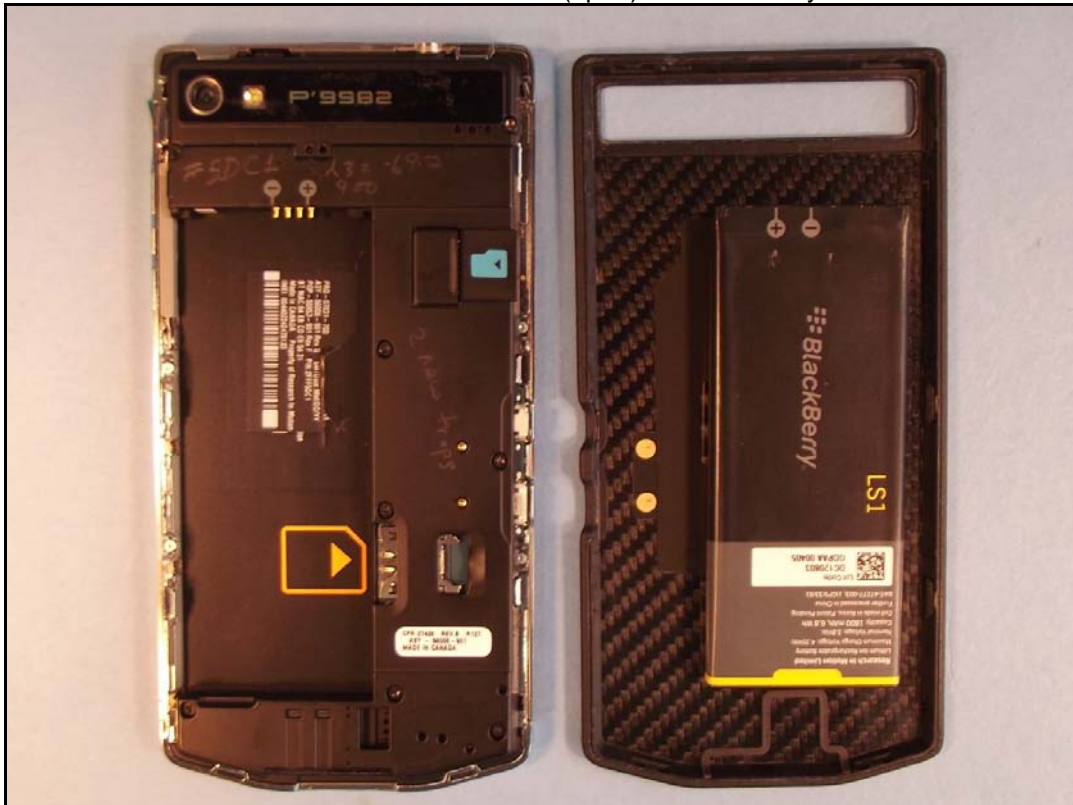
Photo 6: DUT - rear view (open) without battery

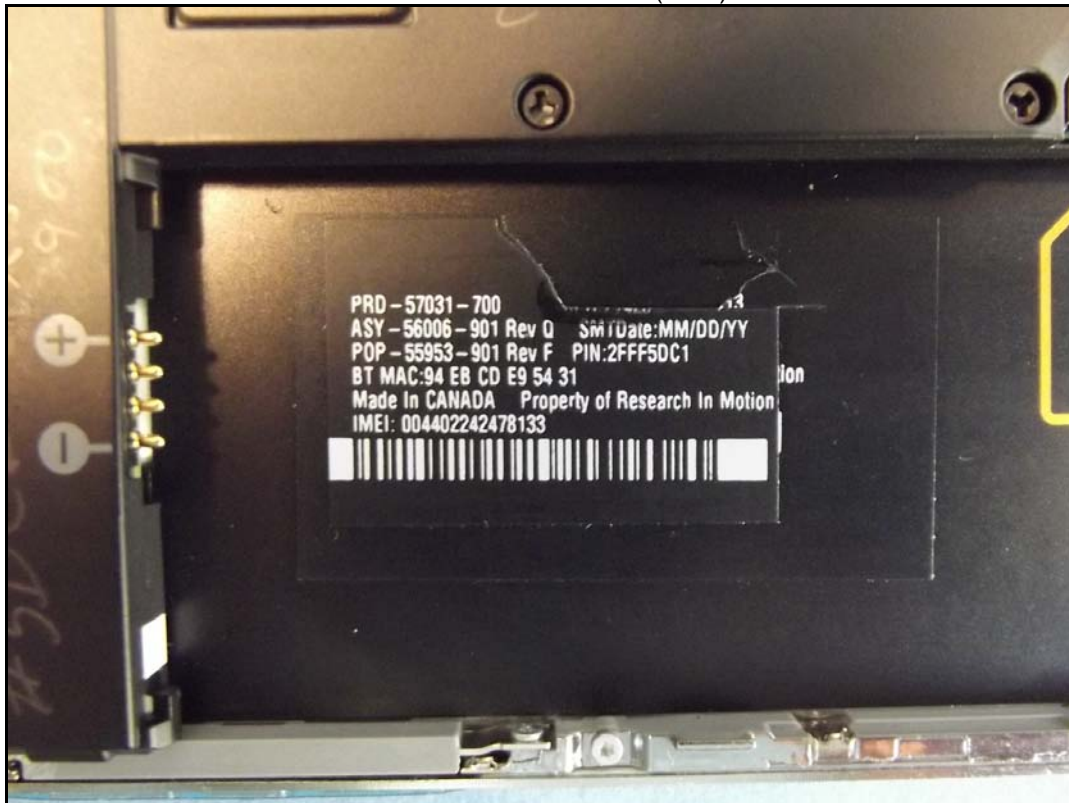
Photo 7: DUT - rear view (label)

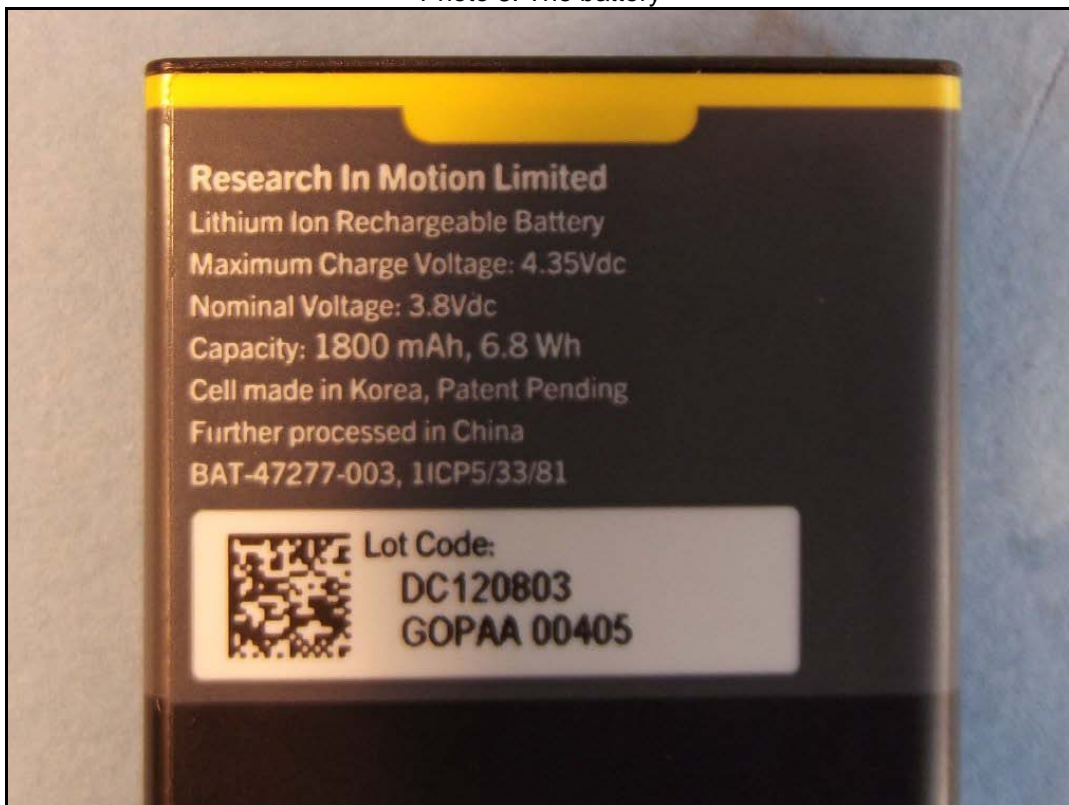
Photo 8: The battery

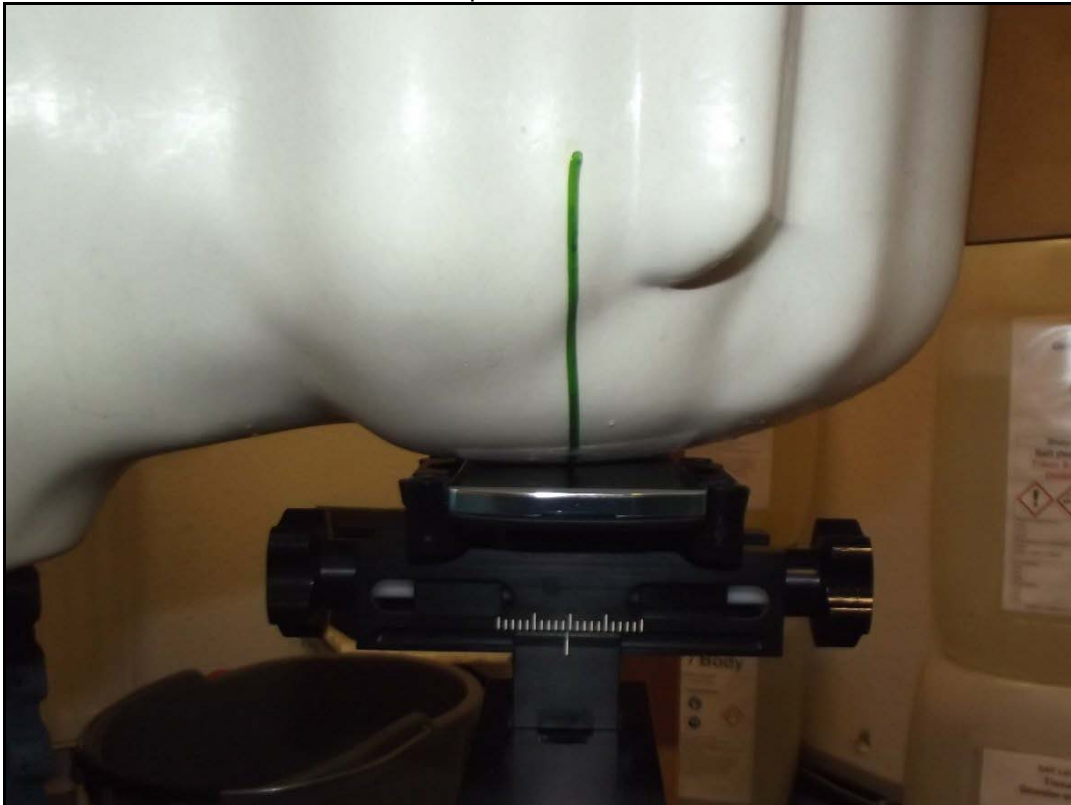
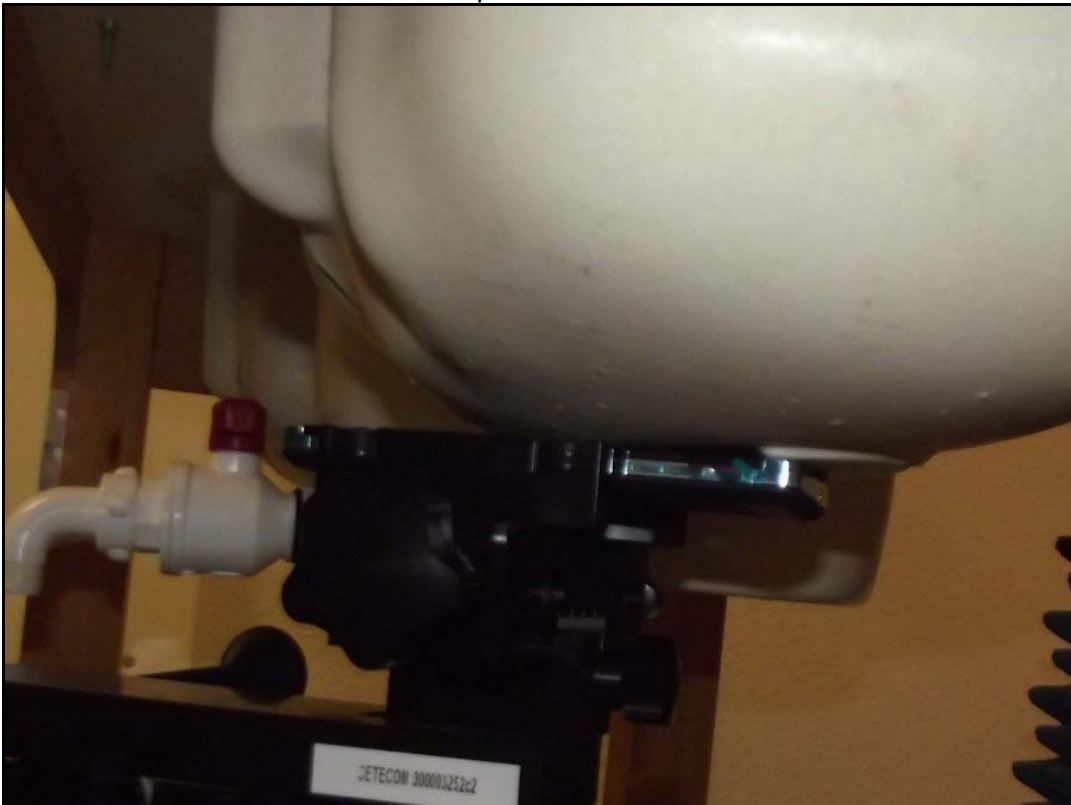
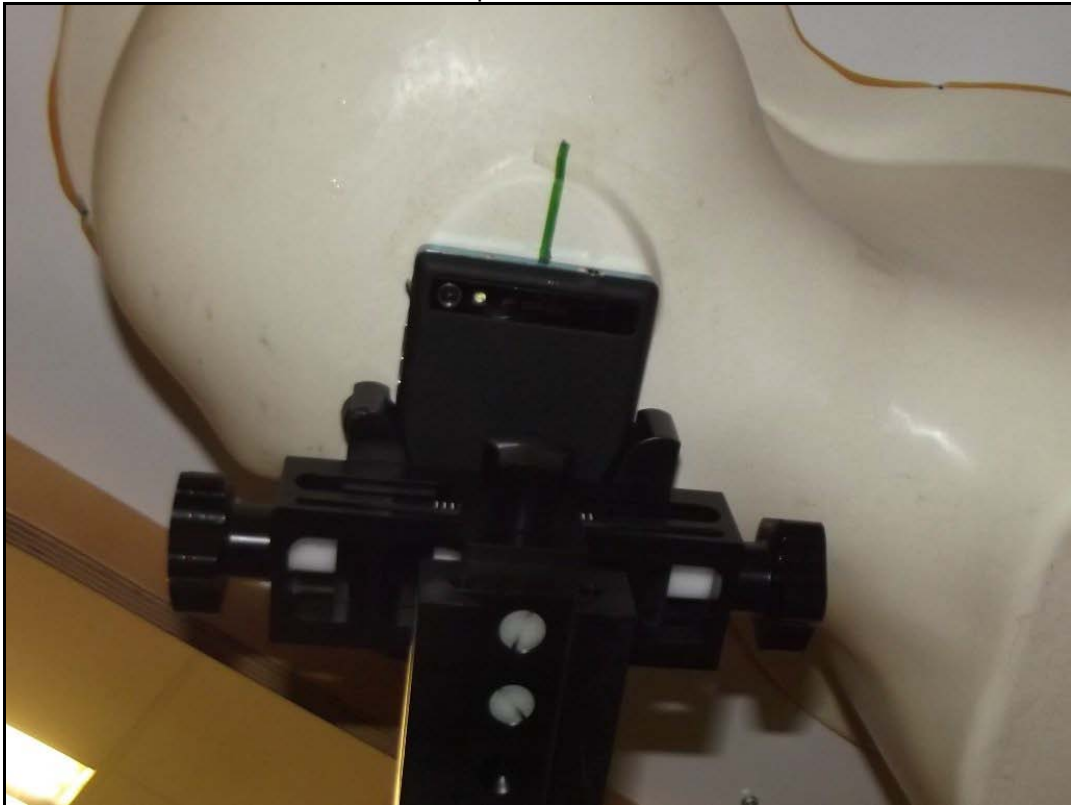
Photo 9: Test position left hand touched

Photo 10: Test position left hand touched

Photo 11: Test position left hand touched

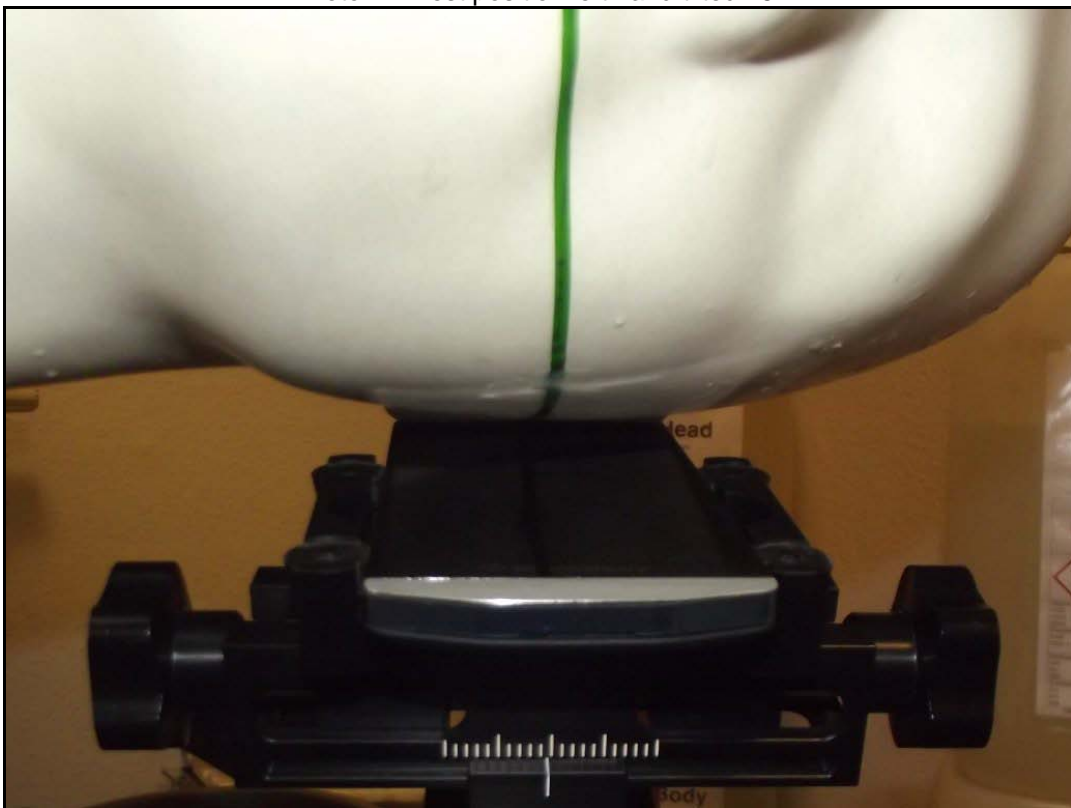
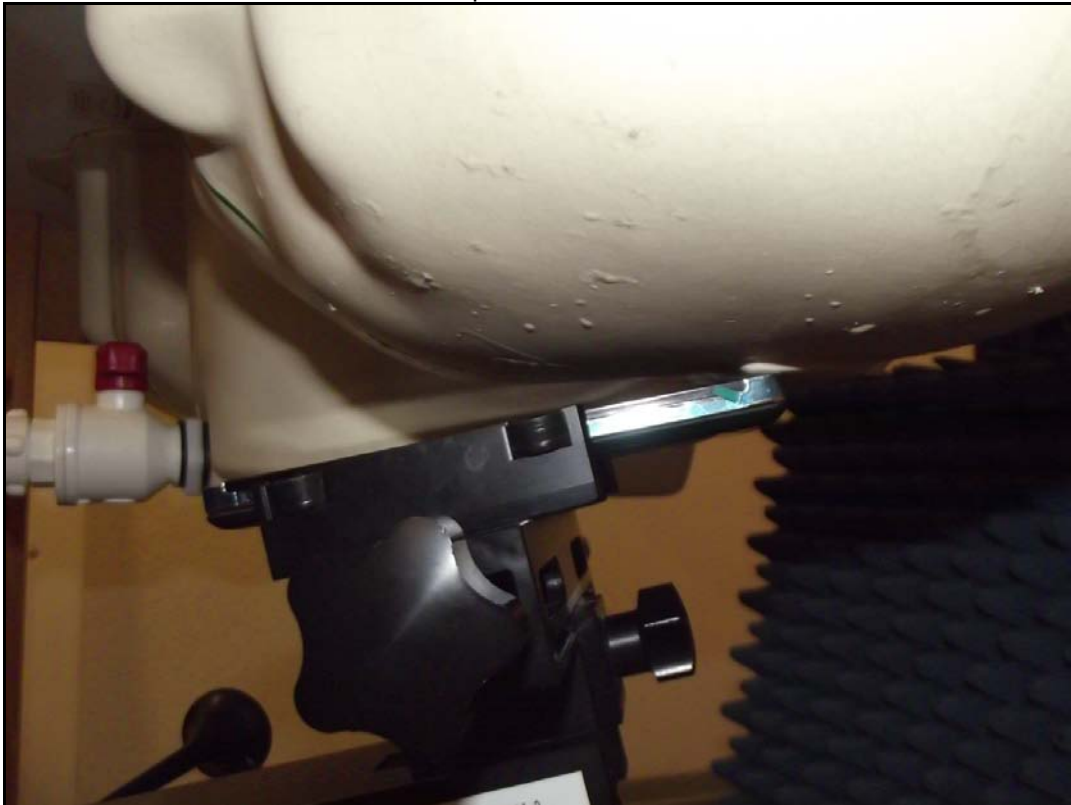
Photo 12: Test position left hand tilted 15°

Photo 13: Test position left hand tilted 15°

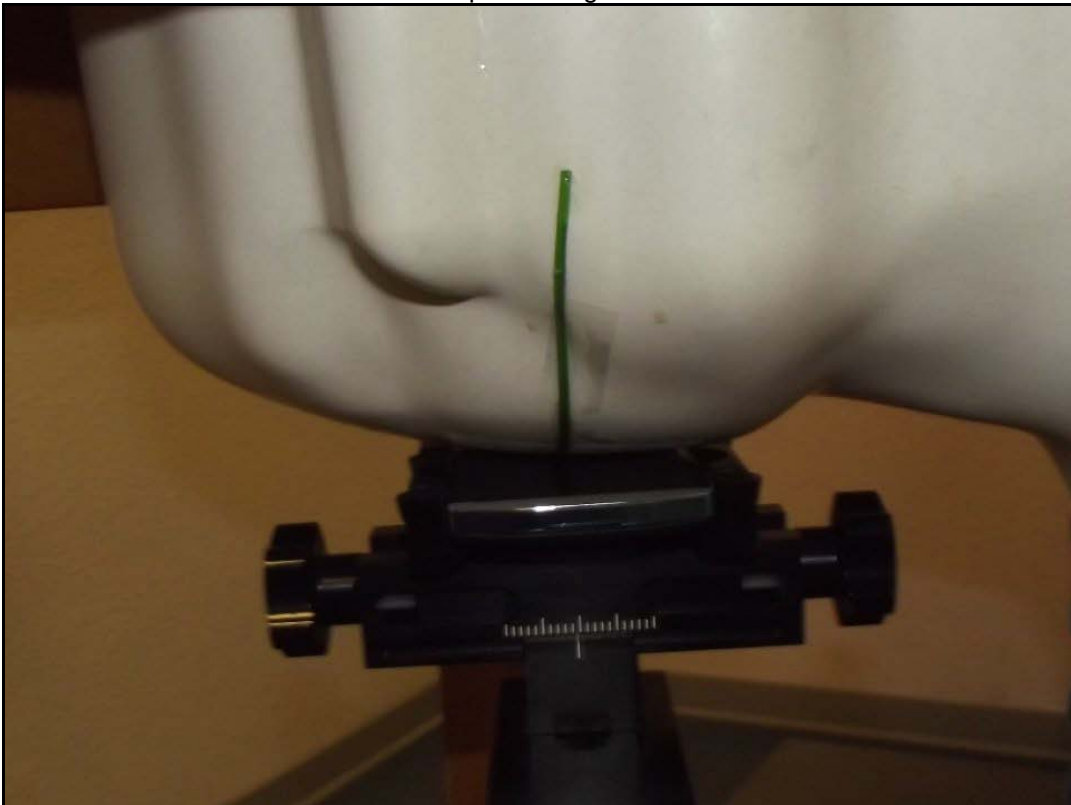
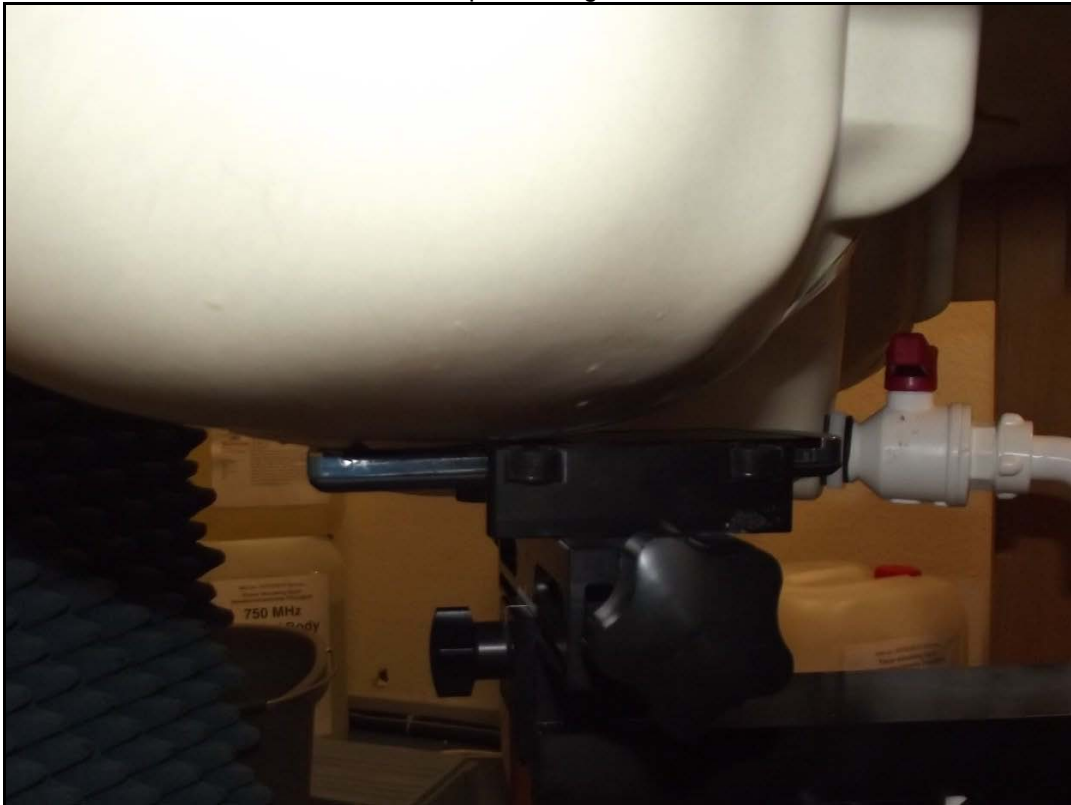
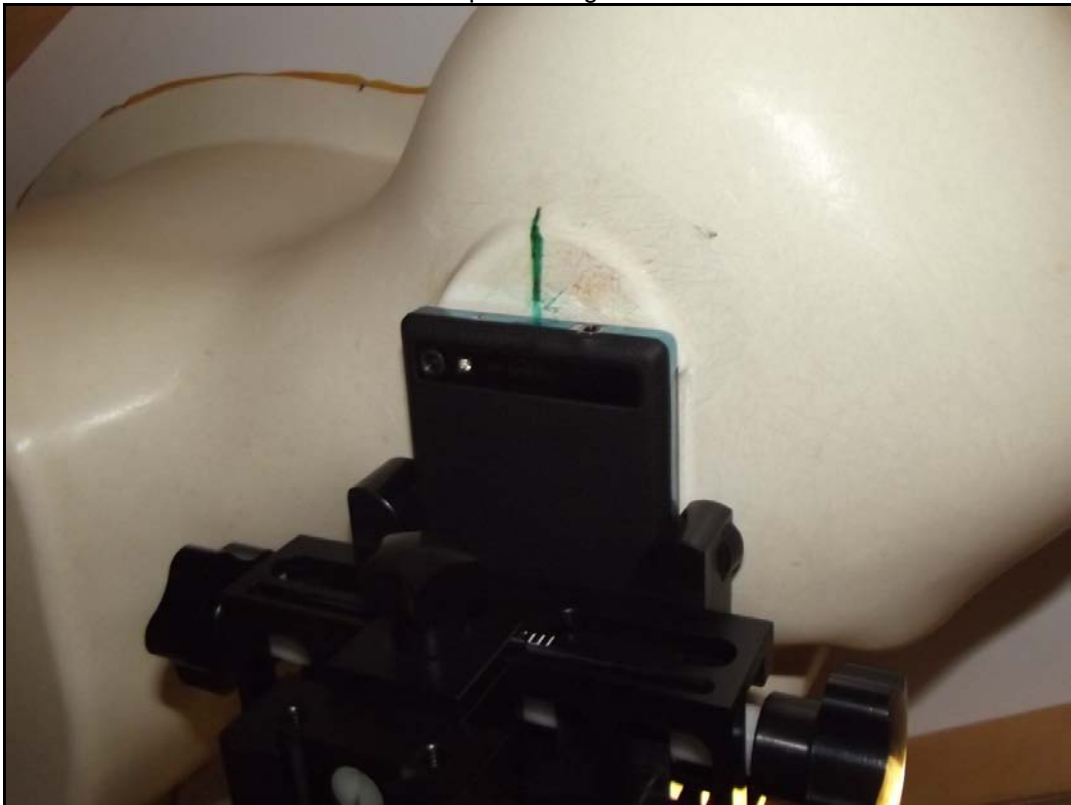
Photo 14: Test position right hand touched

Photo 15: Test position right hand touched

Photo 16: Test position right hand touched

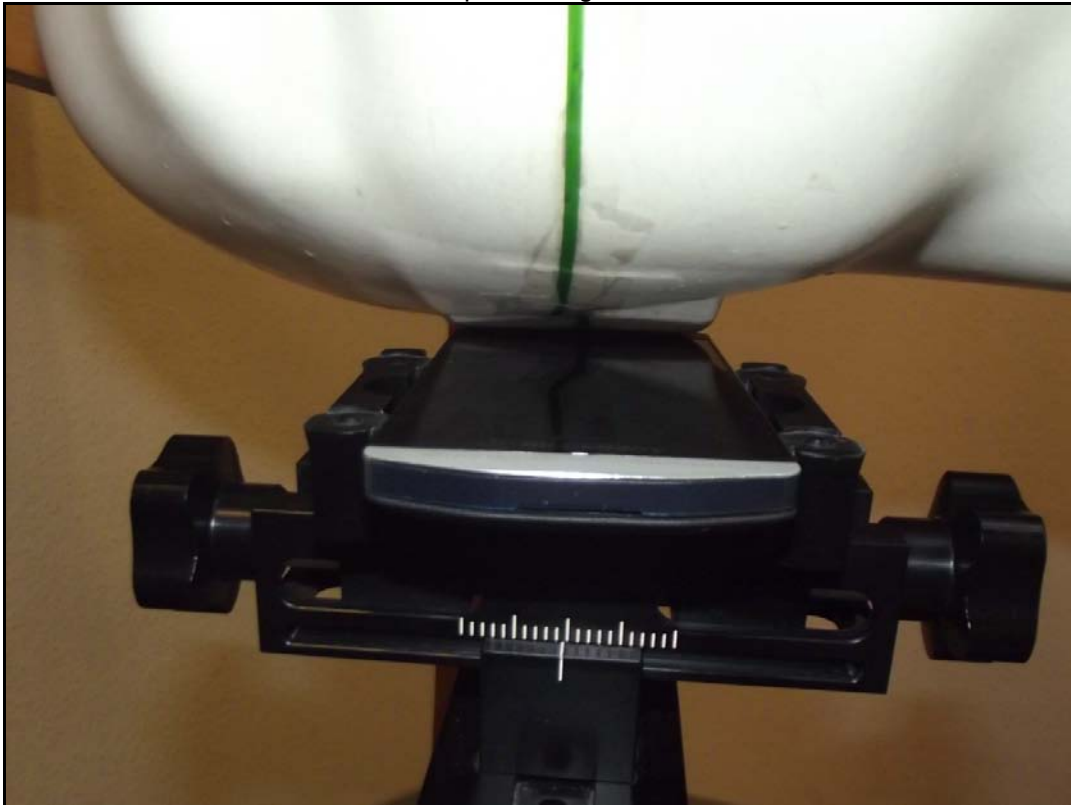
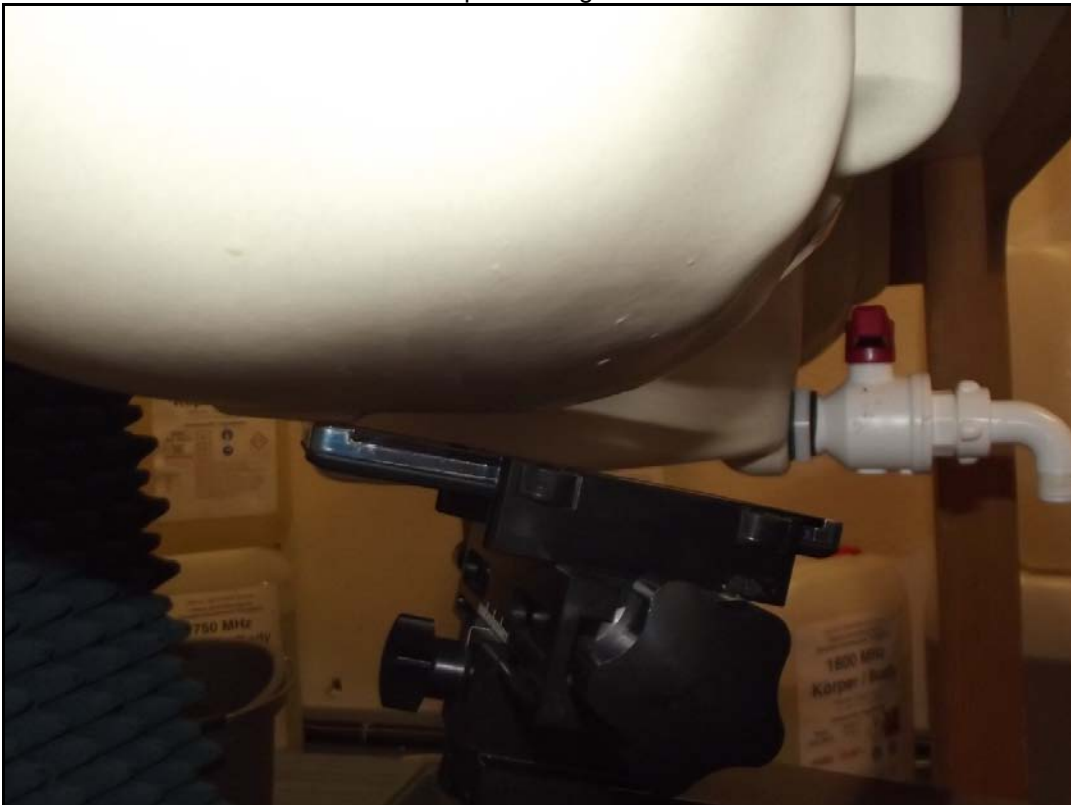
Photo 17: Test position right hand tilted 15°

Photo 18: Test position right hand tilted 15°

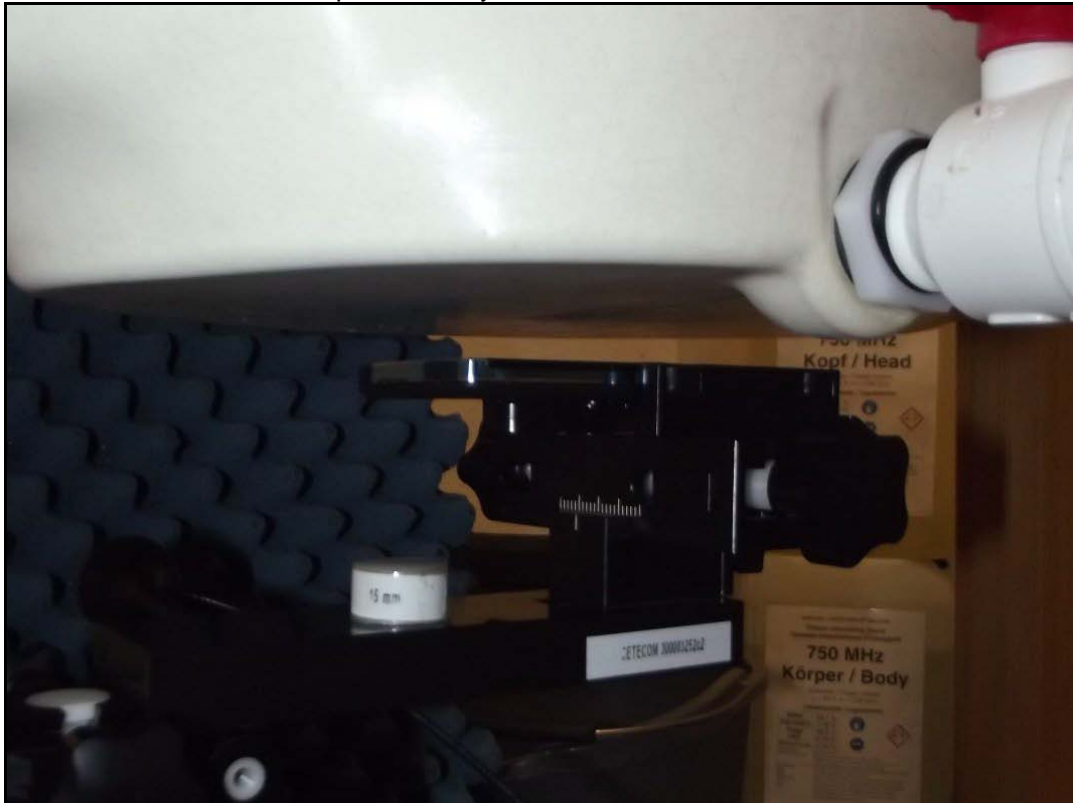
Photo 19: Test position body worn front side with 15 mm distance

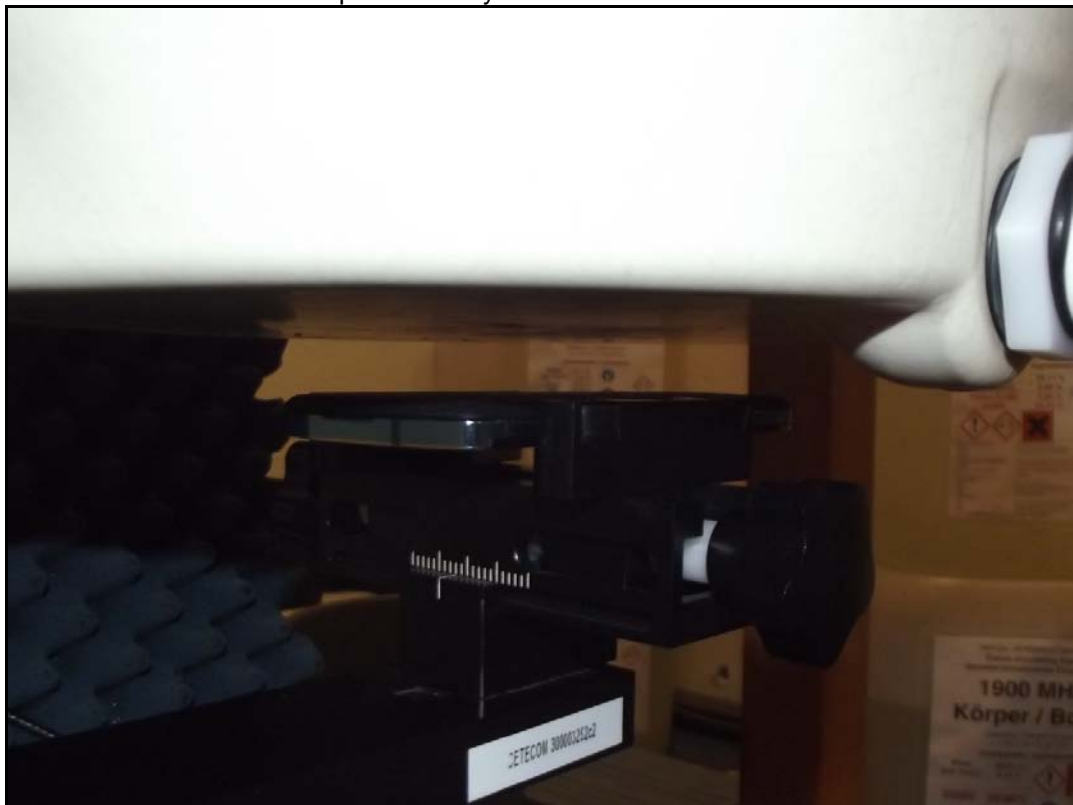
Photo 20: Test position body worn rear side with 15 mm distance

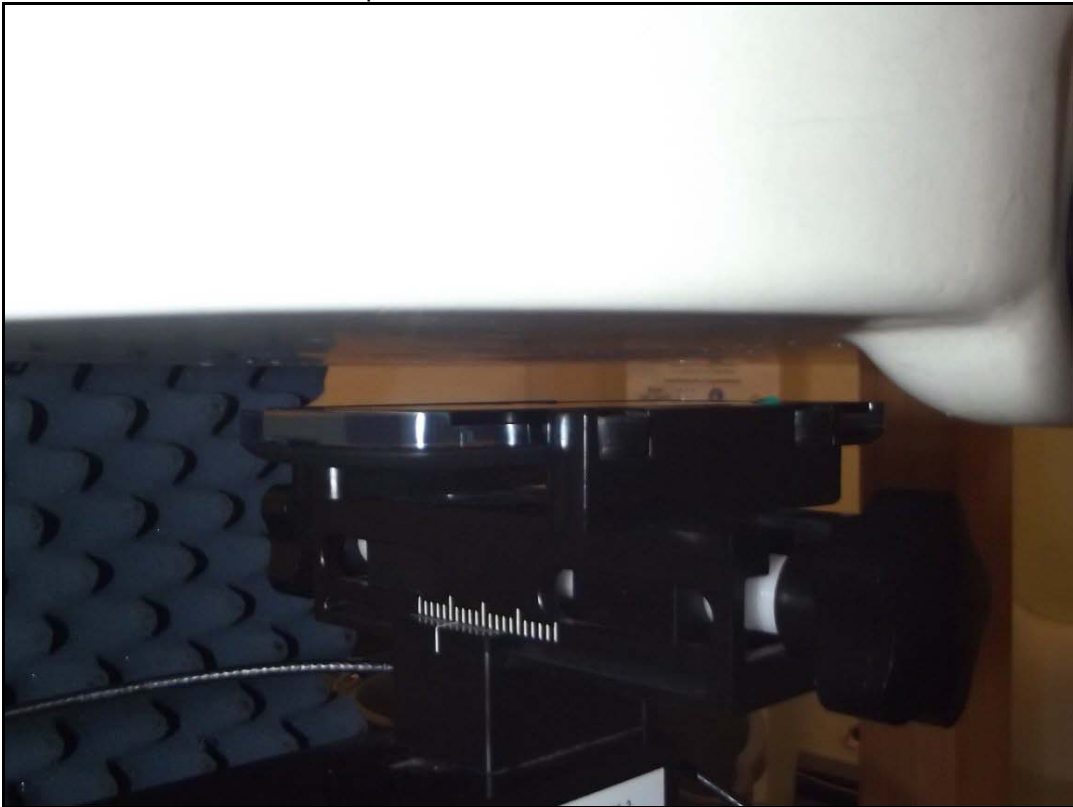
Photo 21: Test position MHS front side with 10 mm distance

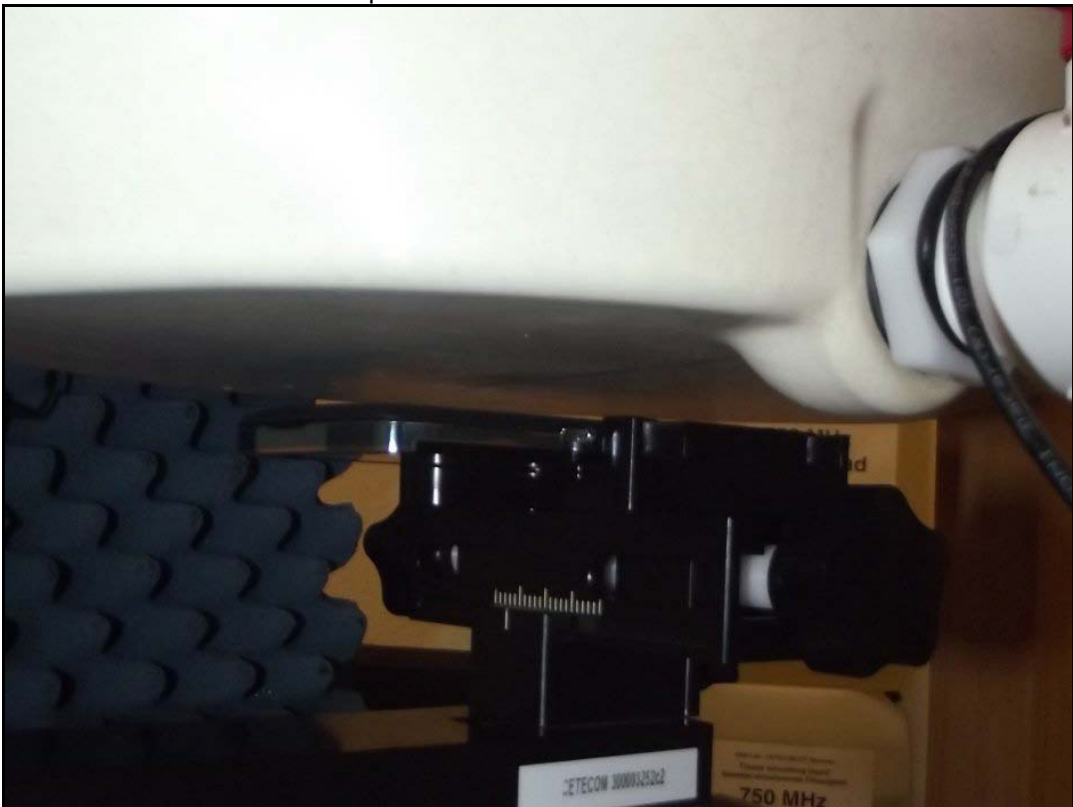
Photo 22: Test position MHS rear side with 10 mm distance

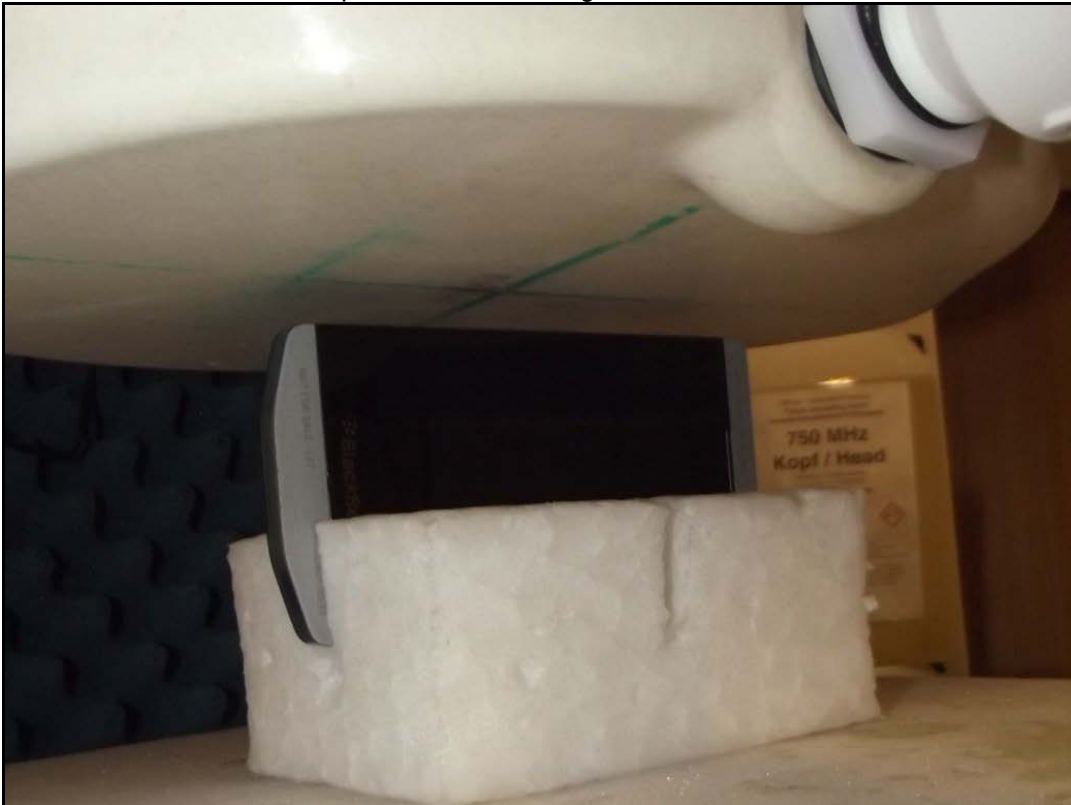
Photo 23: Test position MHS left edge side with 10 mm distance

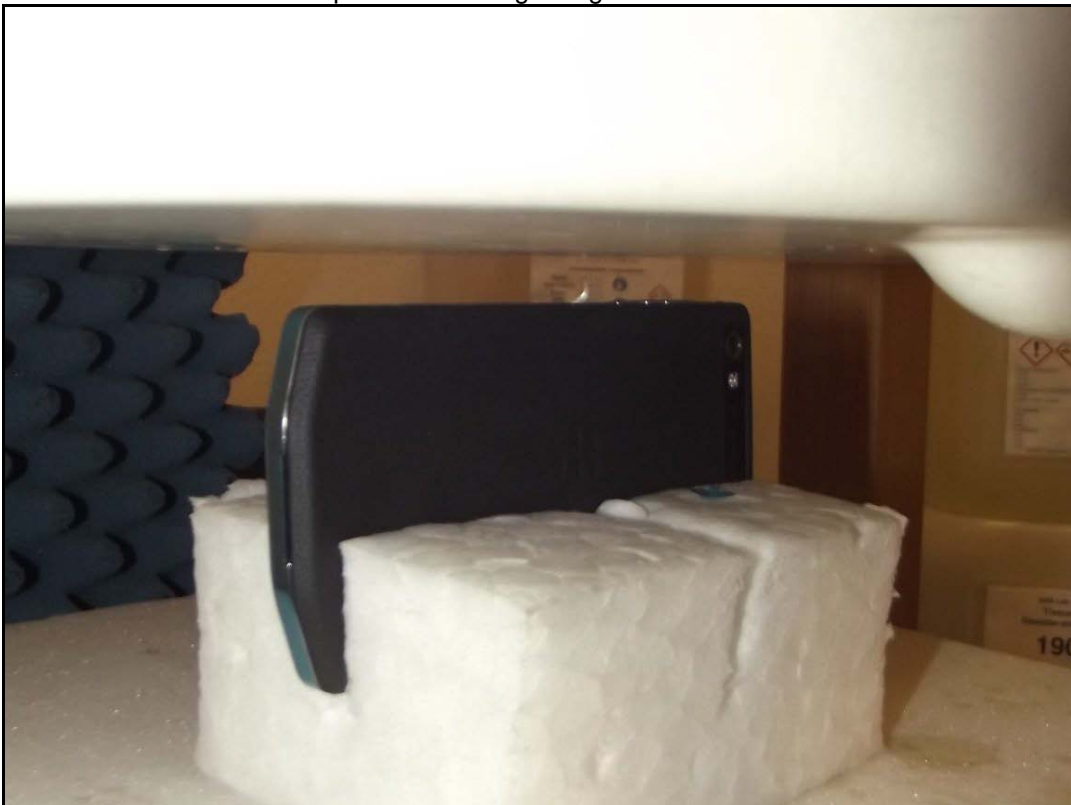
Photo 24: Test position MHS right edge side with 10 mm distance

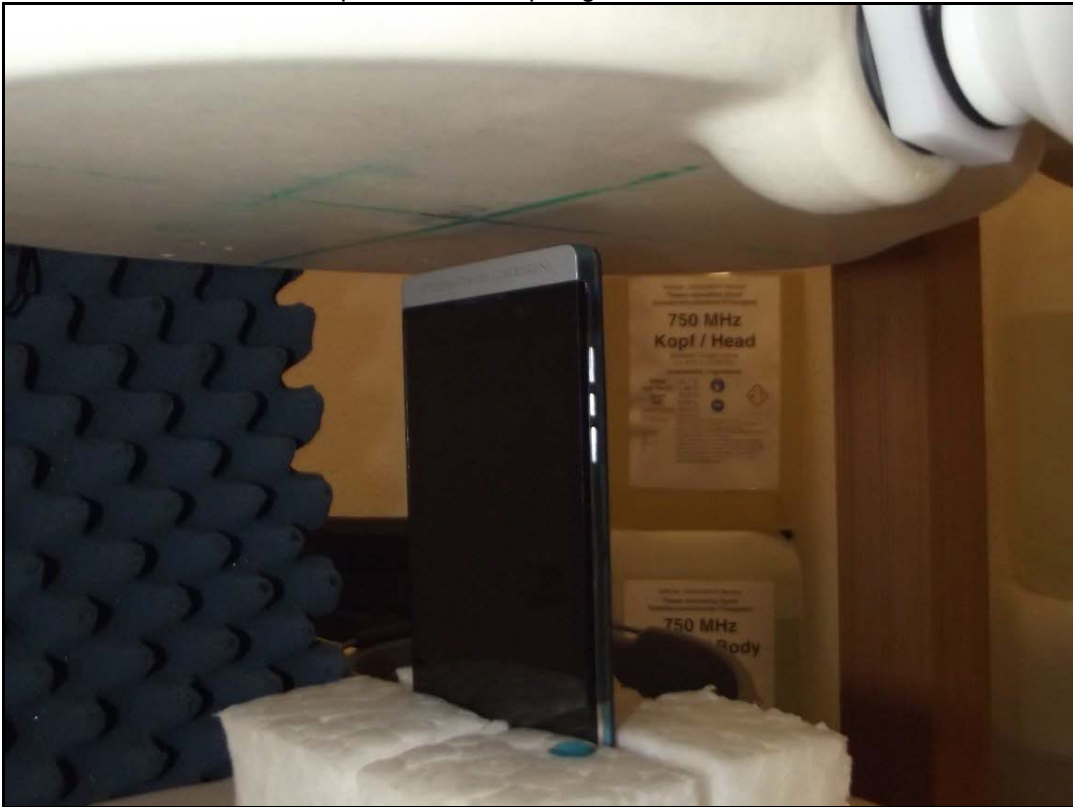
Photo 25: Test position MHS top edge side with 10 mm distance

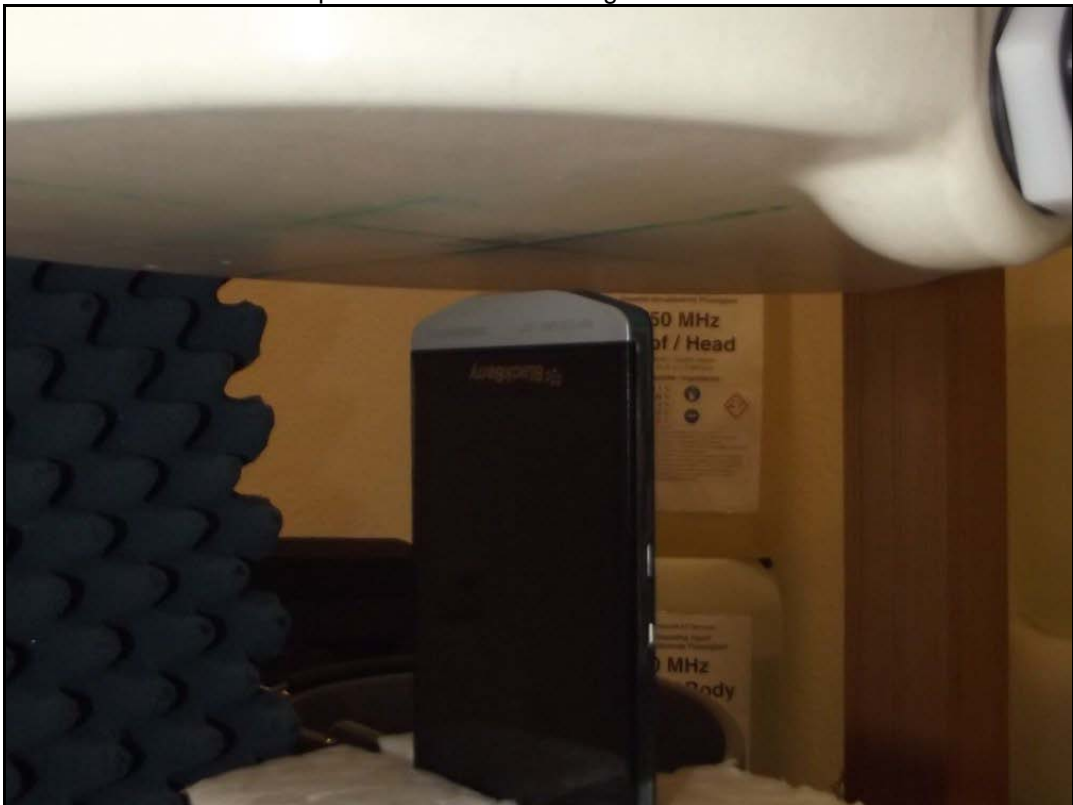
Photo 26: Test position MHS bottom edge side with 10 mm distance
