## INTERTEK TESTING SERVICES

### 3.2 Radiated Emission Configuration Photograph - Base Unit

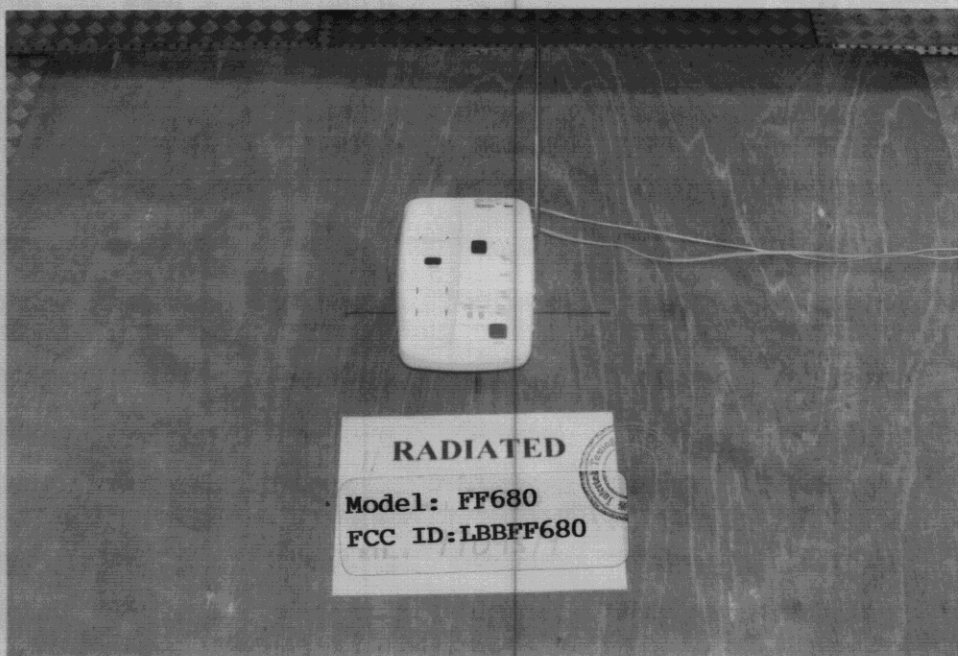
Worst Case Radiated Emission

Front View

at 174.872 MHz

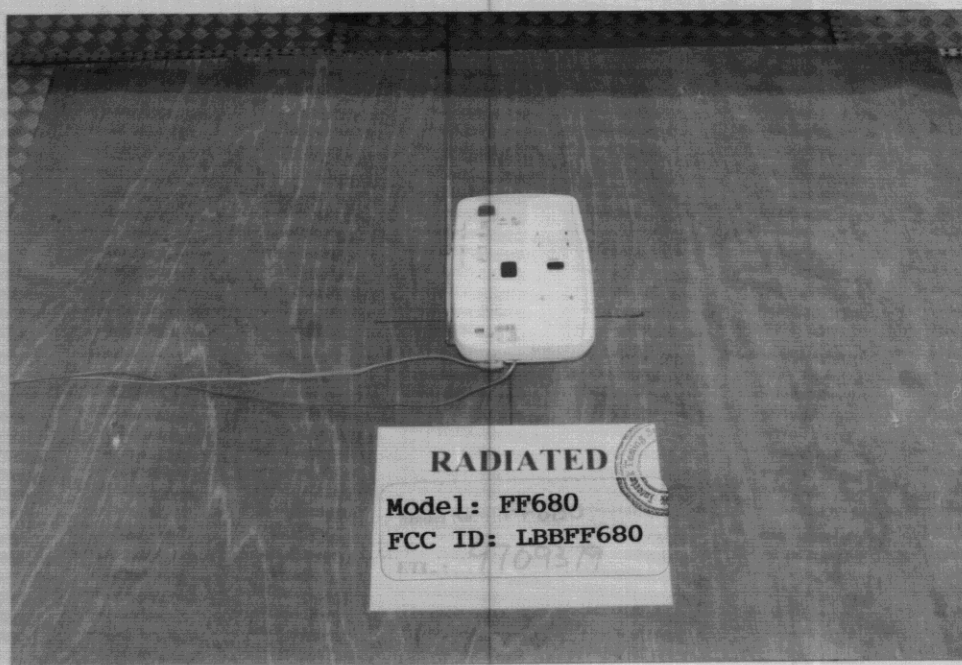
### 3.2 Radiated Emission Configuration Photograph (cont.) - Base Unit

Worst Case Radiated Emission

Rear View

at 174.872 MHz

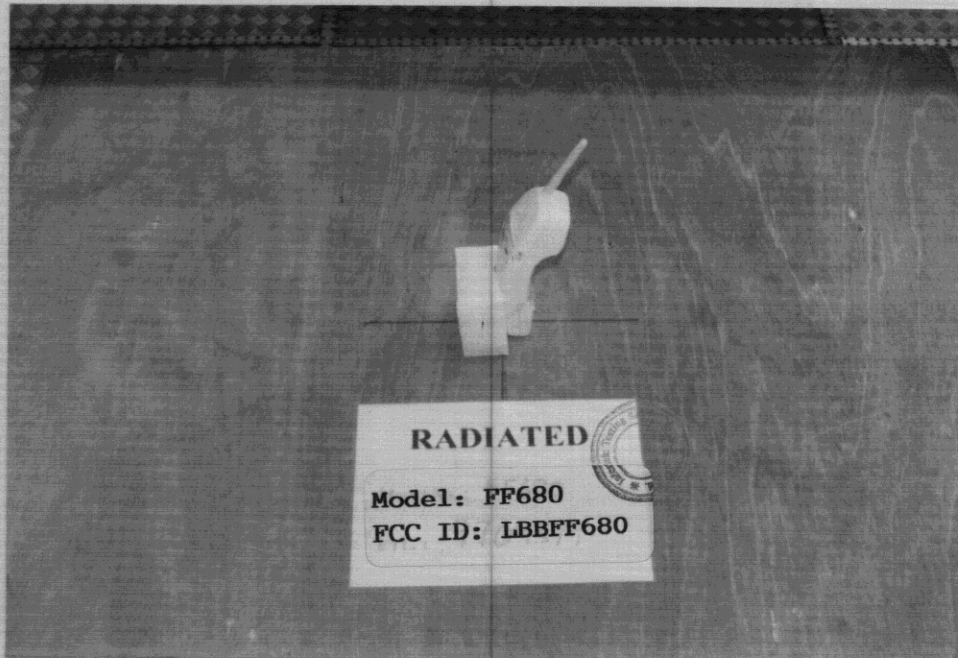
### 3.4 Radiated Emission Configuration Photograph - Handset

Worst Case Radiated Emission

Front View

at 49.360 MHz

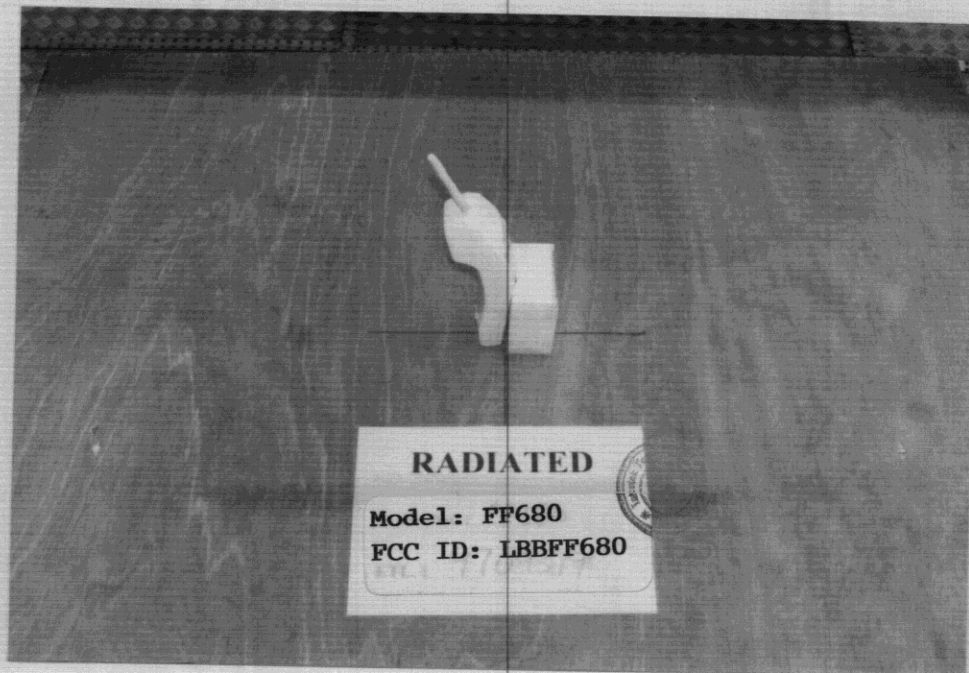
### 3.4 Radiated Emission Configuration Photograph (cont.) - Handset

Worst Case Radiated Emission

Rear View

at 49.360 MHz

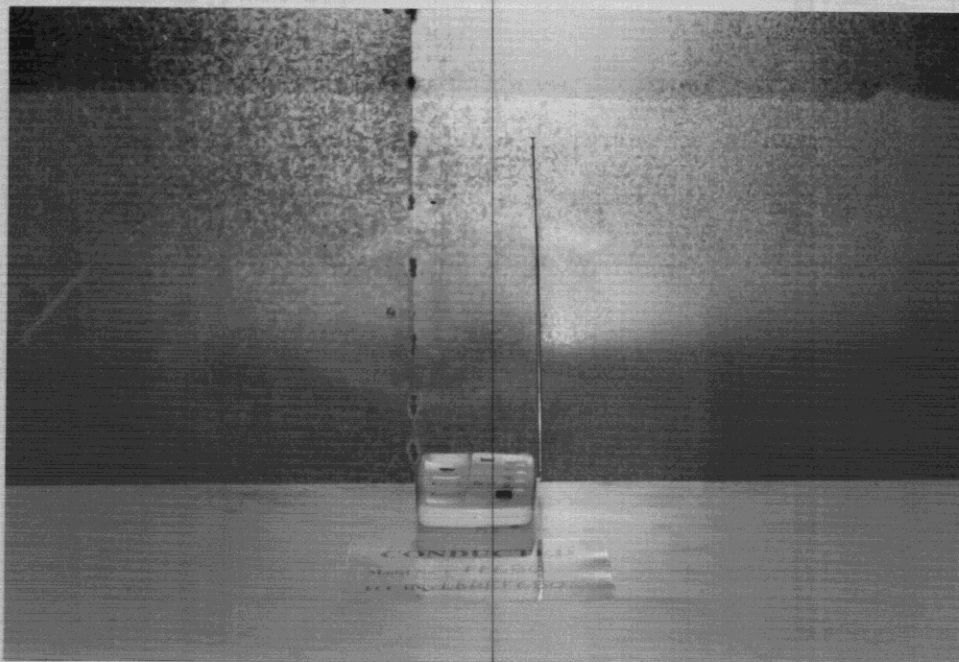
### 3.6 Line Conducted Configuration Photograph - Base Unit

#### Worst Case Line-Conducted Configuration

#### Front View

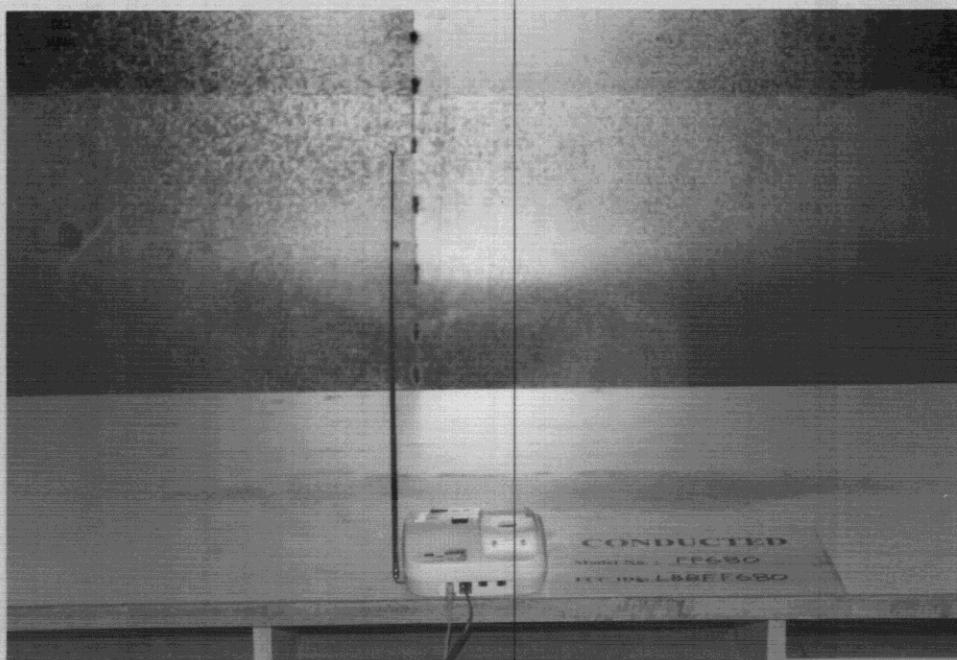
### 3.6 Line Conducted Configuration Photograph (cont.) - Base Unit

#### Worst Case Line-Conducted Configuration

#### Rear View

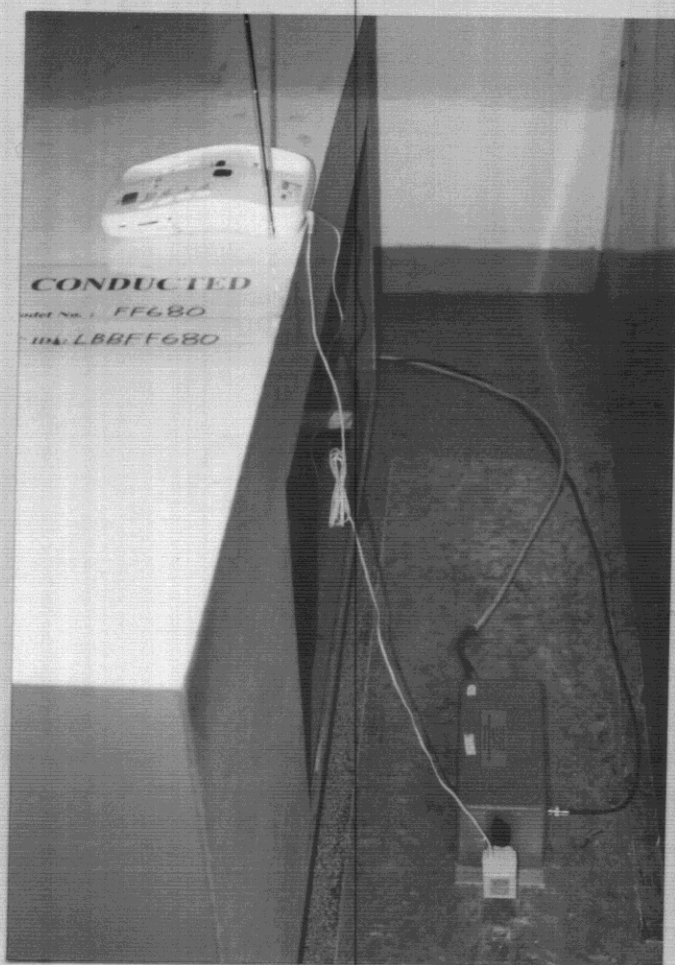
### 3.6 Line Conducted Configuration Photograph (cont.) - Base Unit

#### Worst Case Line-Conducted Configuration

#### Side View
