Report No.: 99023741

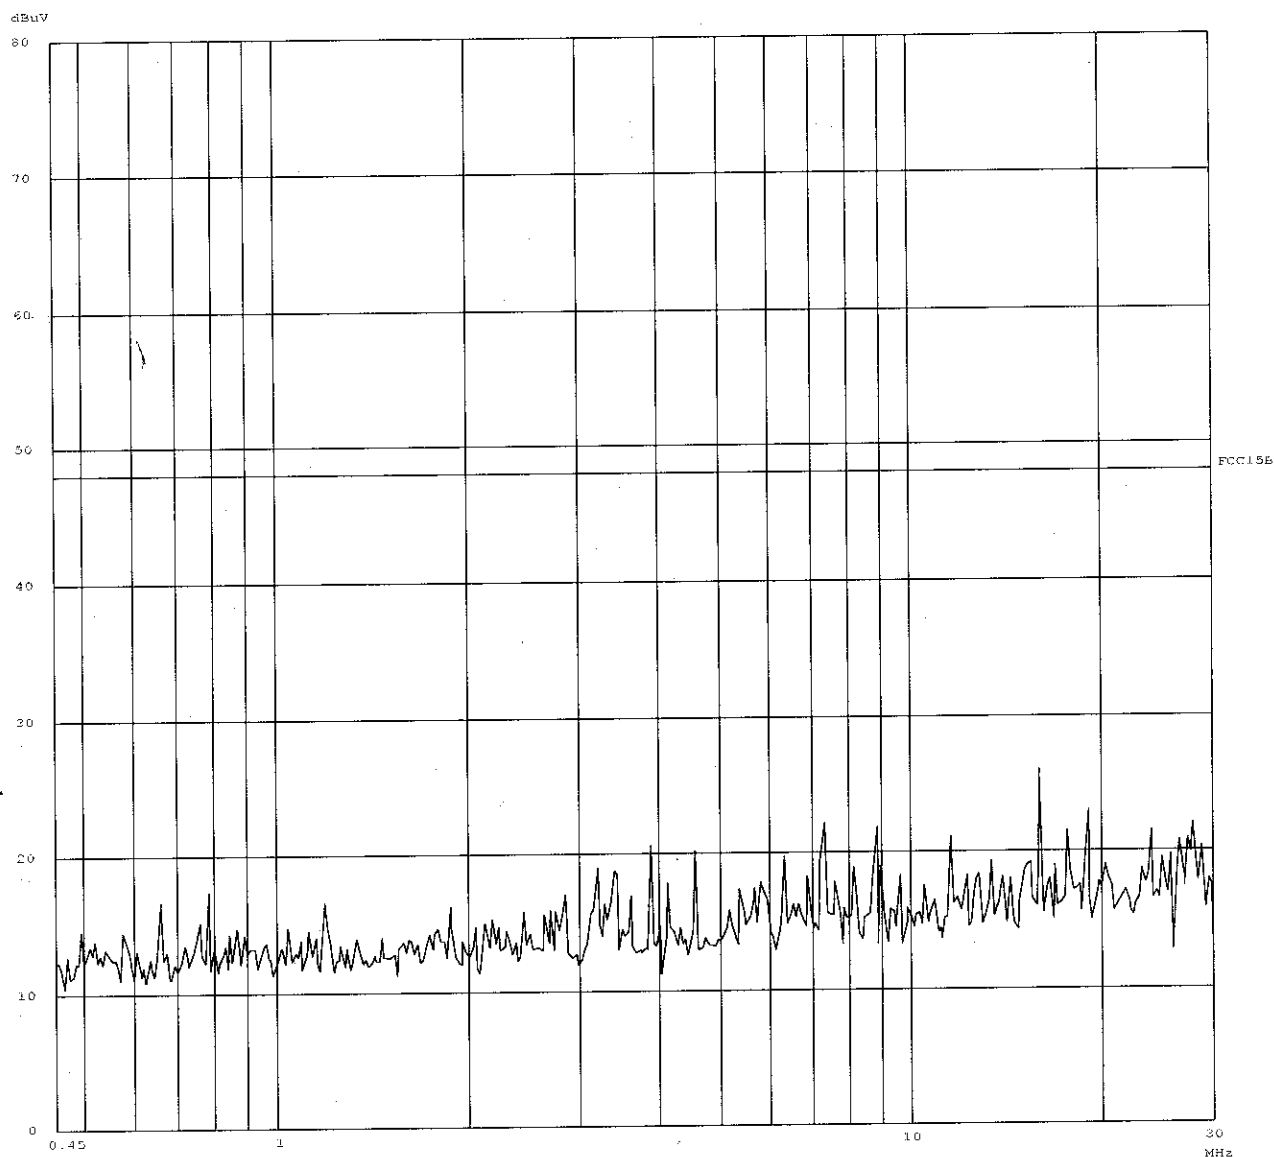
Scan Settings (J Range) |-----| Receiver Settings |-----|

| Start | Stop | Step | IF BW | Detector | M-Time | Atten | Preamp | OpRge |
| 450k | 30M | 5k | 10K | PK | 20ms | AUTO | LN OFF | 60dB |

| Transducer No. | Start | Stop | Name |
| 3 | 9k | 30M | 21078 |

Final Measurement: X QP  
 Meas Time: 1 s  
 Subranges: 16  
 Acc Margin: 20dB
