## Setup photos for HAC RF Emissions Test Report

| Test report no.: | HAC_Photo_RX-51_02 | Date of report: | 2010-04-22 |
| Tested devices: | RM-51 (Hearing aid mode active) | | |
| Testing has been carried out in accordance with: | <b>ANSI C63.19-2007</b><br>American National Standard for Methods of Measurement of Compatibility between Wireless Communications Devices and Hearing Aids | | |

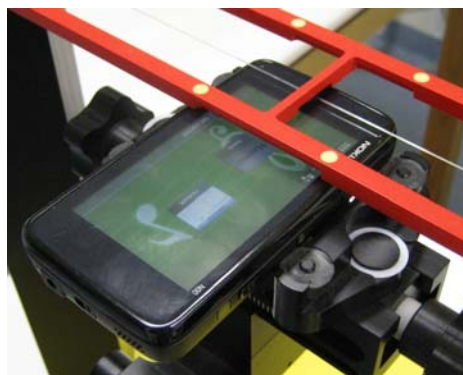
The device was positioned such that Device Reference plane was touching the bottom of the Test Arch. The scan is centered at the acoustic output by aligning the acoustic output with the intersection of the Test Arch's middle bar and dielectric wire.

Photo of the device positioned under Test Arch
