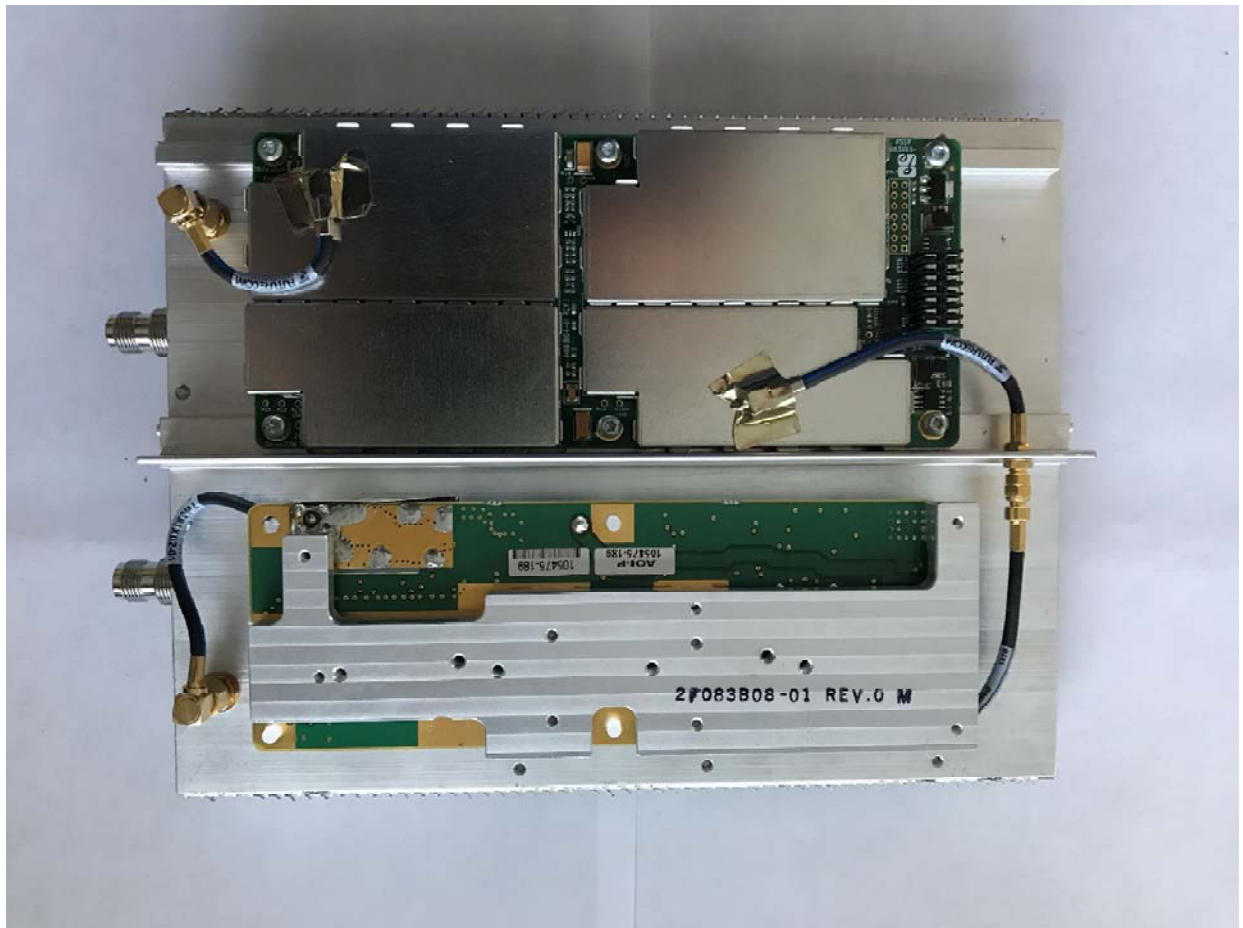
Finger stock was added on both long partition edges.

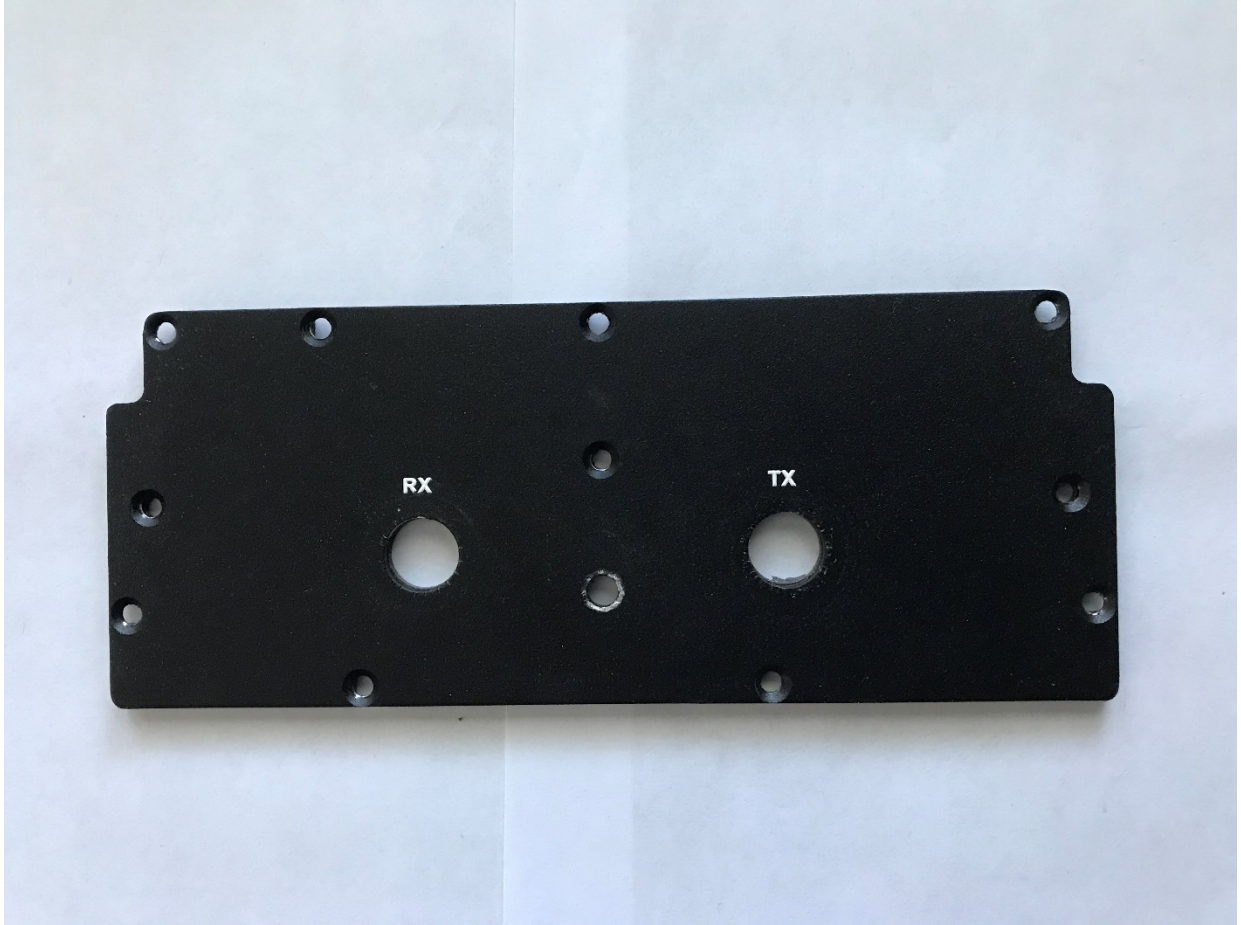
The cover is 4mm larger and the upper corner screws were added

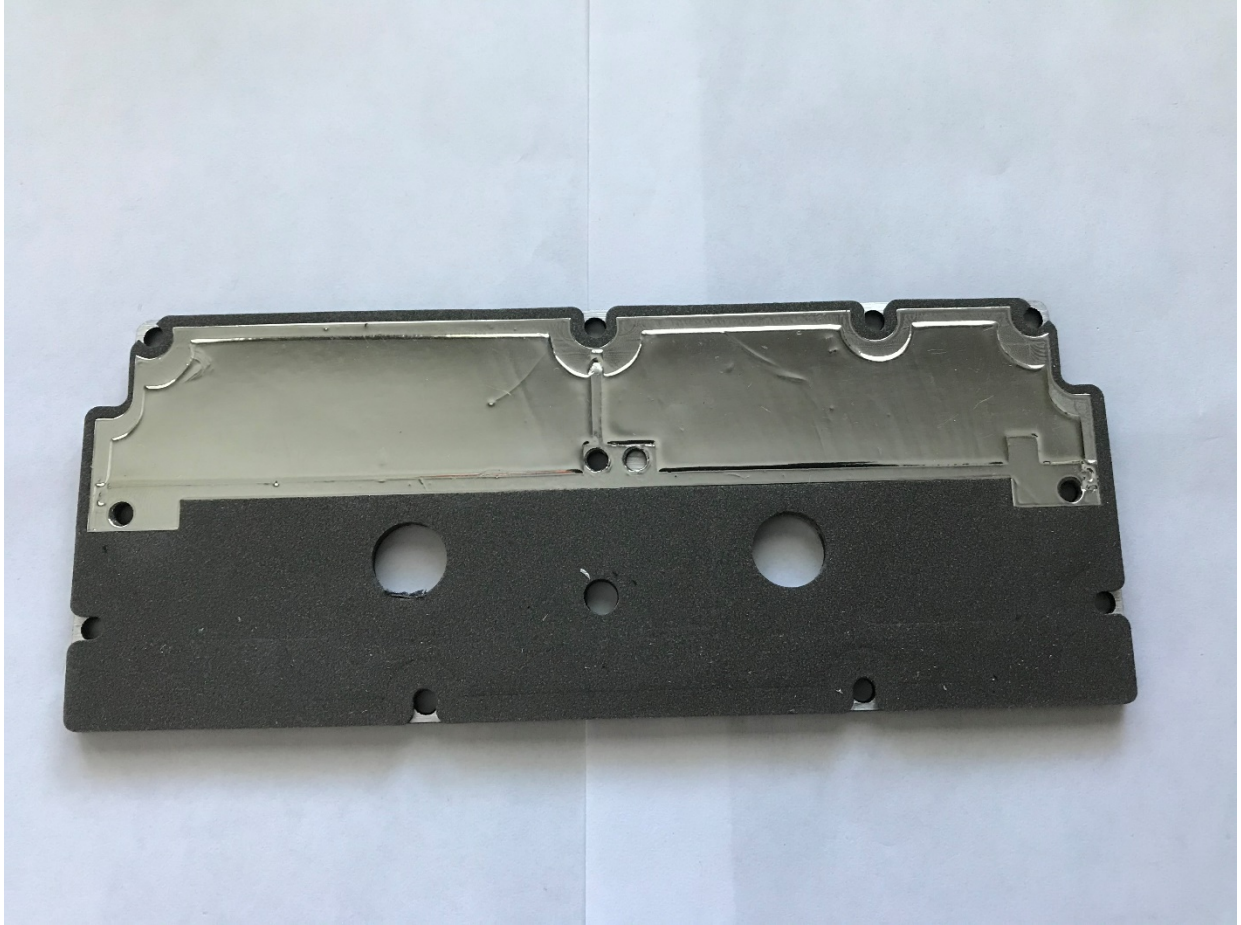
Foil was added on the EMI gasket

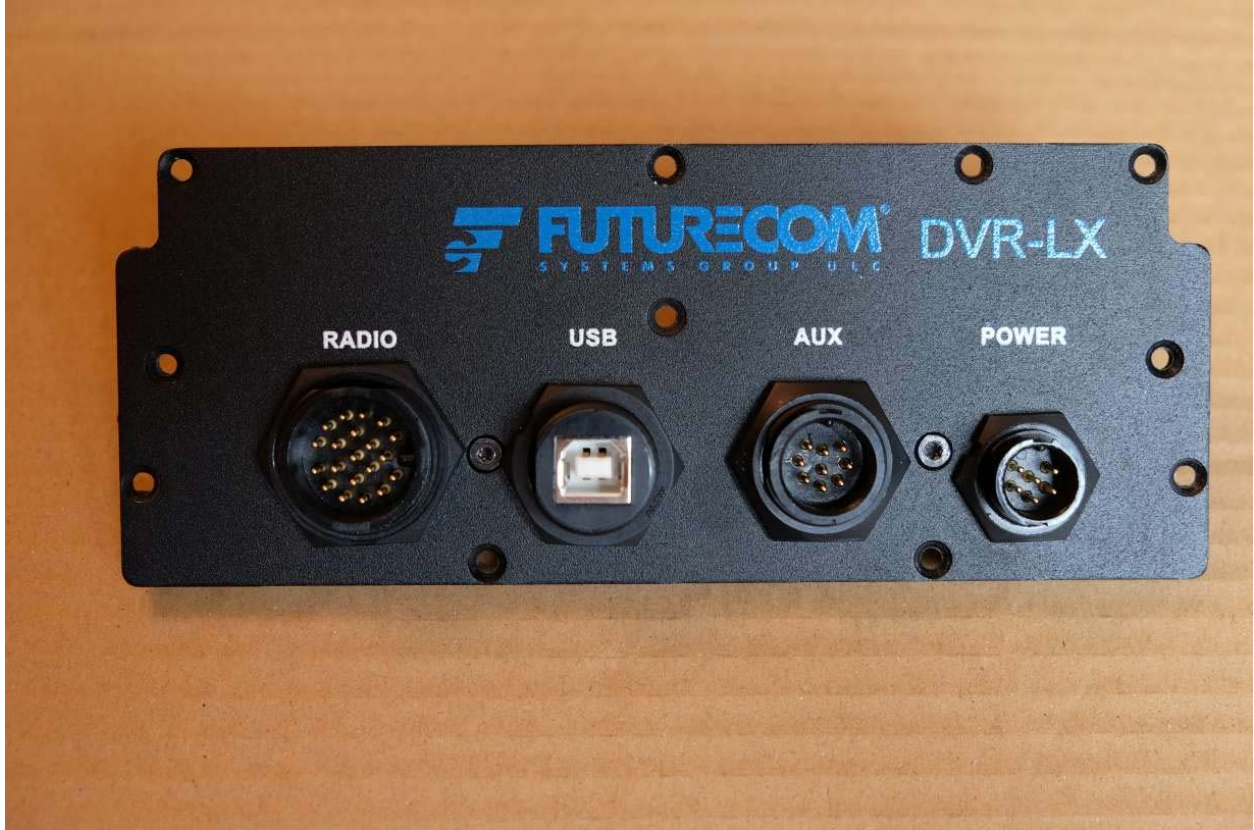
The cover is 4mm larger and screws were added in upper corners.
