ANNEX 1 - TEST SETUP PHOTOS

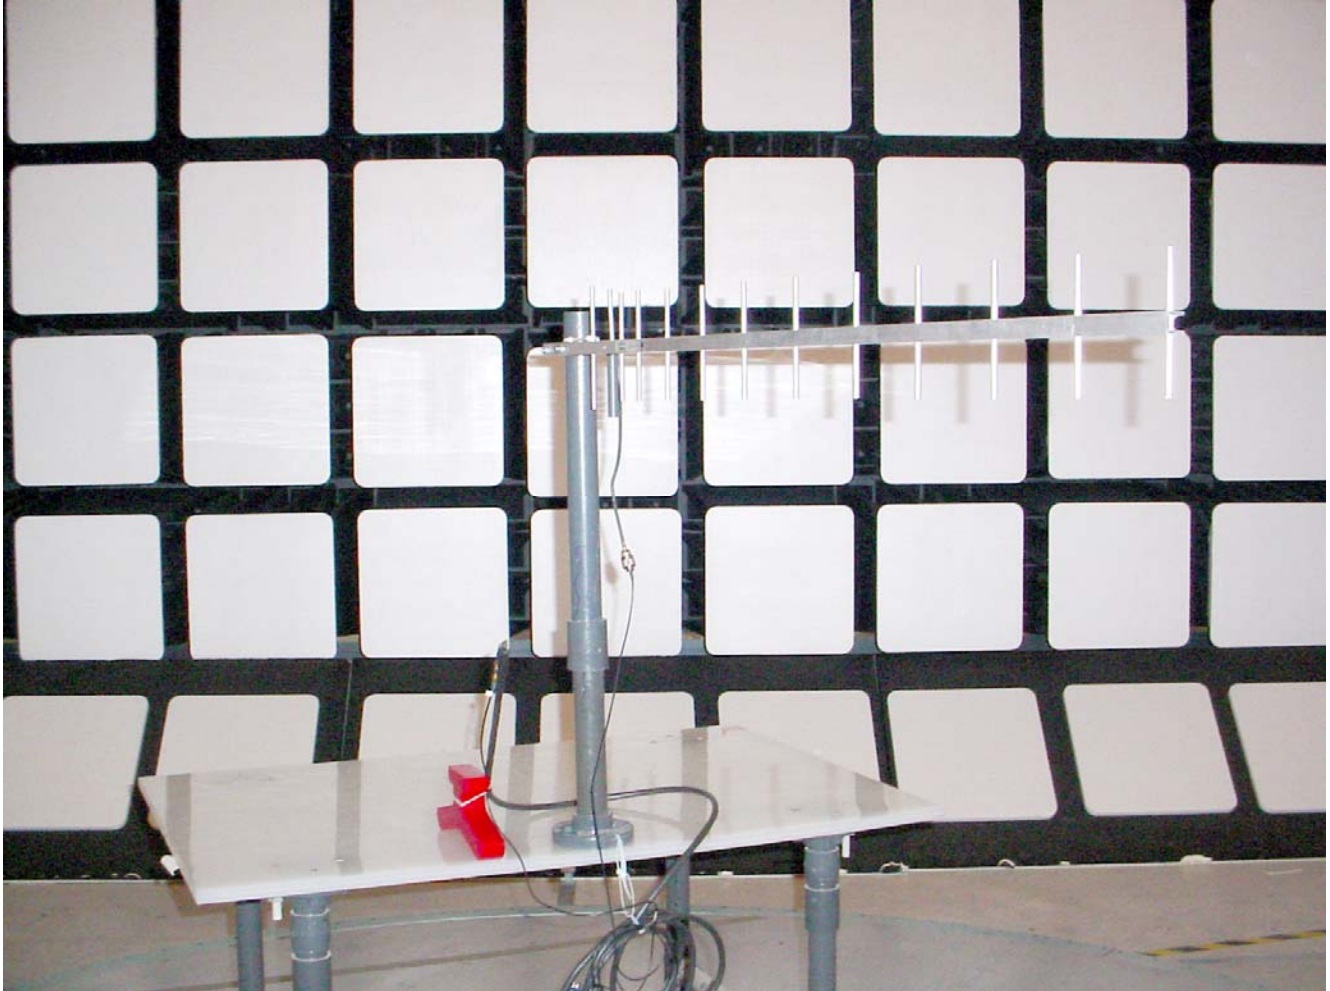
Radiated Emissions @ 3 m
EUT tested with 15.1 dBi Cushcraft Yagi Antenna and 3.35 dB Assembly Cable Loss
EUT Orientation: Orthogonal Position 3
