ANNEX 1 - TEST SETUP PHOTOS

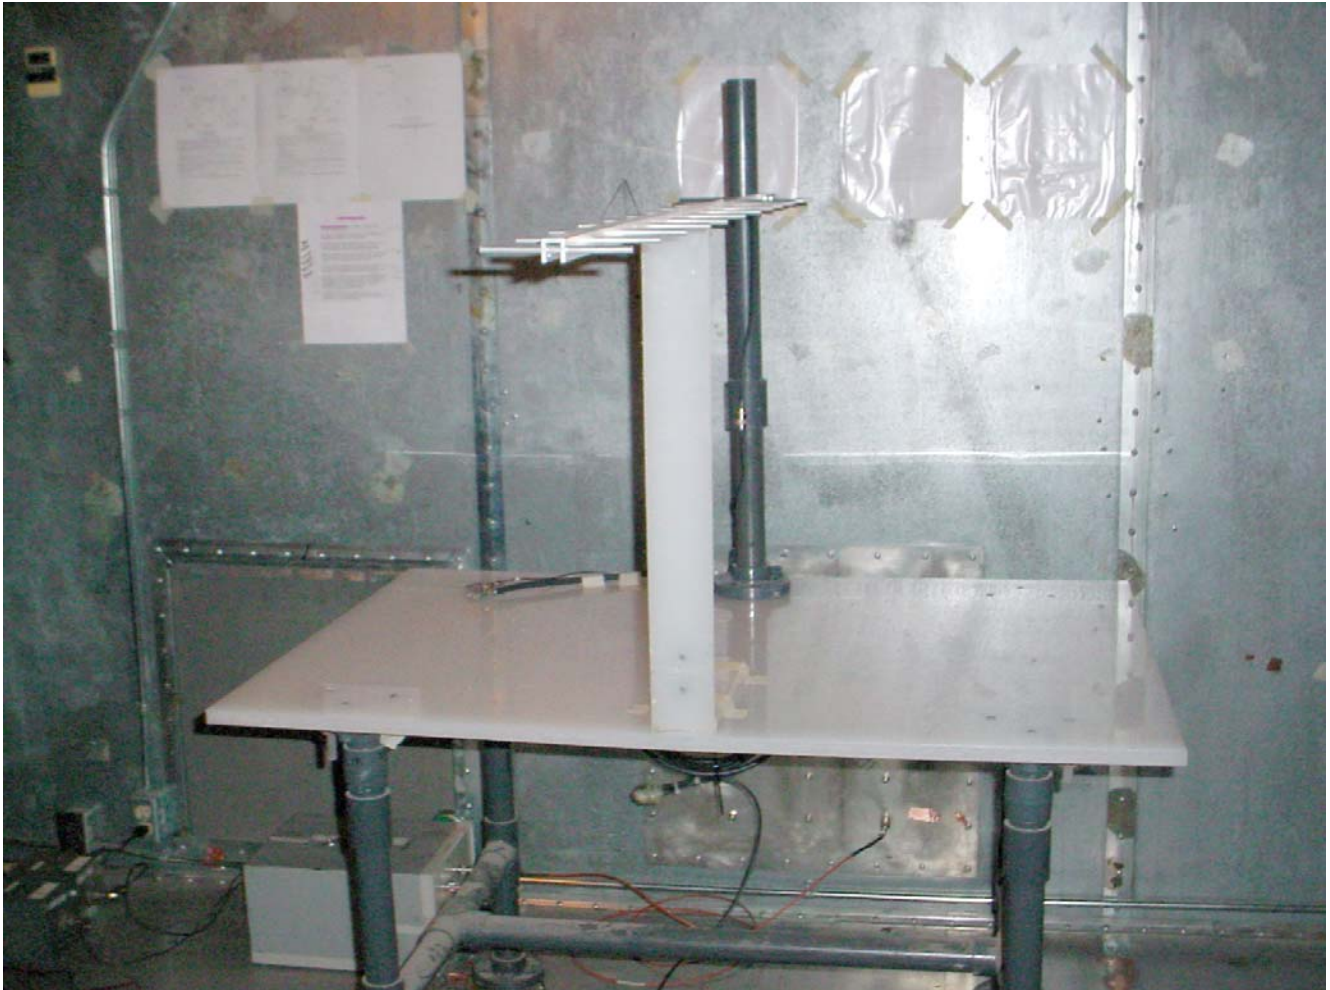
Power Line Conducted Emissions

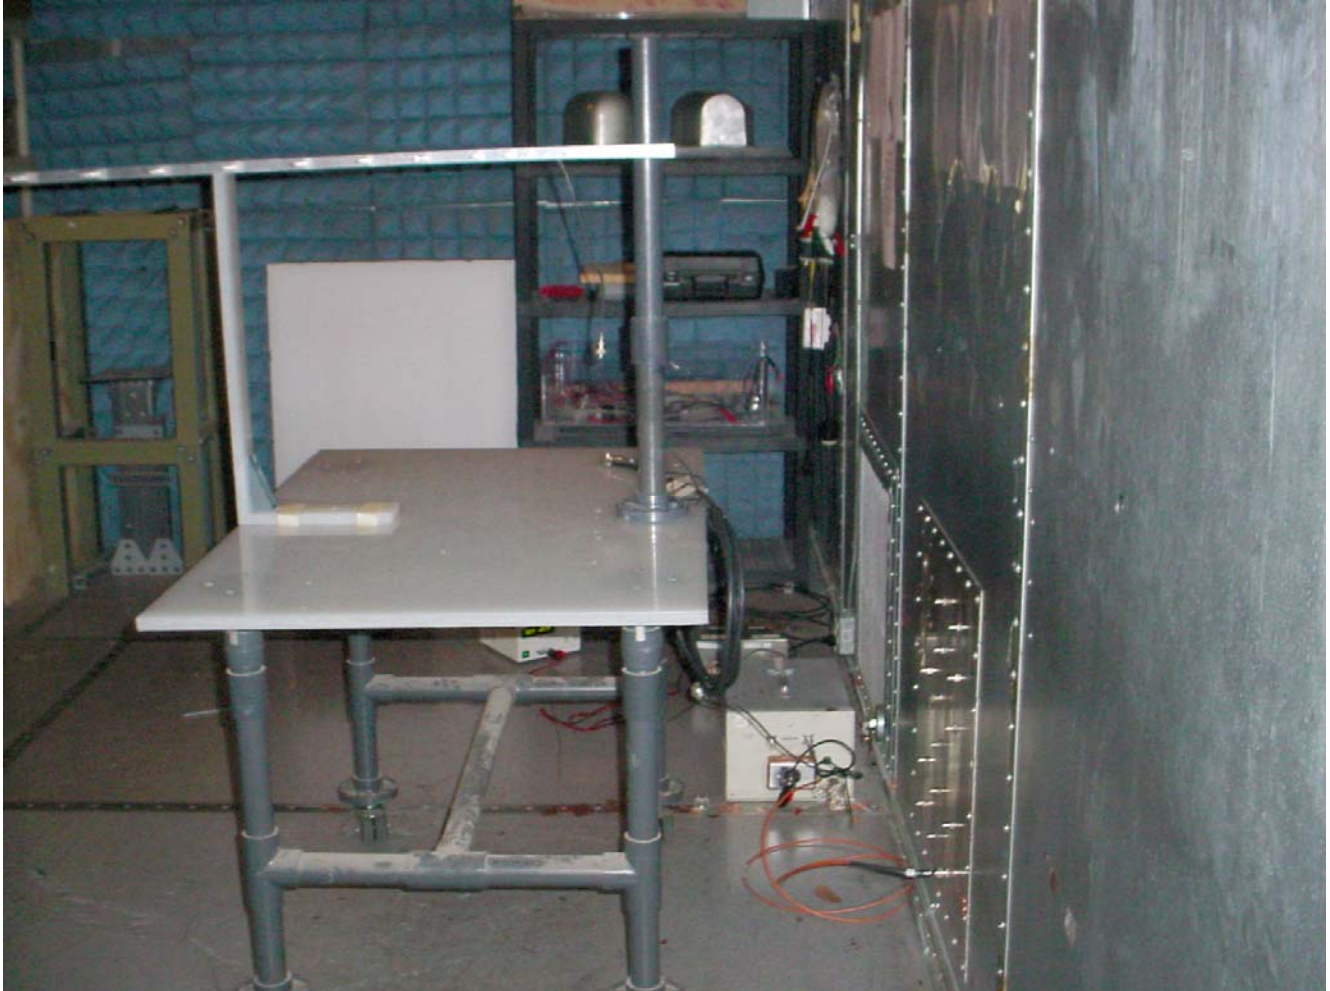
Power Line Conducted Emissions

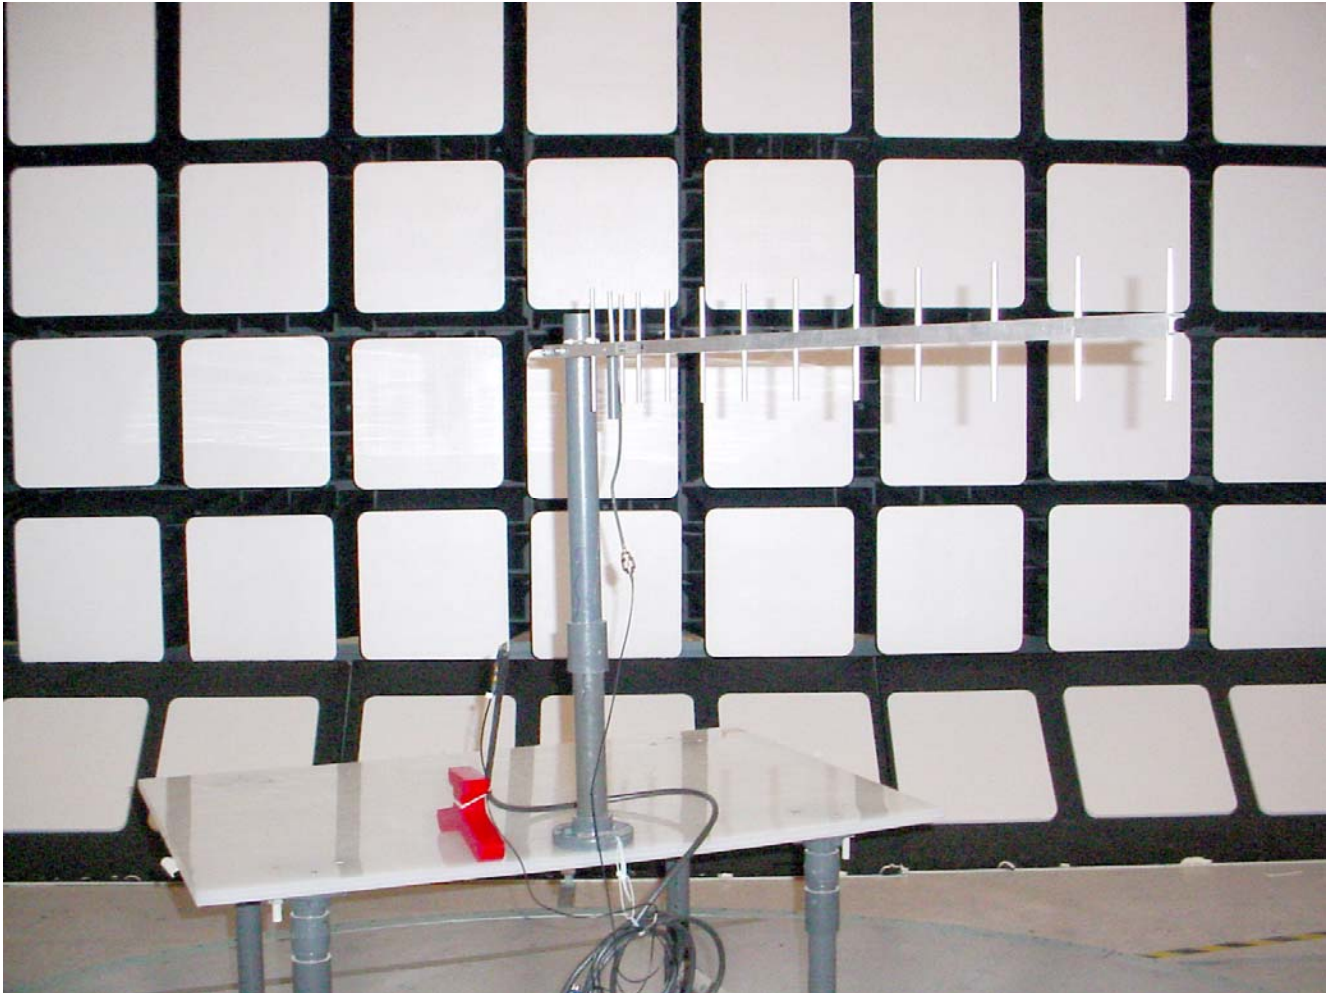
Radiated Emissions @ 3 m
EUT tested with 15.1 dBi Cushcraft Yagi Antenna and 3.35 dB Assembly Cable Loss
EUT Orientation: Orthogonal Position 3
