Report No.: 0319352  
Tx Mode  
Unit A, Channel I

Report No.: 0319352  
Tx Mode  
Unit C, Channel I

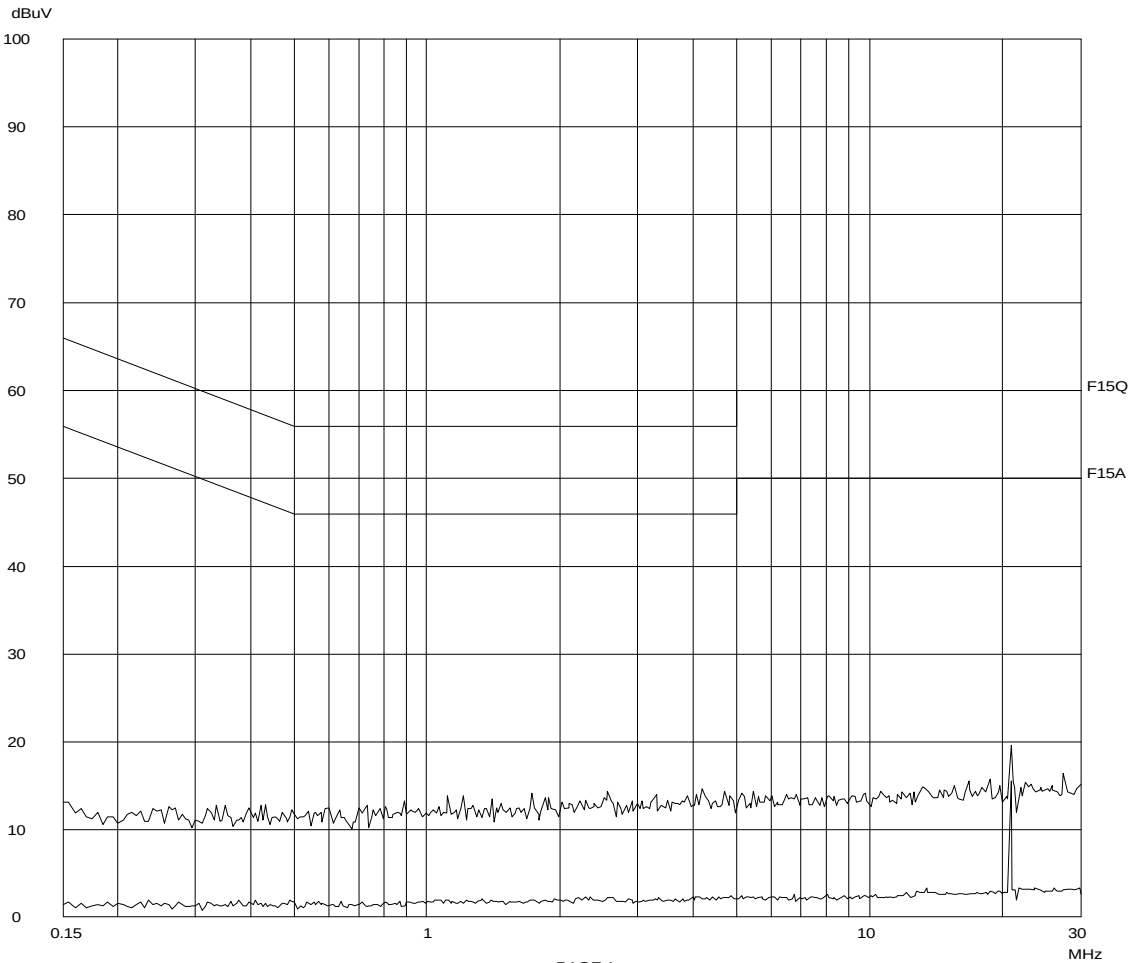
Scan Settings (1 Range)

| Frequencies | | | | Receiver Settings | | | | |
|---|---|---|---|---|---|---|---|---|
| 150k | 30M | 5k | 10k | PK+AV | 10ms | AUTO | LN OFF | 60dB |

Final Measurement: x QP / + AV

Meas Time: 1 s  
Subranges: 16  
Acc Margin: 20dB

Final Measurement Results:

no Results

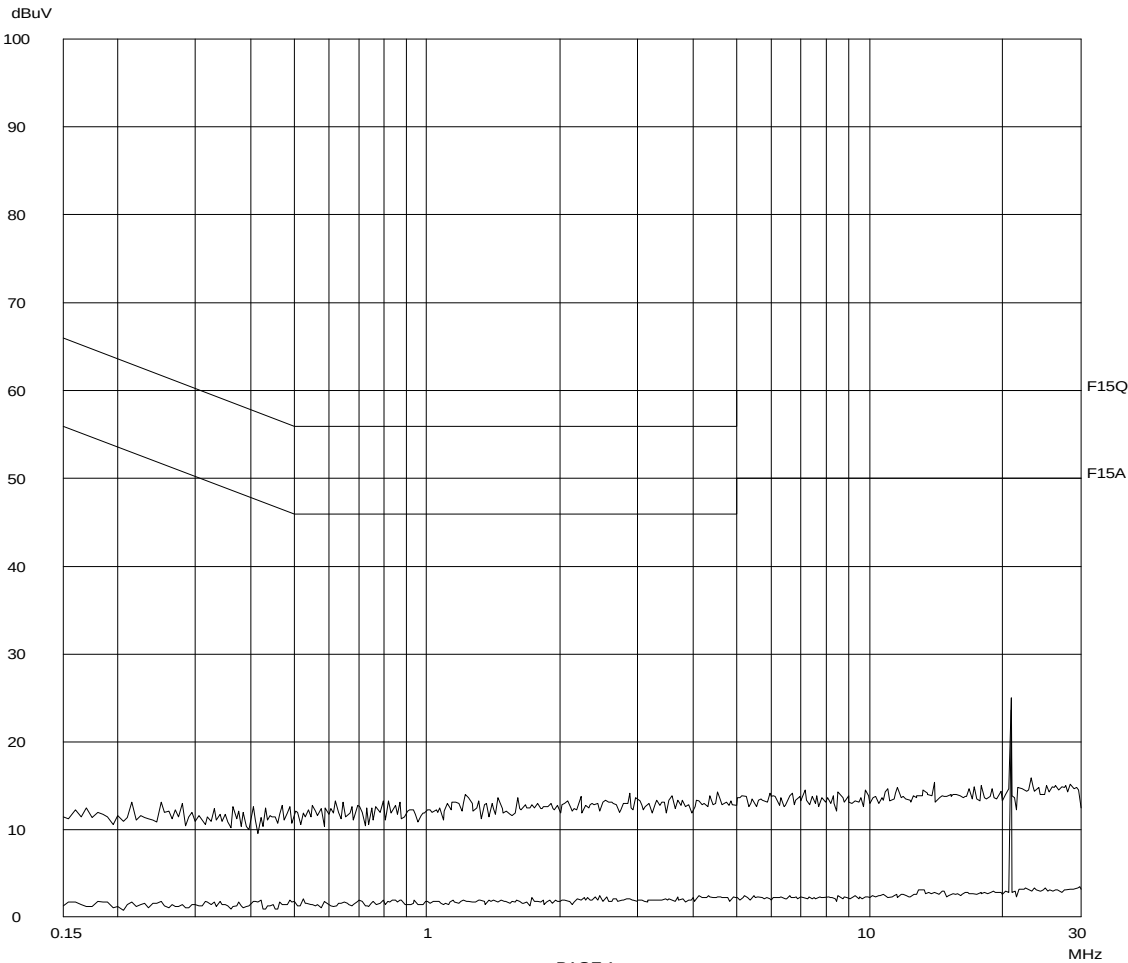
Scan Settings (1 Range)

| Frequencies | | | | Receiver Settings | | | | |
|---|---|---|---|---|---|---|---|---|
| 150k | 30M | 5k | 10k | PK+AV | 10ms | AUTO | LN OFF | 60dB |

Final Measurement: x QP / + AV

Meas Time: 1 s  
Subranges: 16  
Acc Margin: 20dB

Final Measurement Results:

no Results
