APPENDIX 3: Photographs of test setup

Radiated emission

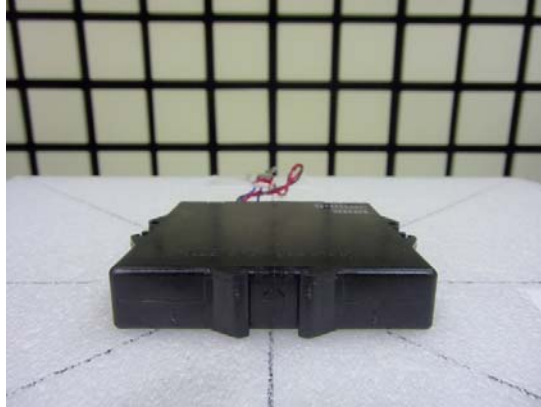
Worst case position

Below 1GHz (Horizontal: X-axis / Vertical: Y-axis)

Above 1GHz (Horizontal: X-axis / Vertical: Z-axis)
