APPENDIX 3: Photographs of test setup

Radiated emission

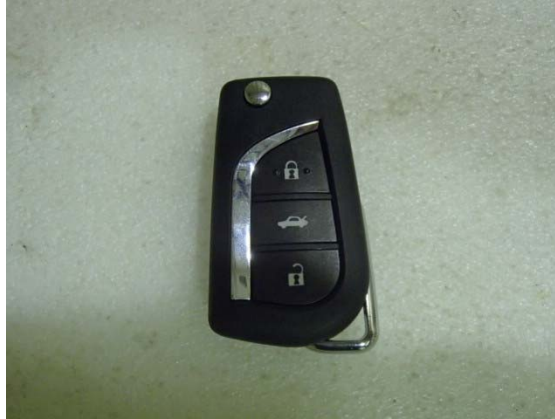
Worst case position

Below 1 GHz (Horizontal: X-axis / Vertical: Y-axis)

Above 1 GHz (Horizontal: X-axis / Vertical: Y-axis)

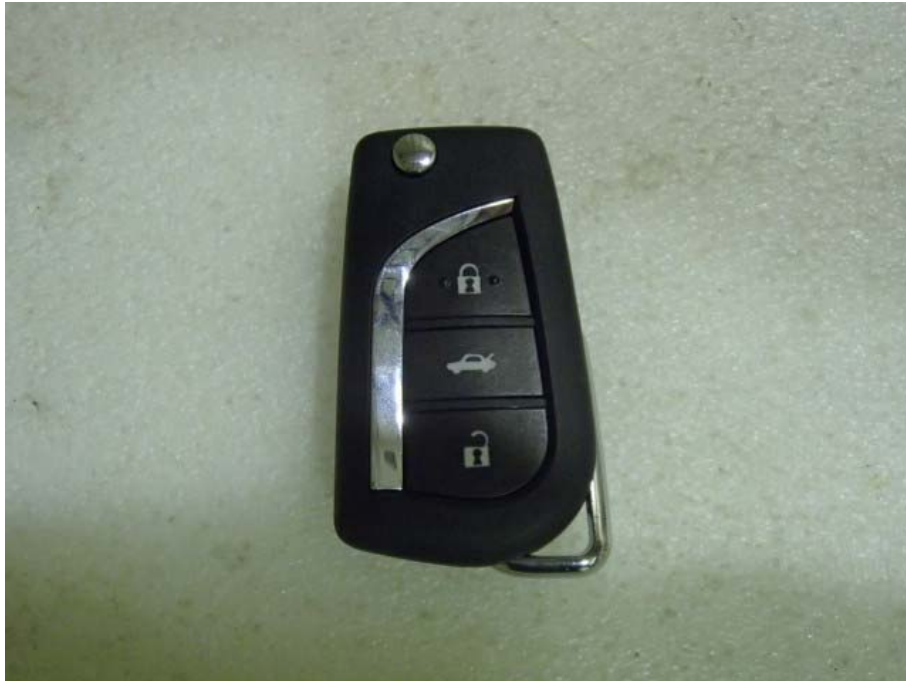
Worst case position

Mechanical Key (folded in) Worst (Above 1 GHz)

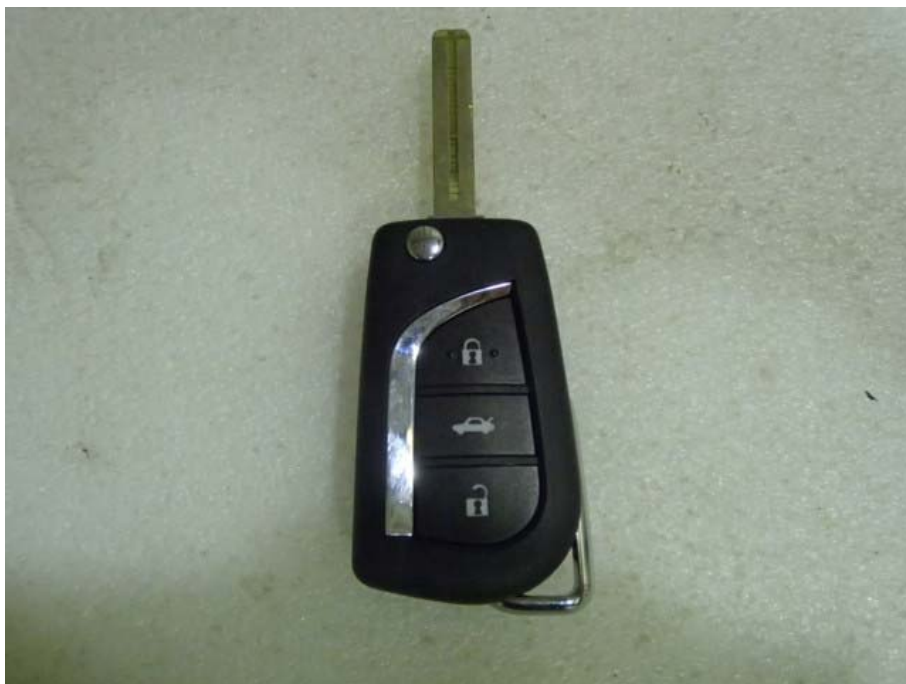
Mechanical Key (folded out) Worst (Below 1 GHz)
