APPENDIX 3: Photographs of test setup

Radiated emission

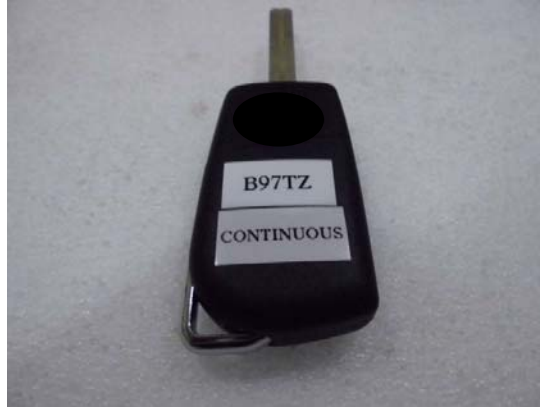
Worst case position

Below 1GHz (Horizontal: X-axis / Vertical: Y-axis)

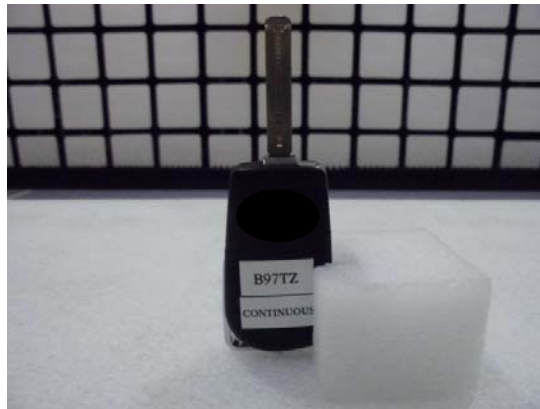
Y-axis

Above 1GHz (Horizontal: Z-axis / Vertical: Y-axis)

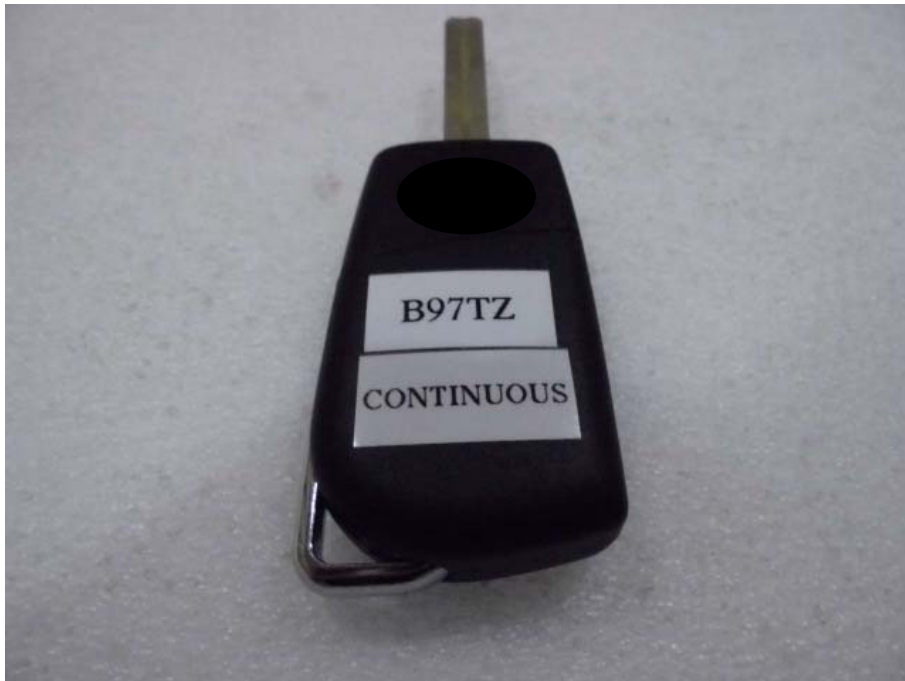
Worst case position

Mechanical Key (Not Inserted) Worst

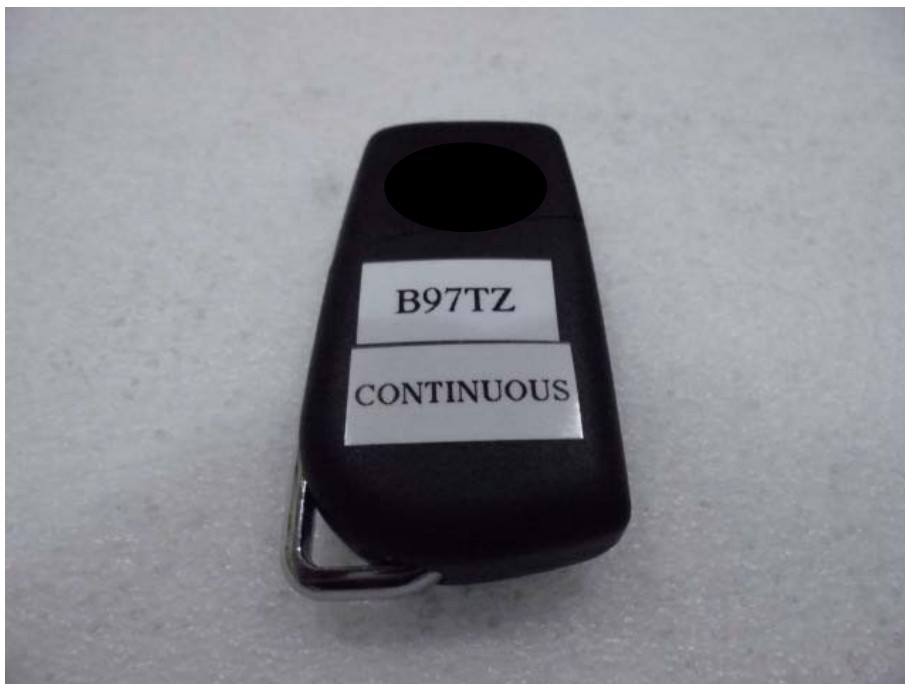
Mechanical Key (Inserted)
