APPENDIX 3: Photographs of test setup

Radiated Emission

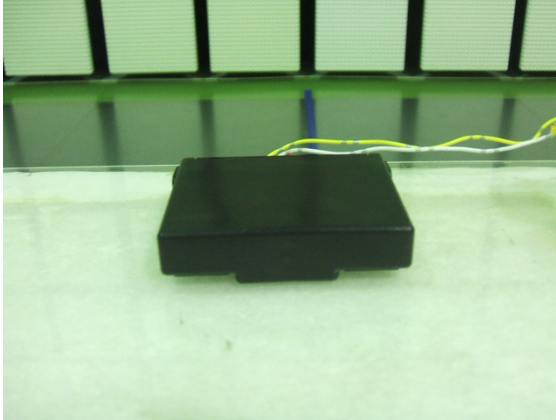
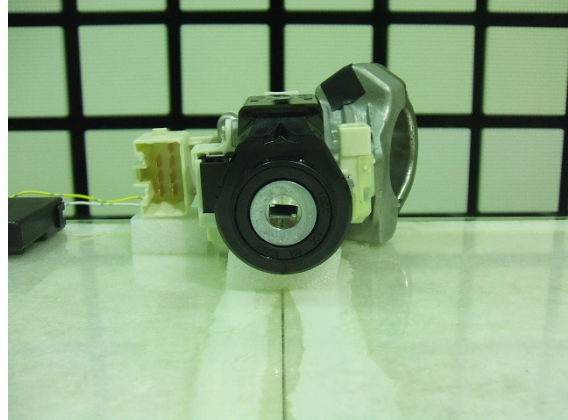
Below 30MHz (Controller: X-axis / Antenna: X-axis)
Above 30MHz (Controller: Horizontal: X-axis, Vertical: X-axis)
Above 30MHz (Antenna: Horizontal: X-axis, Vertical: X-axis)

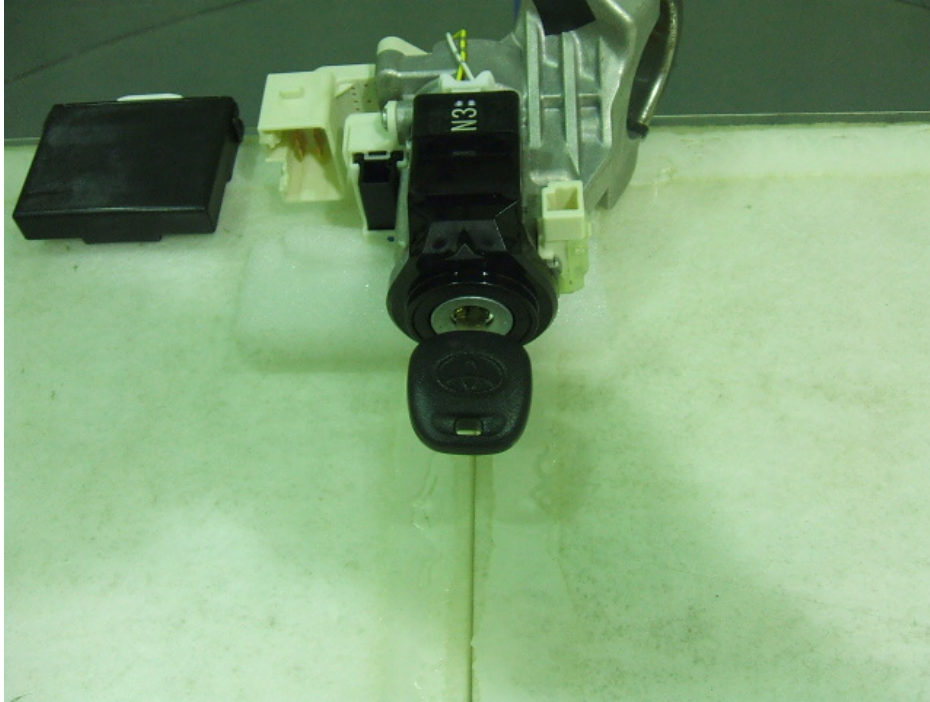
Mechanical Key (Inserted)

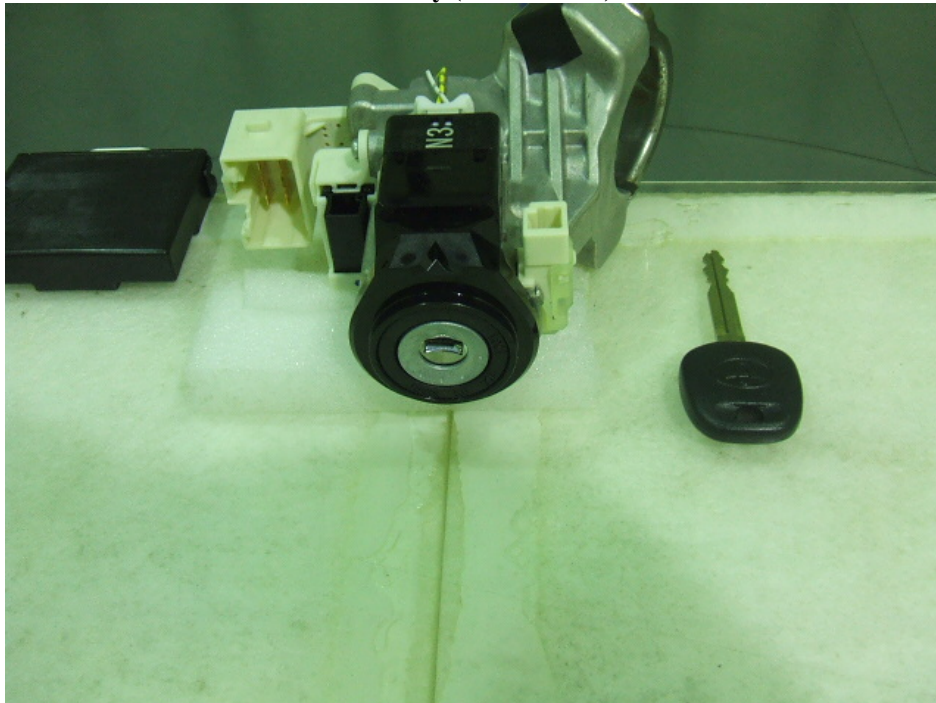
Mechanical Key (Not Inserted) Worst
