APPENDIX 3: Photographs of test setup

Radiated Emission

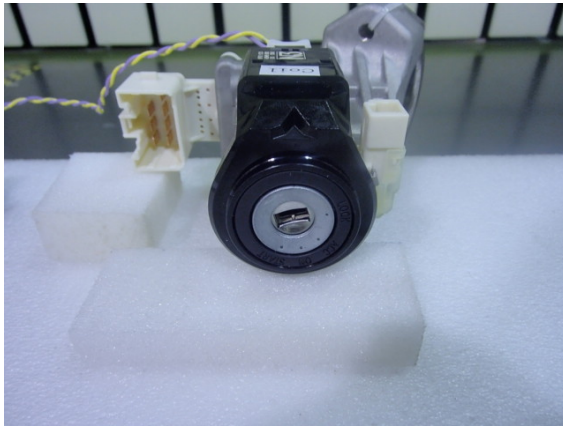
**Antenna
X-axis**

Below 30MHz **Antenna:** **X-axis / ECU: X-axis**
Above 30MHz **Antenna:** **Horizontal: X-axis Vertical: Z-axis**
 ECU: **Horizontal: X-axis Vertical: X-axis**

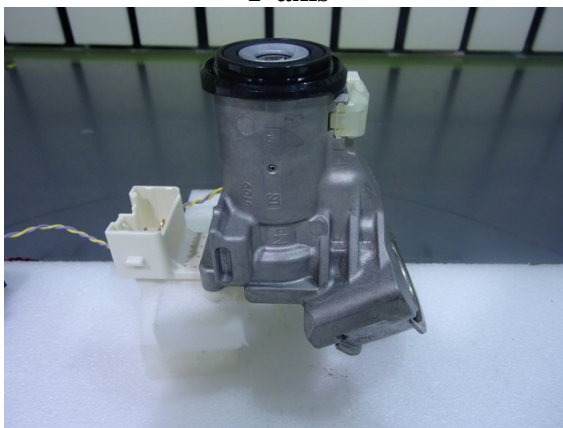
Y-axis

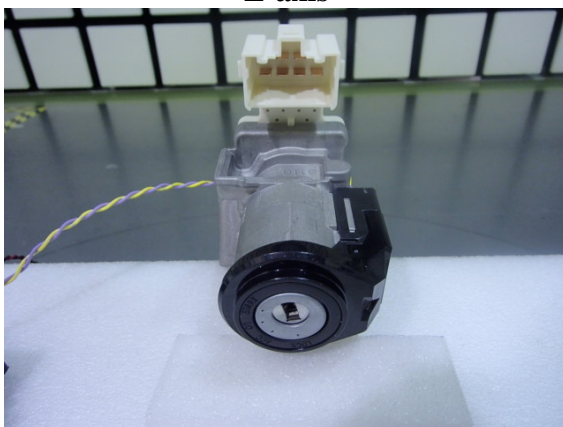
Z-axis

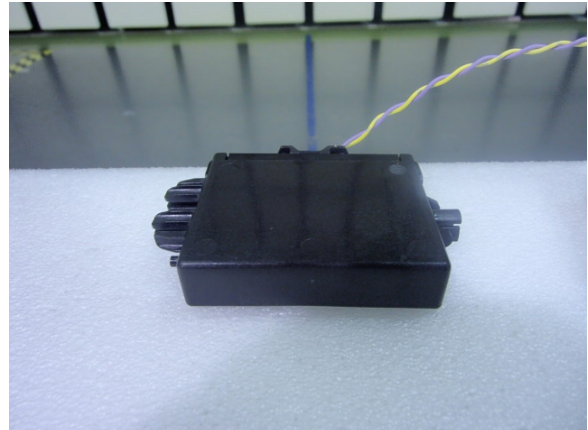
**ECU
X-axis**

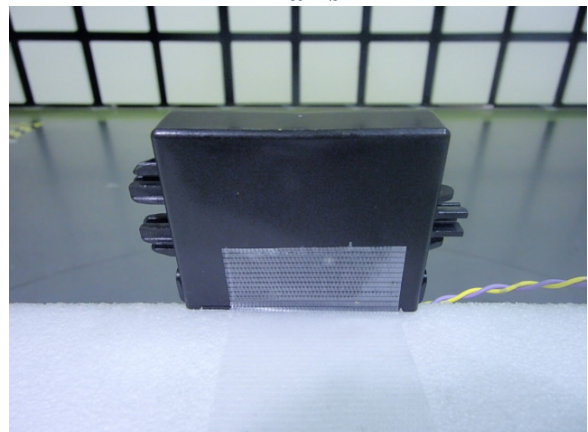
Y-axis

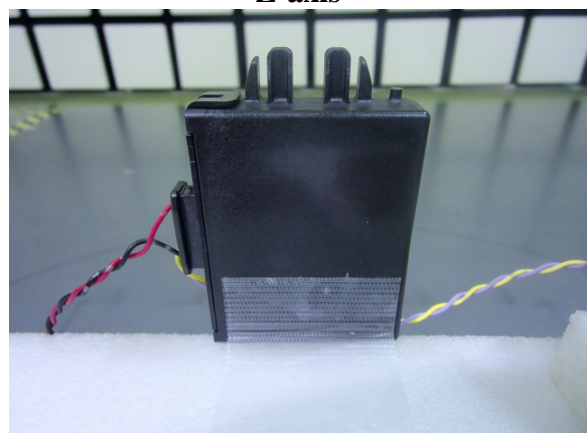
Z-axis

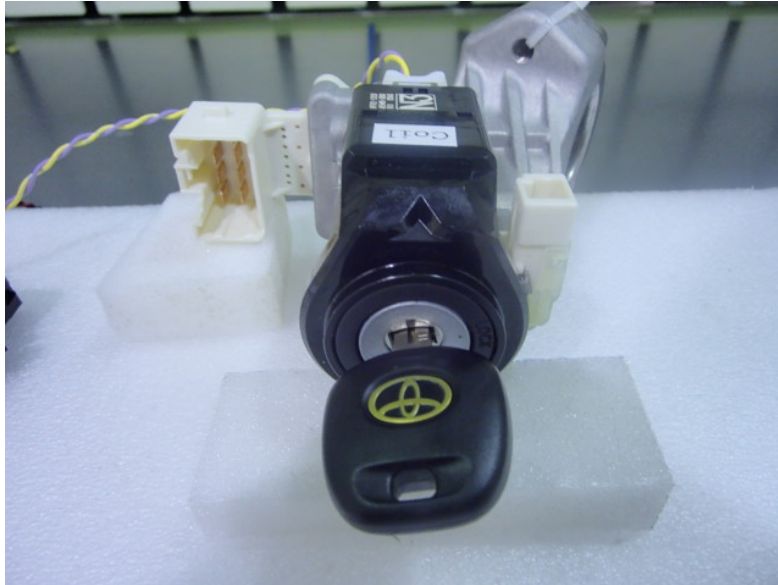
Mechanical Key (Inserted)

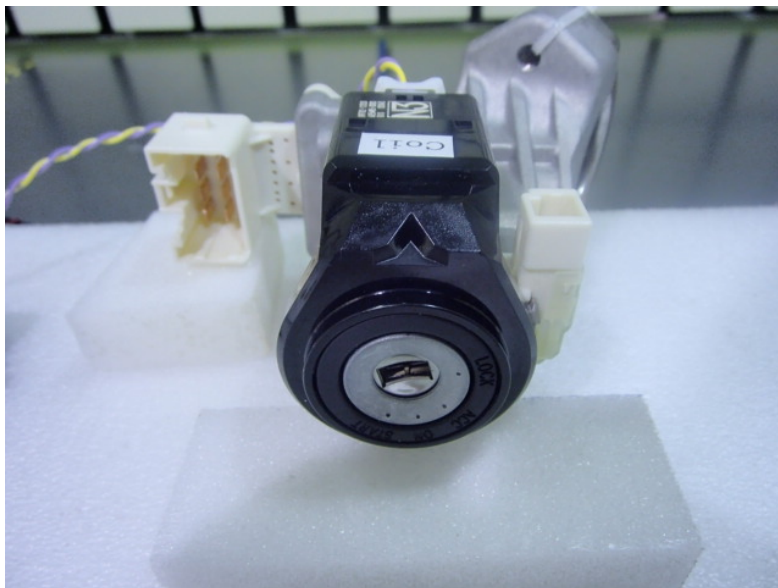
Mechanical Key (Not Inserted) Worst
