APPENDIX 3: Photographs of test setup

Radiated Emission

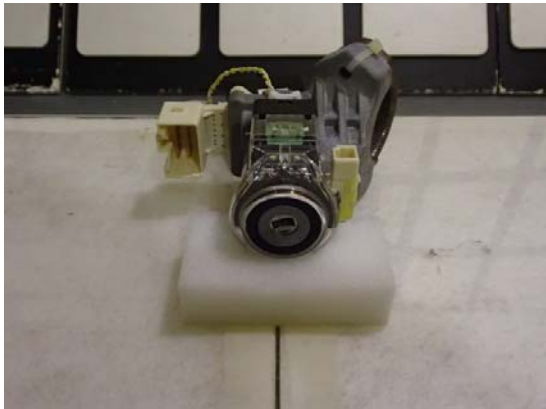
Immobilizer
Below 30 MHz
X-axis
Above 30 MHz
Horizontal: Z-axis / Vertical: Z-axis
X-axis

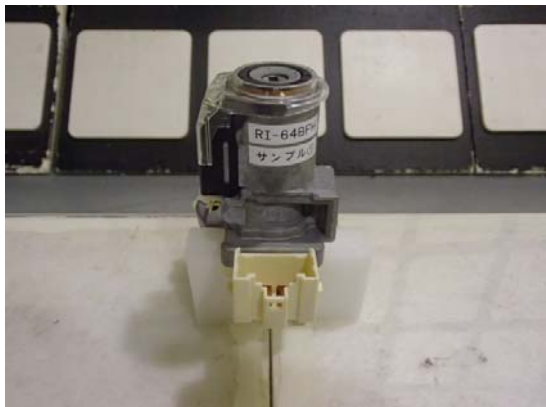
Y-axis

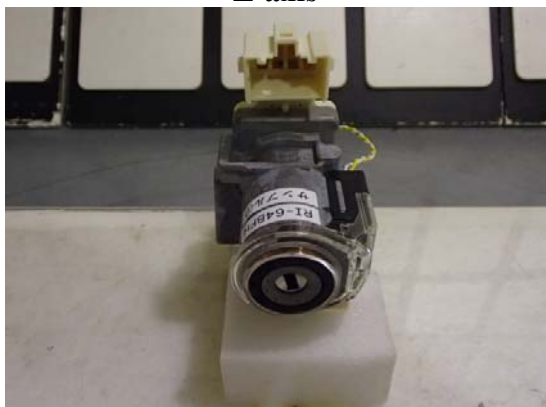
Z-axis

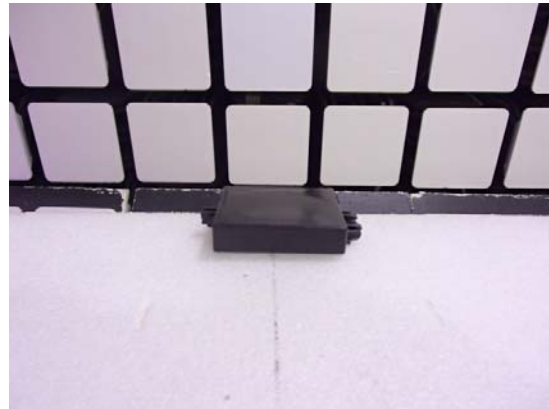
Controller with Amplifier
Below 30 MHz
X-axis
Above 30 MHz
Horizontal: X-axis / Vertical: X-axis
X-axis

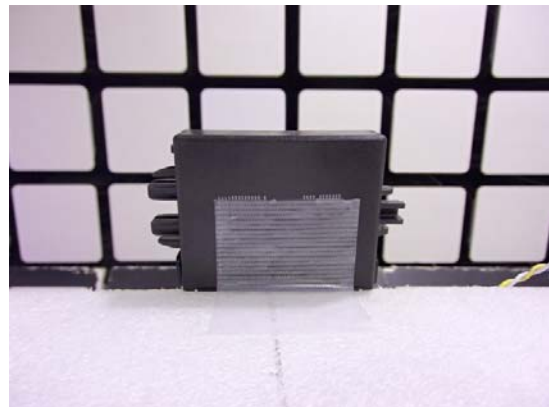
Y-axis

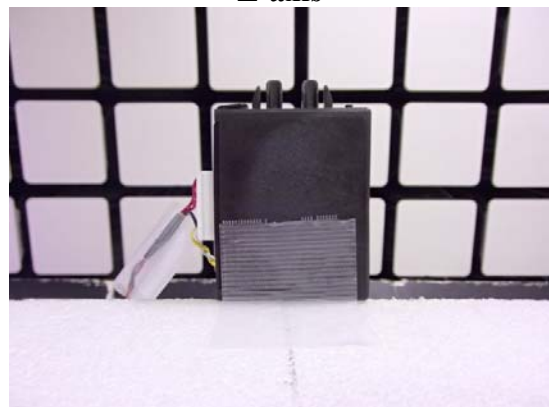
Z-axis

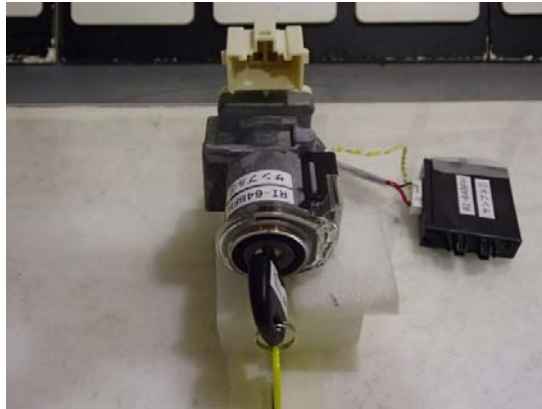
With key

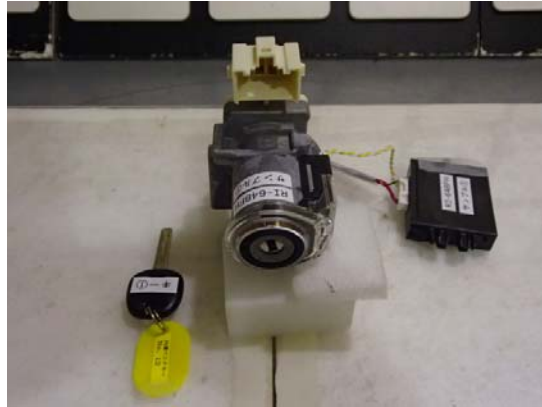
Without key (Worst)
