## TEST REPORT

REPORT NO: **SATEL-TR-0046-LH**  
TEST PERIOD: 08.09.2005  
TEST SITE: Satel / R&D Dept., Salo

DEVICE UNDER TEST: **SATELLINE-3AS VHF**

- Transient Frequency Behavior<sup>5</sup> of the transmitter  
#1: at 12.5 kHz channel spacing  
(pages 2 to 10, figures 1-18)  
on various temperatures  
(-30, -20, -10,  $\pm 0$ , +10, +20, +30, +40, +50 °C)

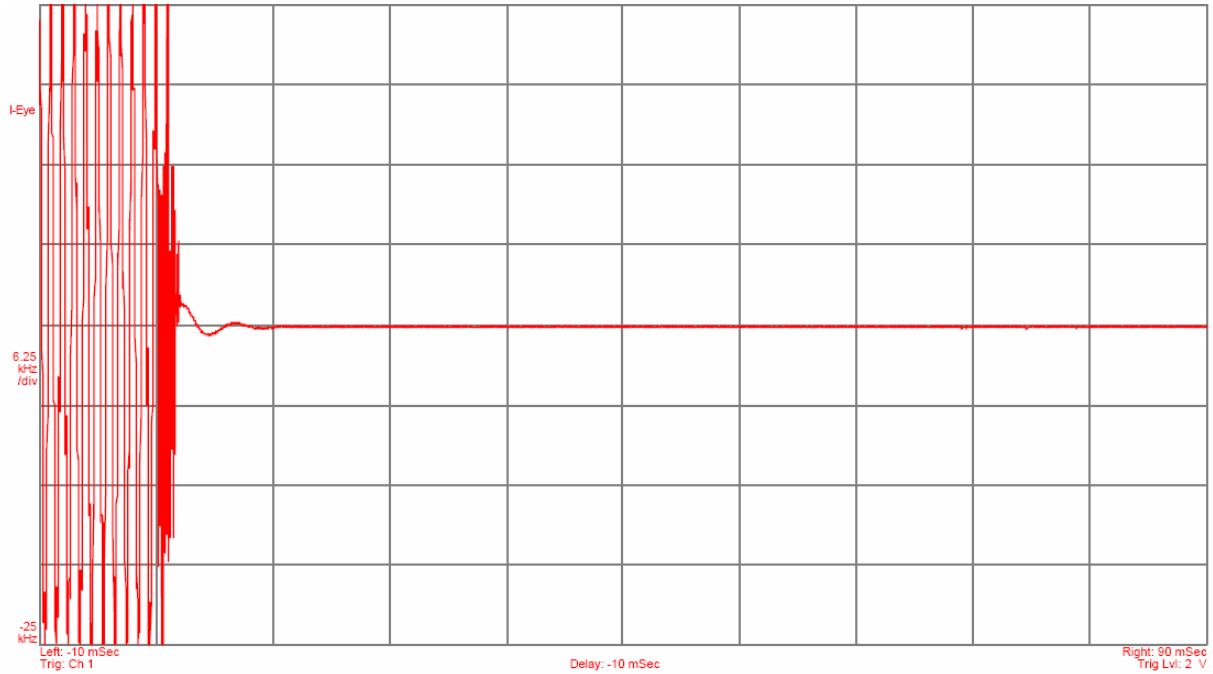
Fig. 1. Transmitter switched ON at  $-30^{\circ}\text{C}$ . (12.5 kHz ch. sp.)

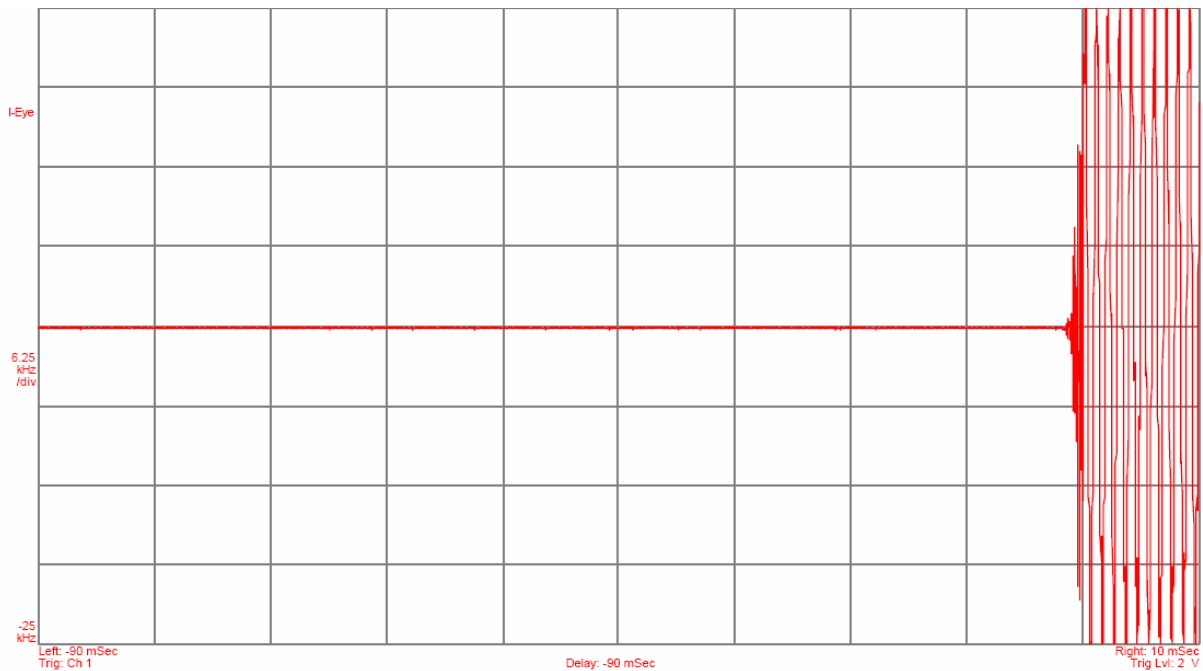
Fig. 2. Transmitter switched OFF at  $-30^{\circ}\text{C}$ . (12.5 kHz ch. sp.)

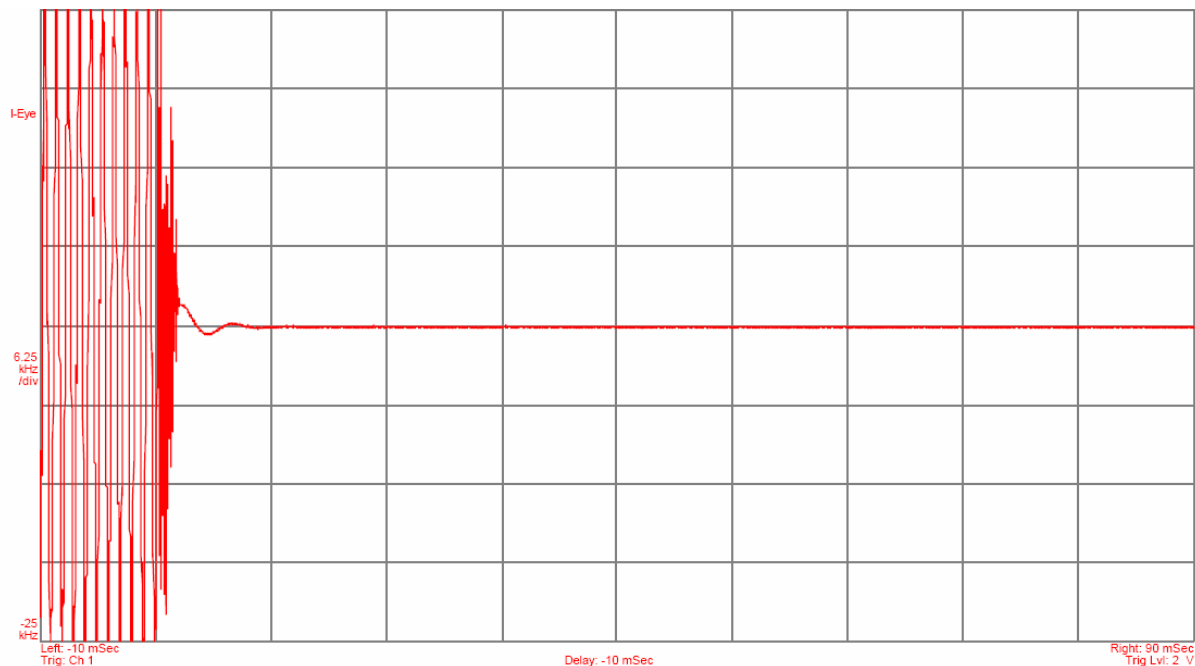
Fig. 3. Transmitter switched ON at  $-20^{\circ}\text{C}$ . (12.5 kHz ch. sp.)

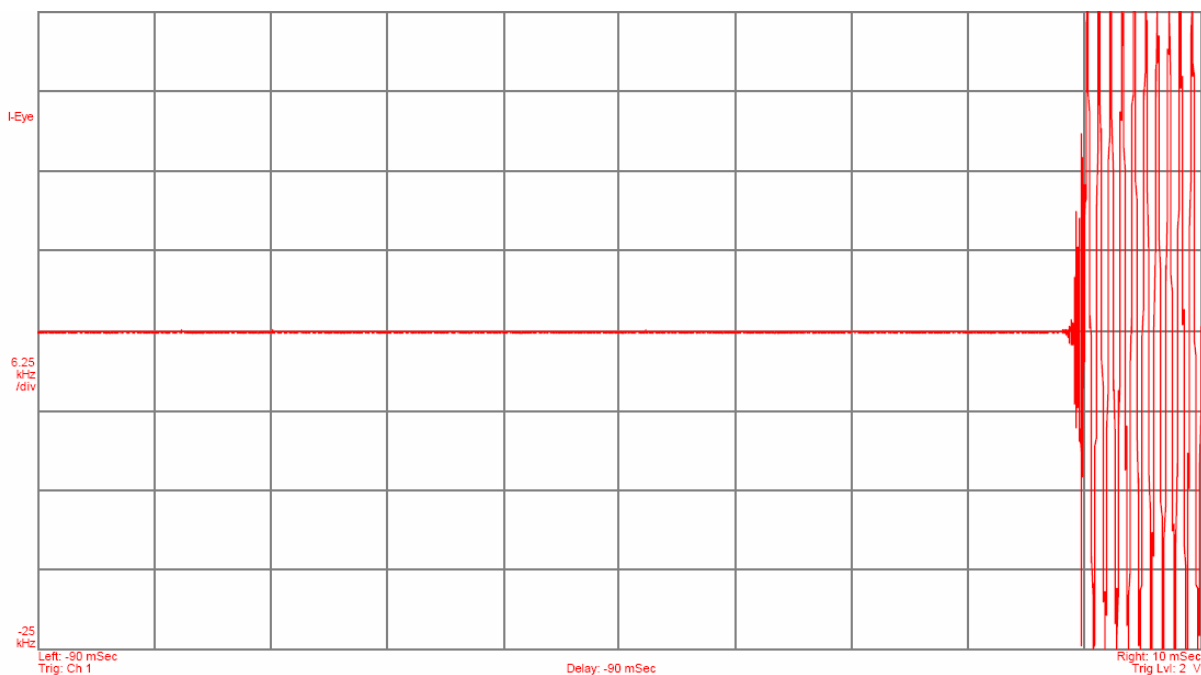
Fig. 4. Transmitter switched OFF at  $-20^{\circ}\text{C}$ . (12.5 kHz ch. sp.)

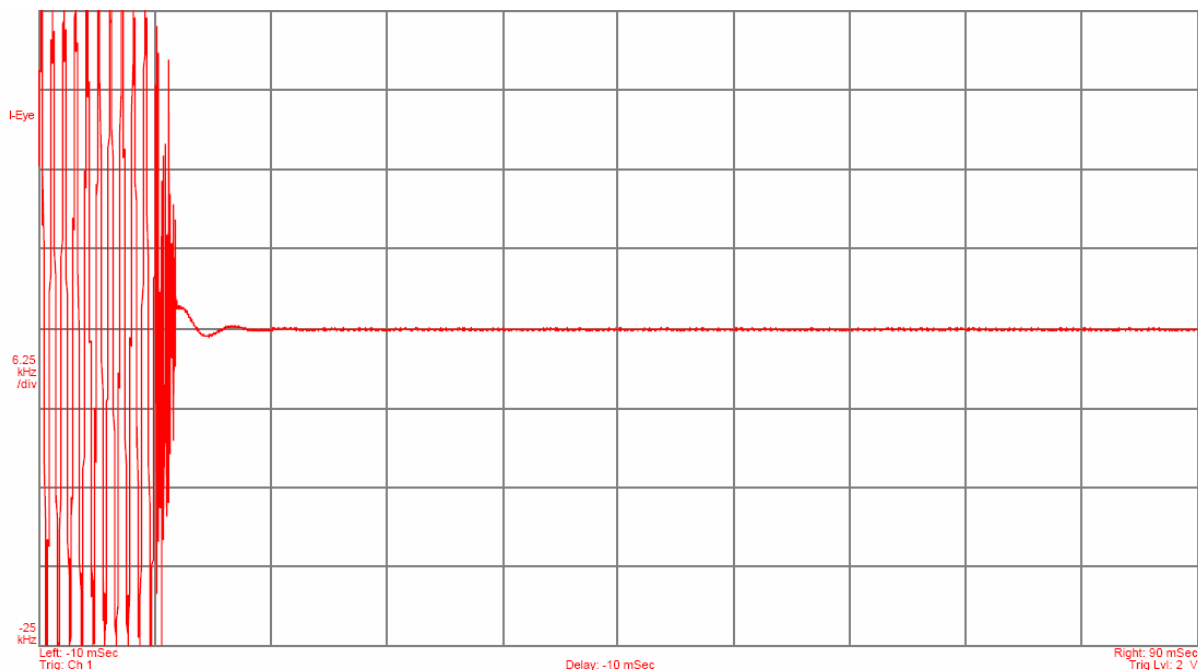
Fig. 5. Transmitter switched ON at  $-10^{\circ}\text{C}$ . (12.5 kHz ch. sp.)

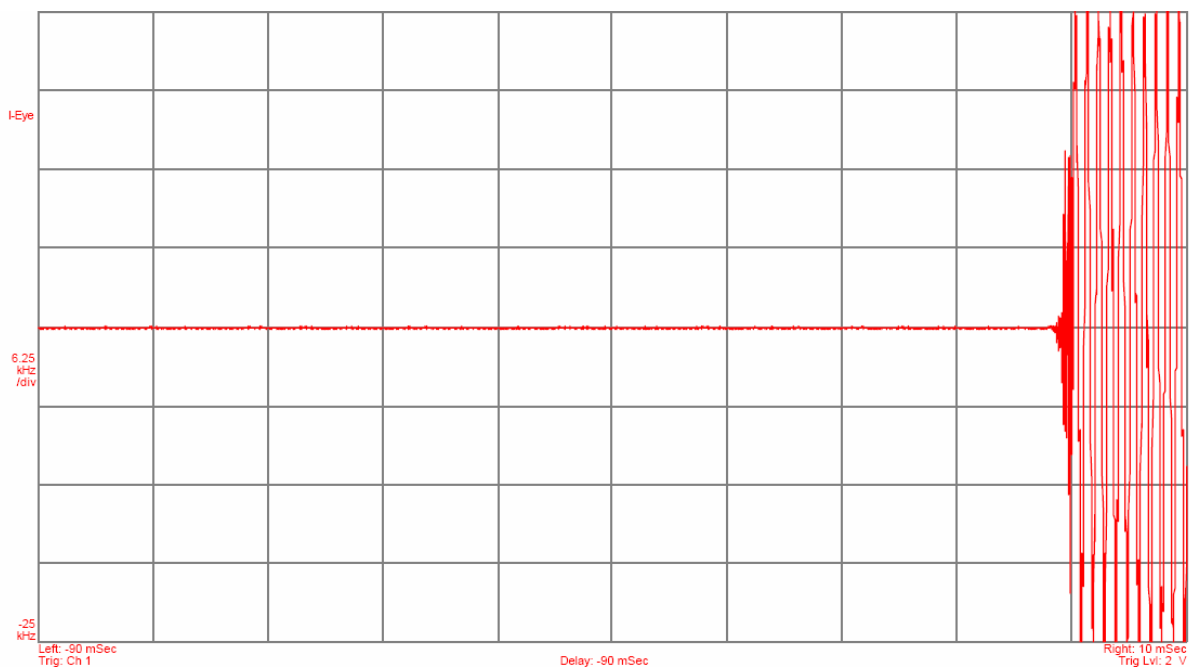
Fig. 6. Transmitter switched OFF at  $-10^{\circ}\text{C}$ . (12.5 kHz ch. sp.)

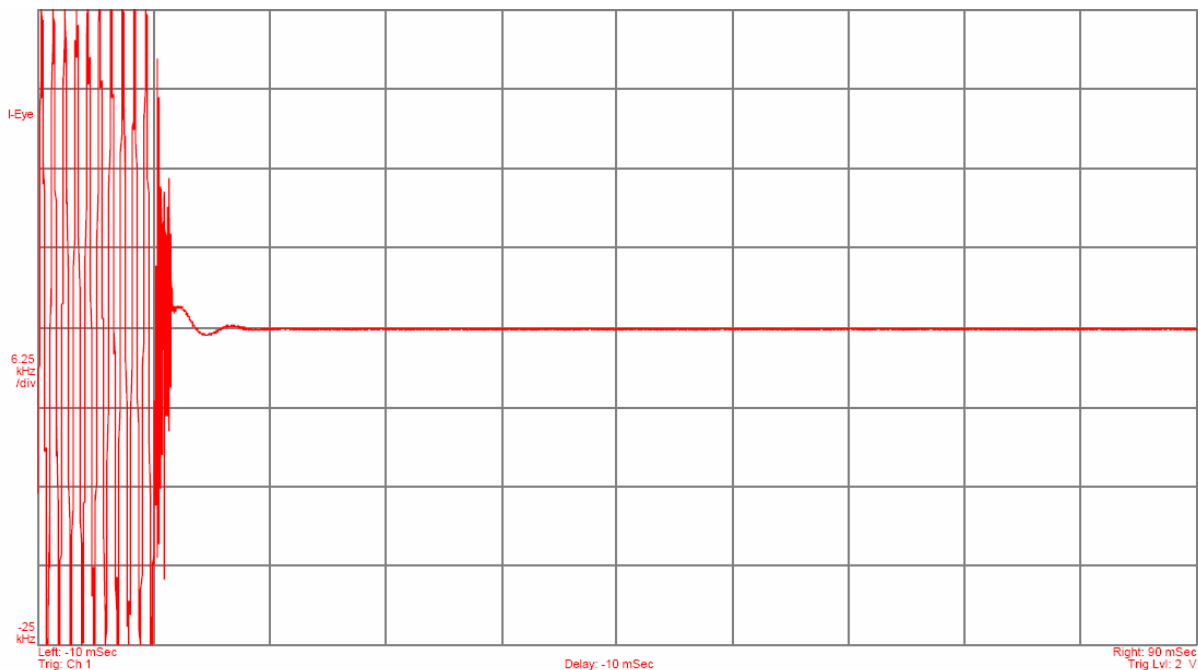
Fig. 7. Transmitter switched ON at 0 °C. (12.5 kHz ch. sp.)

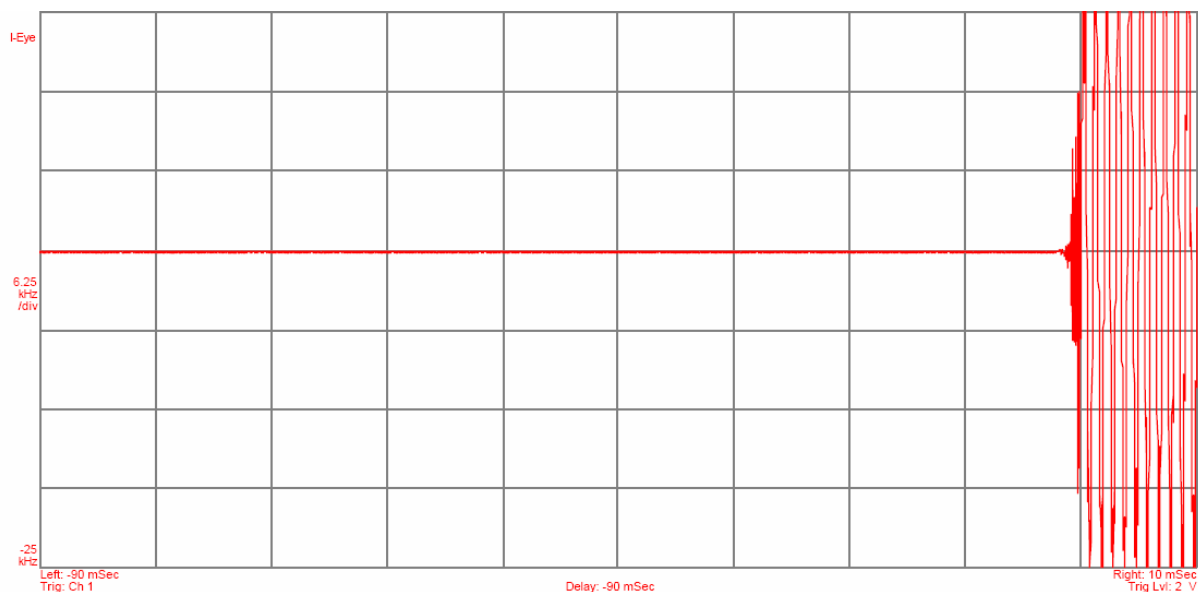
Fig. 8. Transmitter switched OFF at 0 °C. (12.5 kHz ch. sp.)

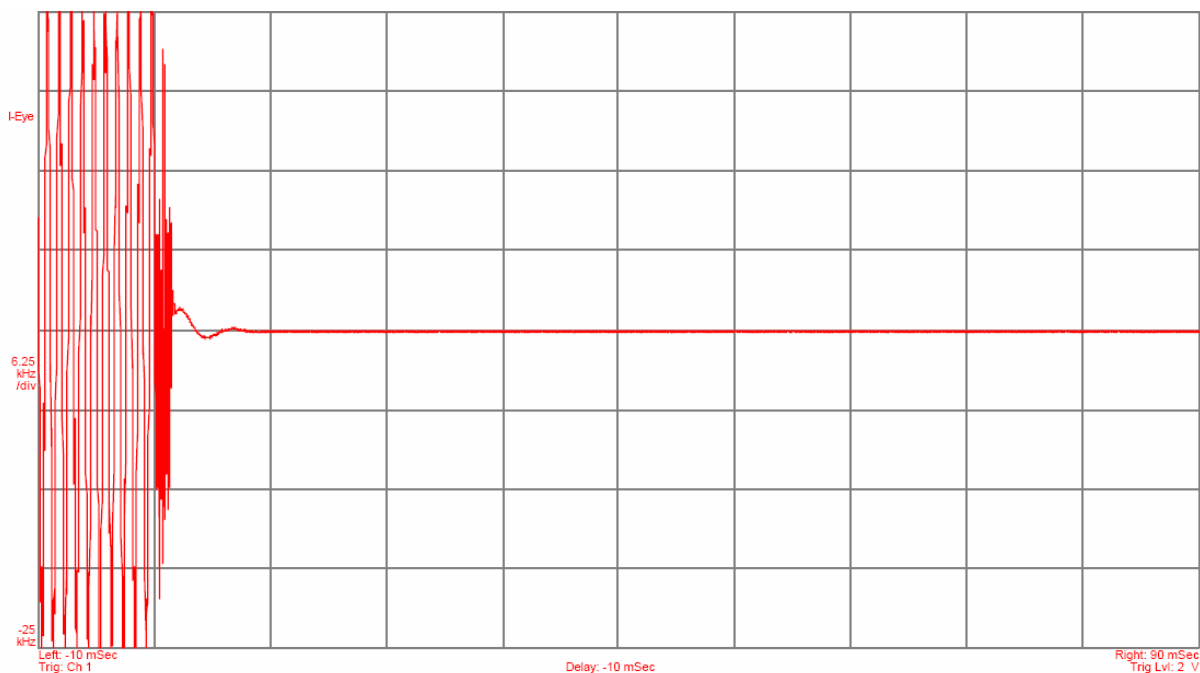
Fig. 9. Transmitter switched ON at +10 °C. (12.5 kHz ch. sp.)

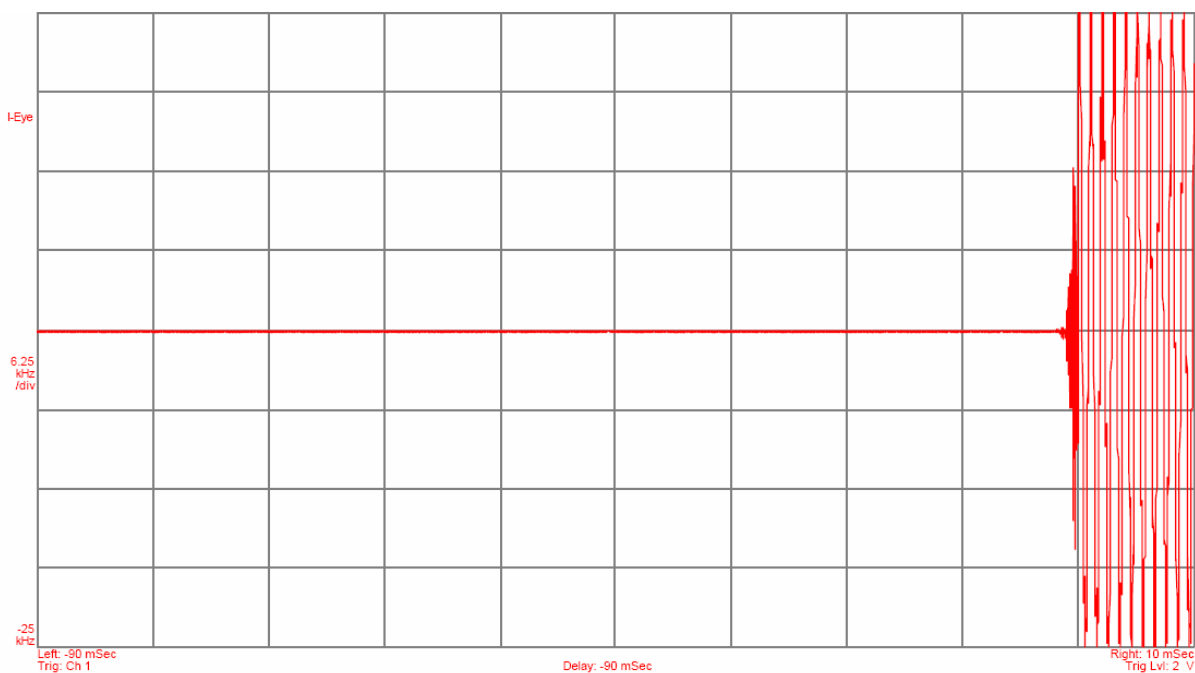
Fig. 10. Transmitter switched OFF at +10 °C. (12.5 kHz ch. sp.)

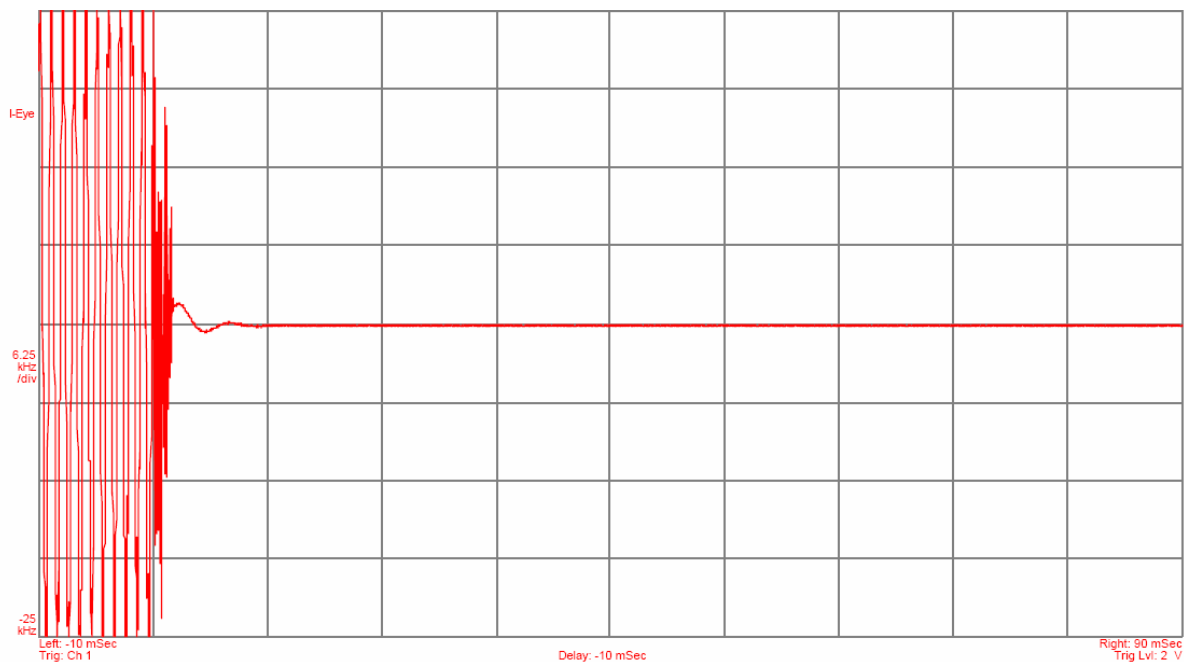
Fig. 11. Transmitter switched ON at +20 °C. (12.5 kHz ch. sp.)

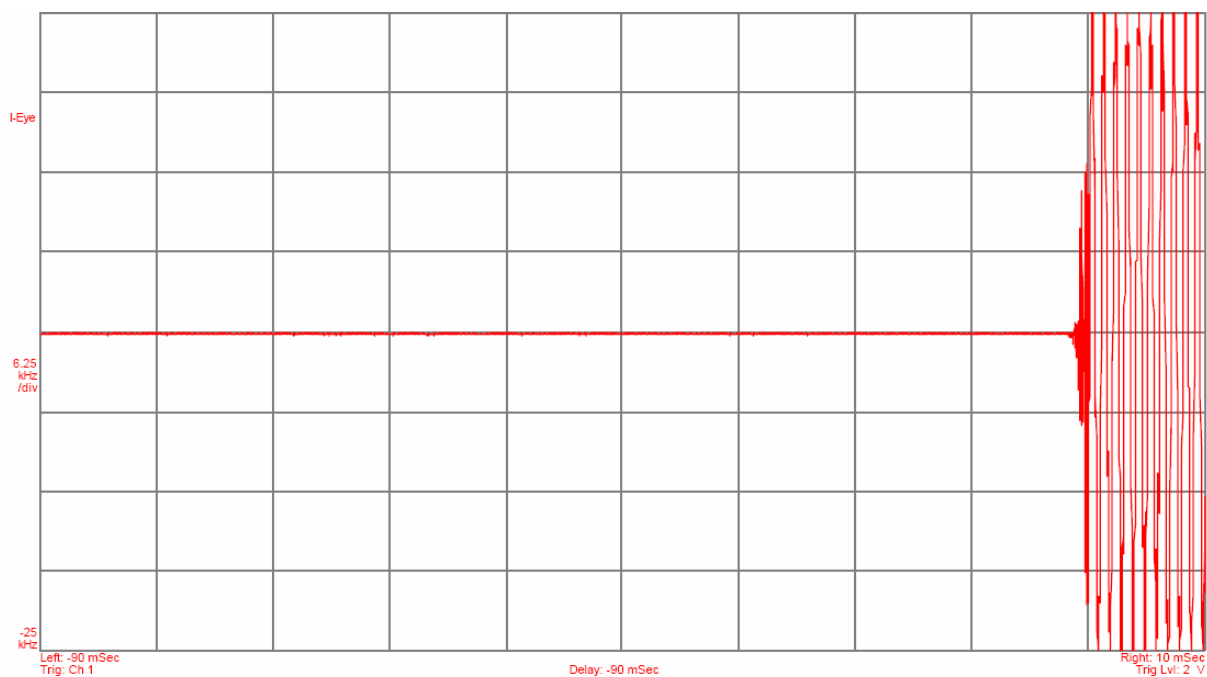
Fig. 12. Transmitter switched OFF at +20 °C. (12.5 kHz ch. sp.)

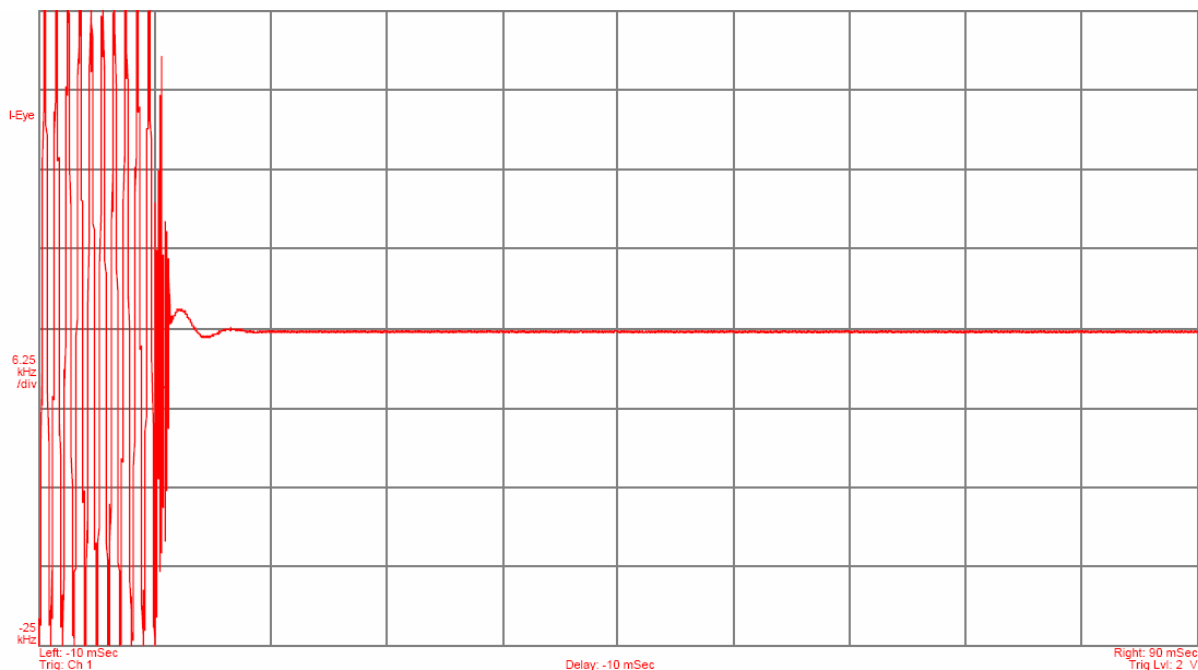
Fig. 13. Transmitter switched ON at +30 °C. (12.5 kHz ch. sp.)

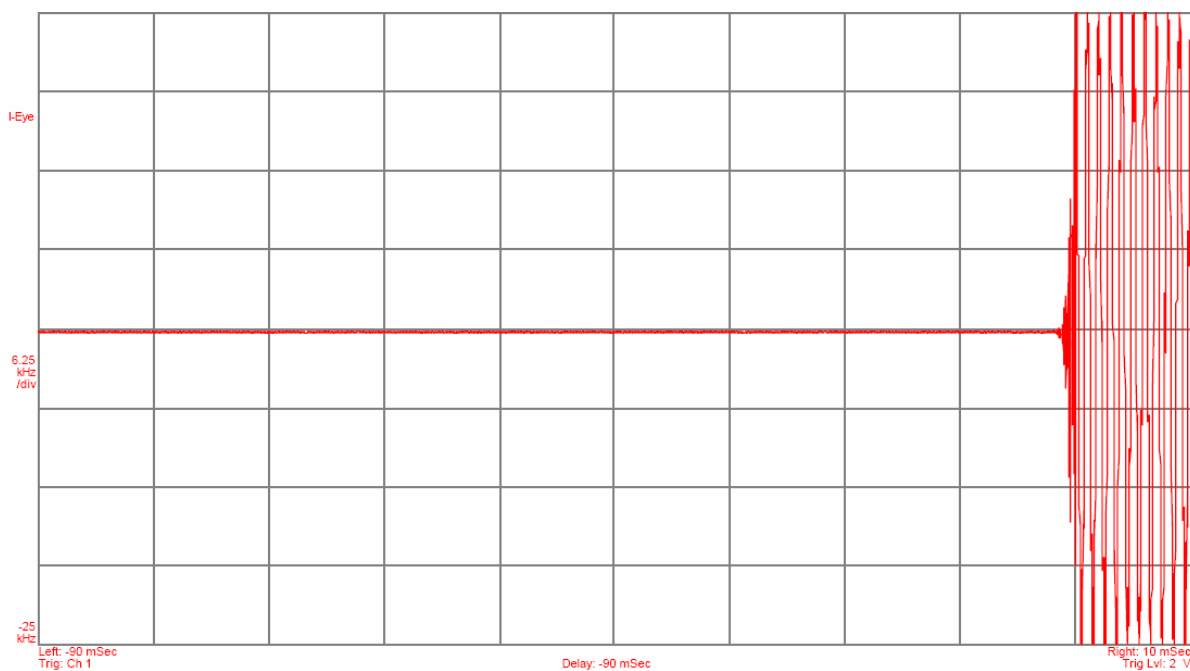
Fig. 14. Transmitter switched OFF at +30 °C. (12.5 kHz ch. sp.)

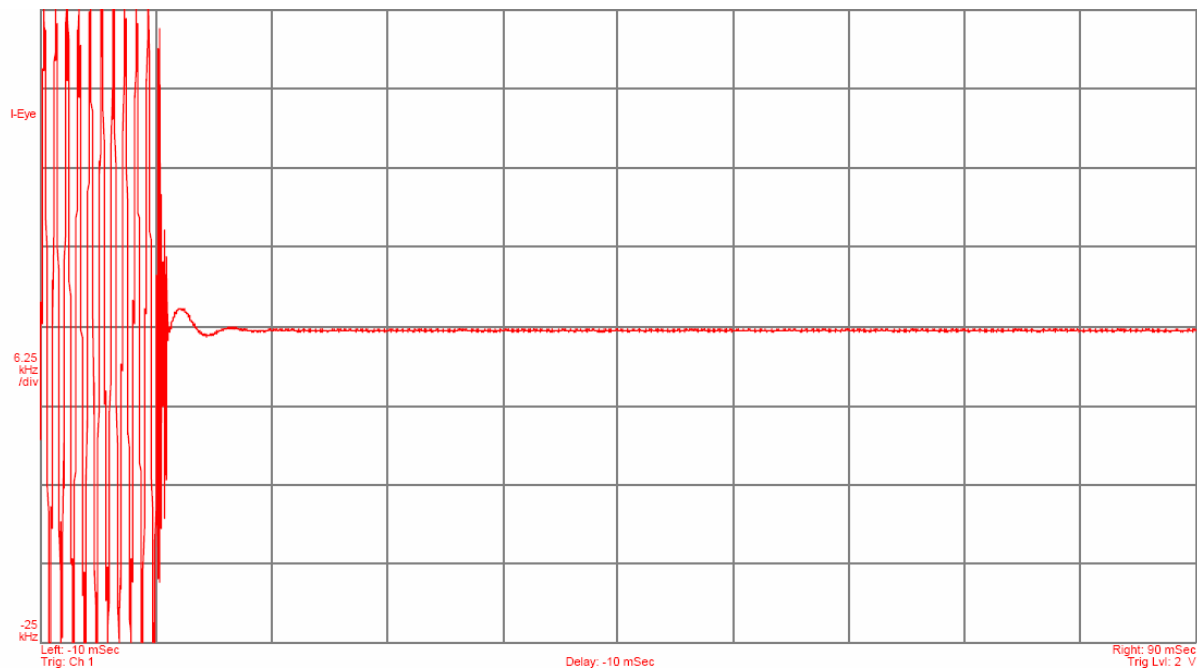
Fig. 15. Transmitter switched ON at +40 °C. (12.5 kHz ch. sp.)

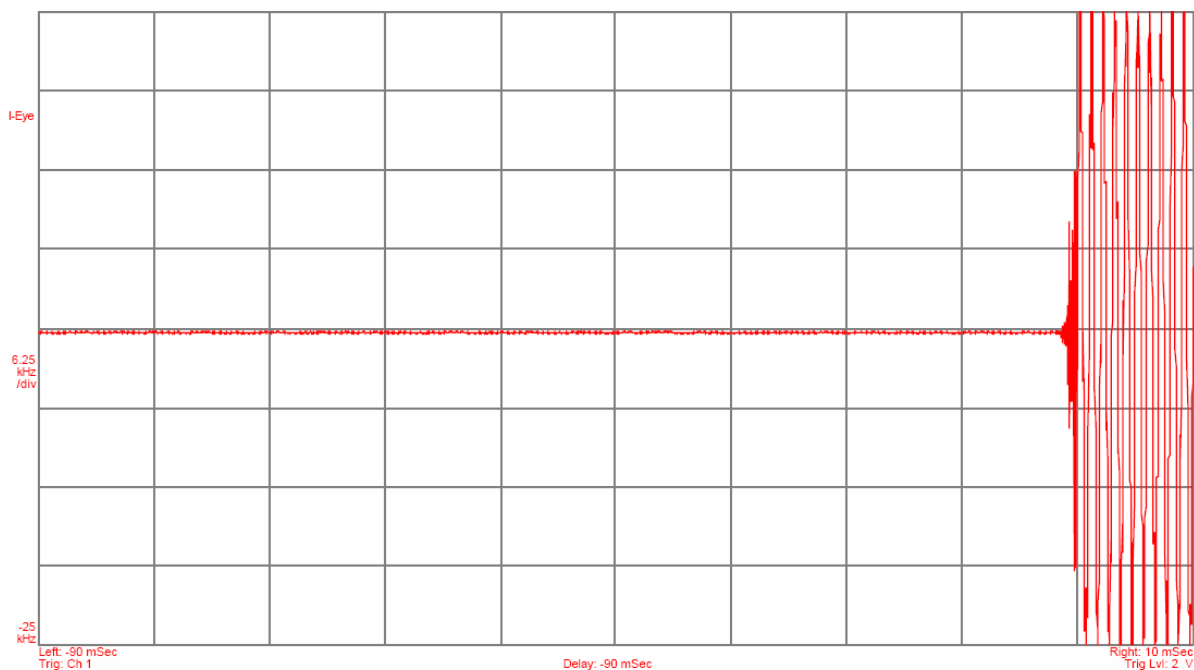
Fig. 16. Transmitter switched OFF at +40 °C. (12.5 kHz ch. sp.)

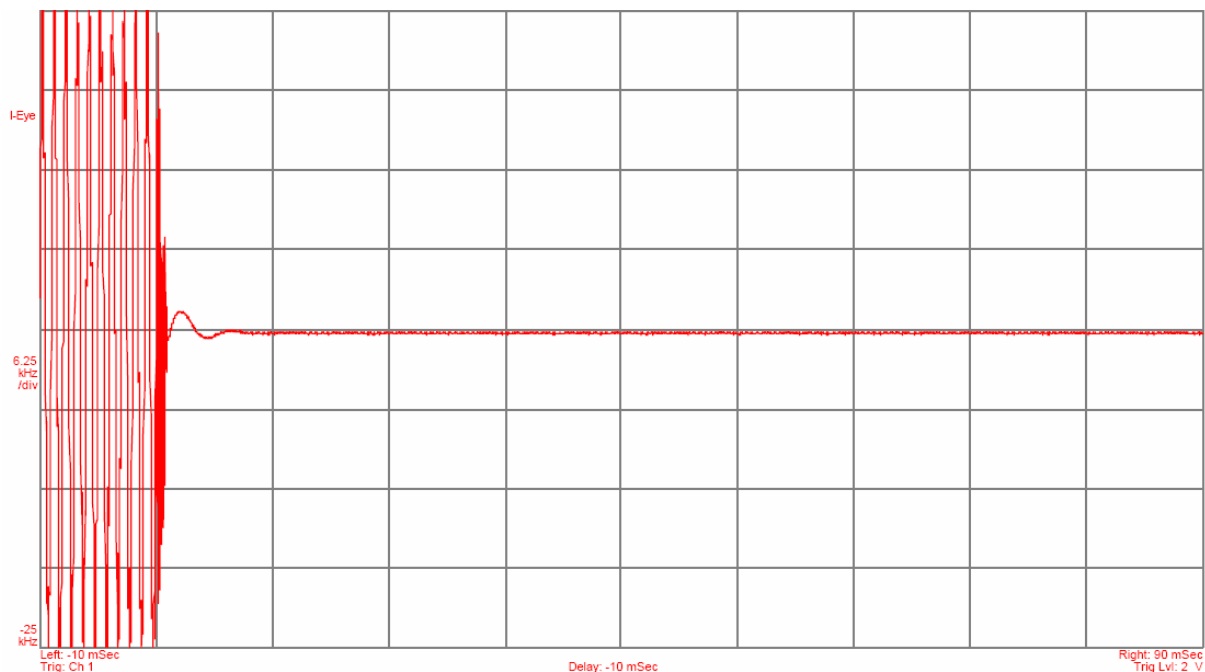
Fig. 17. Transmitter switched ON at +50 °C. (12.5 kHz ch. sp.)

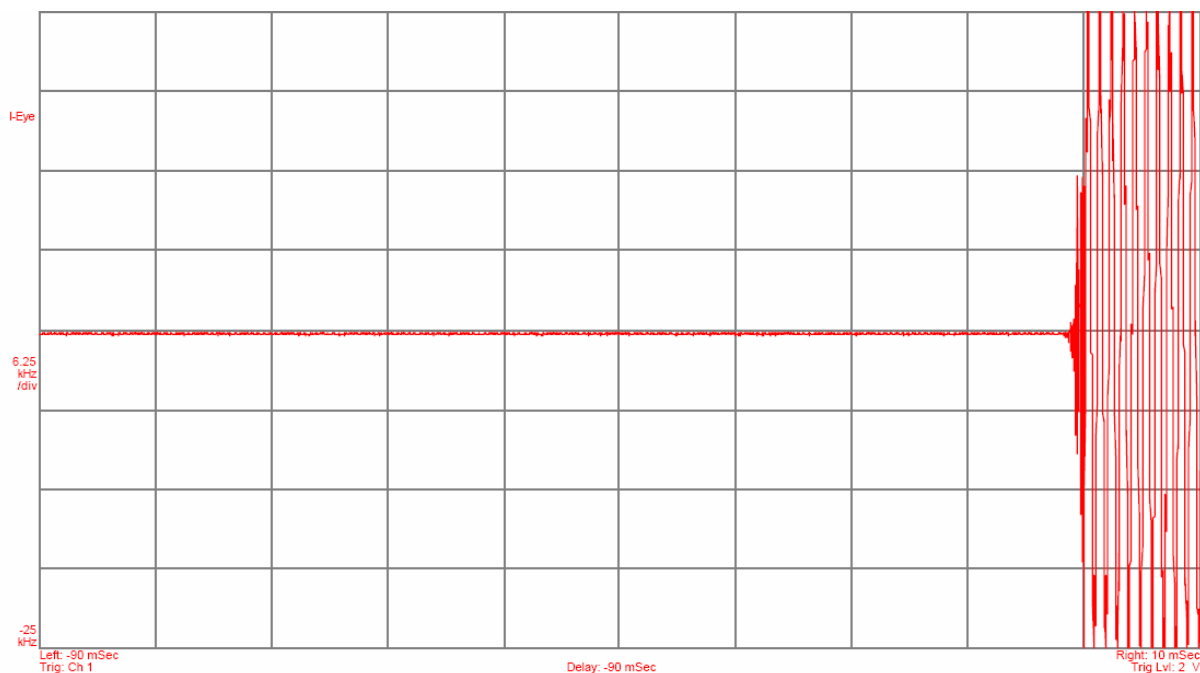
Fig. 18. Transmitter switched OFF at +50 °C. (12.5 kHz ch. sp.)
