RE: Schrader Electronics Limited

FCC: MRXALM4MA4

The following is in response to the comments made on the above referenced application.

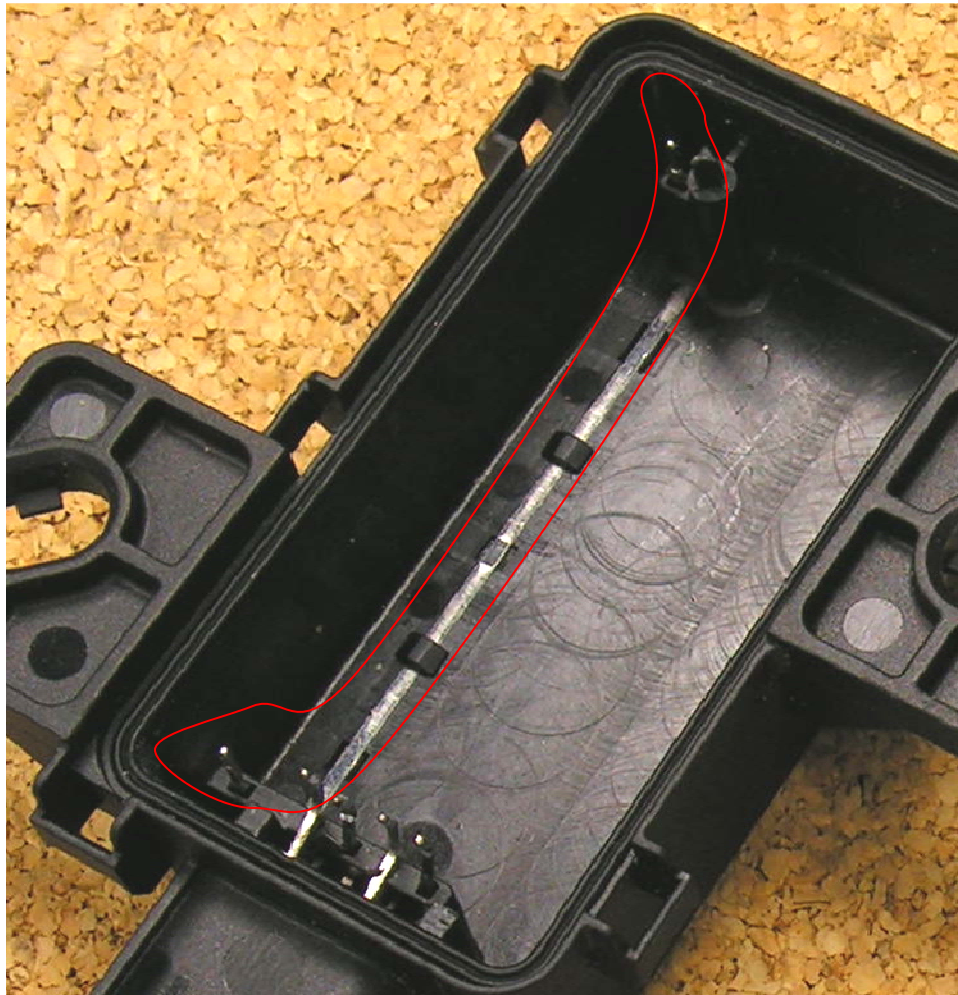
While it is somewhat hard to distinguish, the antenna is a piece of wire embedded into the plastic housing. The photograph below highlights its location.

1) The antenna appears to be external to the board. Is this antenna internal to the case or external? Was the antenna present or terminated into appropriate impedance? Test Photos do not appear to show any external connection other than power. Additionally, if the antenna was not present, then test data regarding 15.111 should be provided. Note there is a reference to Table 4.1 – but it doesn't exist.
