**Prüfbericht - Nr.:**  
*Test Report No.:*

**16013945 001**

## 6 Photographs of the Test Set-Up

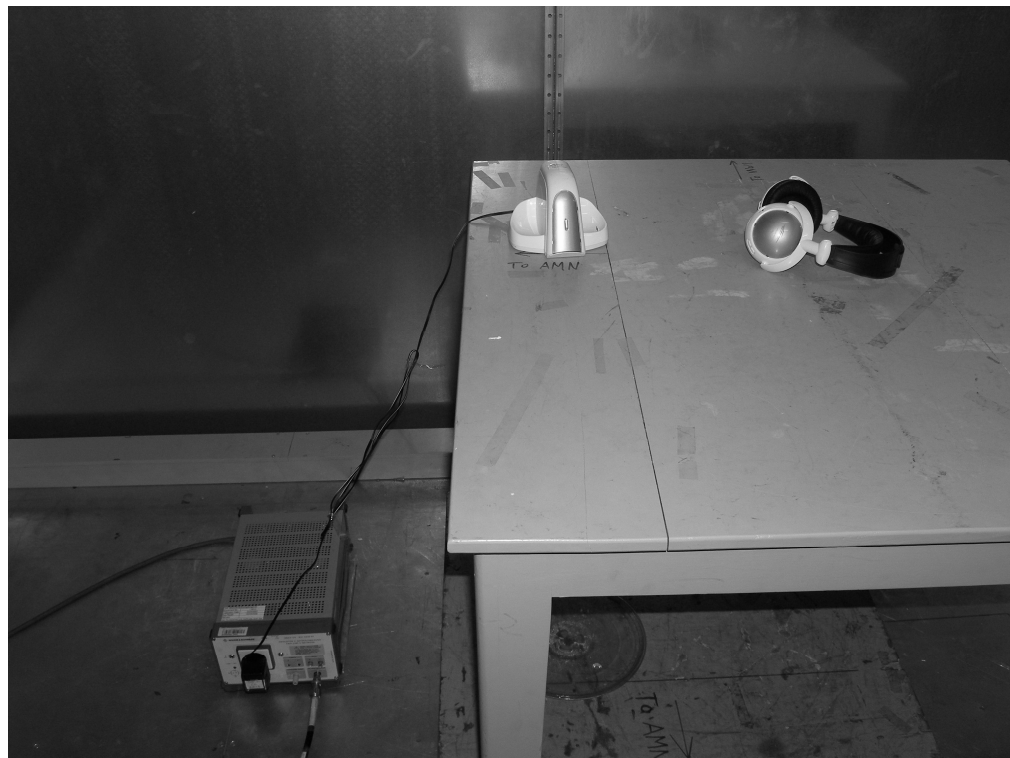
**Photograph 1: Set-up for Conducted Emission Measurement**

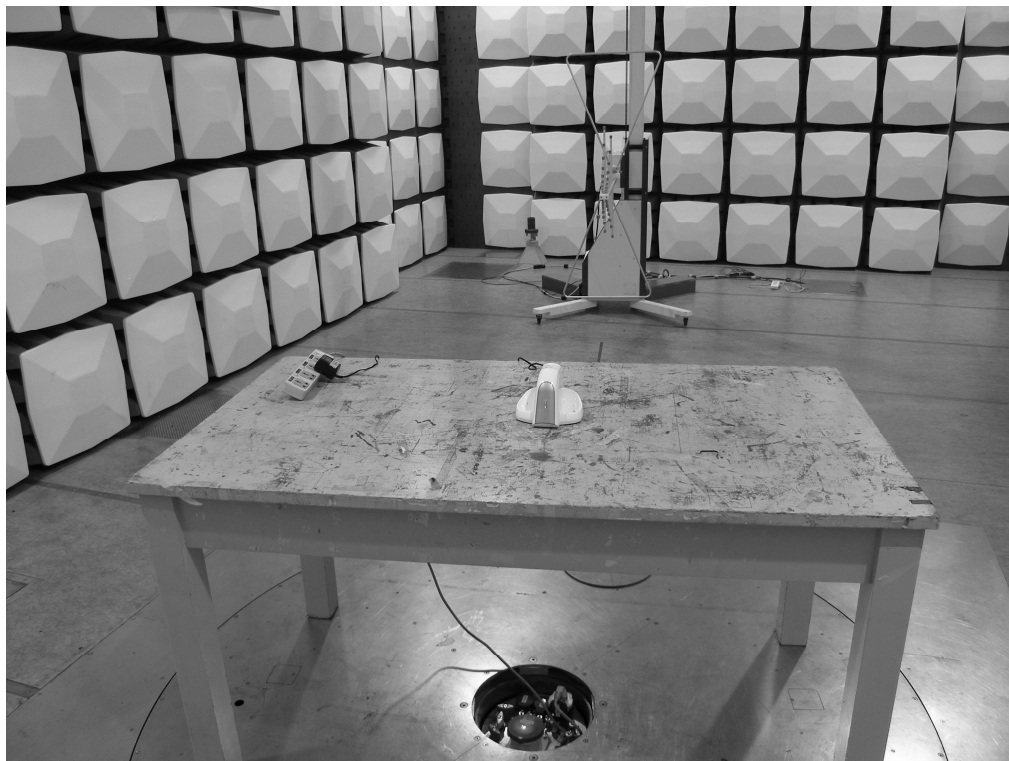
**Photograph 2: Set-up for Radiation Measurement below 1GHz**

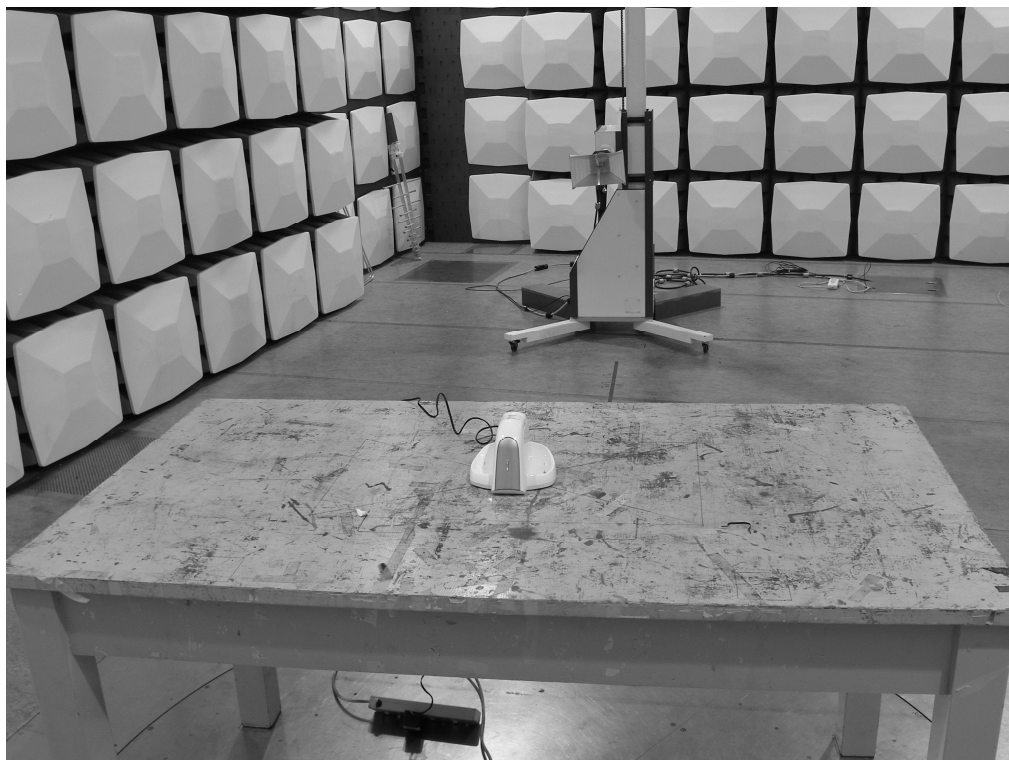
**Photograph 3: Set-up for Radiation Measurement above 1GHz**
